POST-WILDFIRE NATURAL HAZARDS RISK ANALYSIS OF THE 2023 CRATER CREEK WILDFIRE (K52125)

Dated:	June 17, 2025
Presented To:	Ministry of Forests – BC Wildfire Service
Attention:	Mr. Trevor Bohay & Mr. Gareth Wells
CGL Project #	24-0103
Version:	Final - Issued for Use

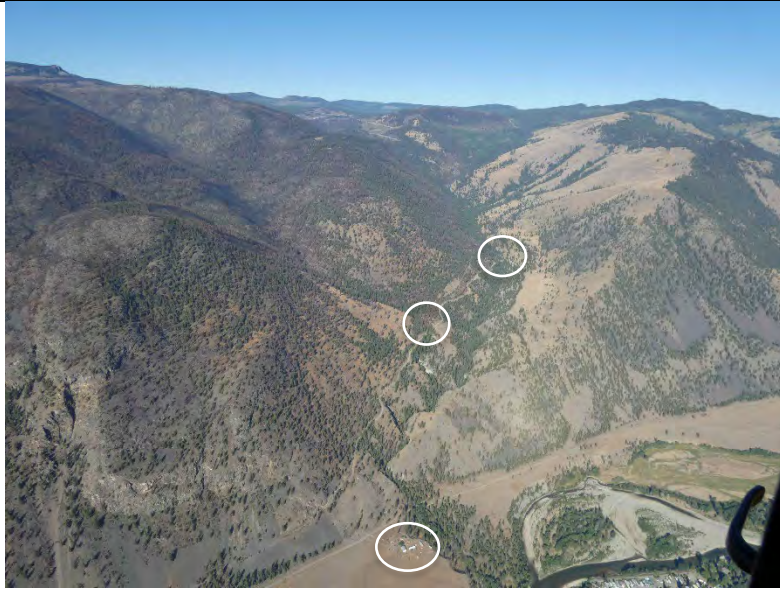
Photo 1: View of Paul Creek Watershed and Rattlesnake Creek Tributary from the Similkameen River. Note burned areas and forested alluvial fan area. Key stream crossings and residence in Ashnola 10 IR are circled.

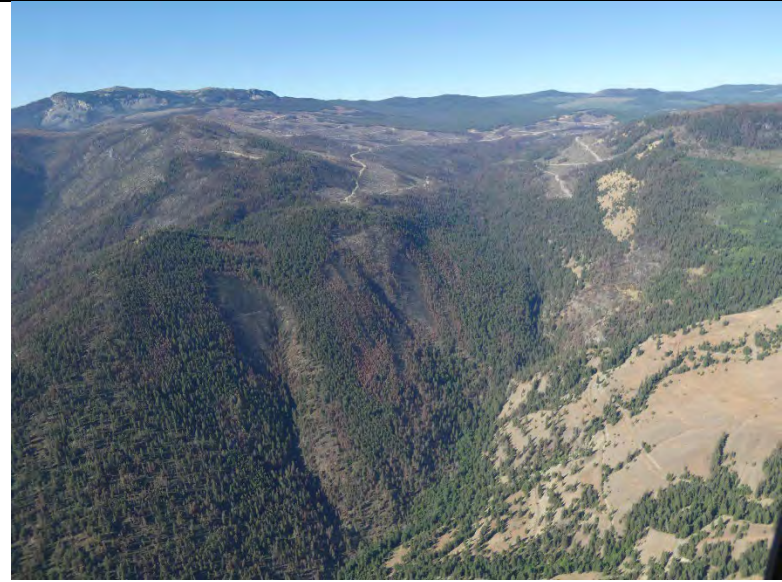
Photo 2: Steep burned gullies along middle Paul Creek and view of upper watershed area that has been logged (incl. salvage logging of burned timber).

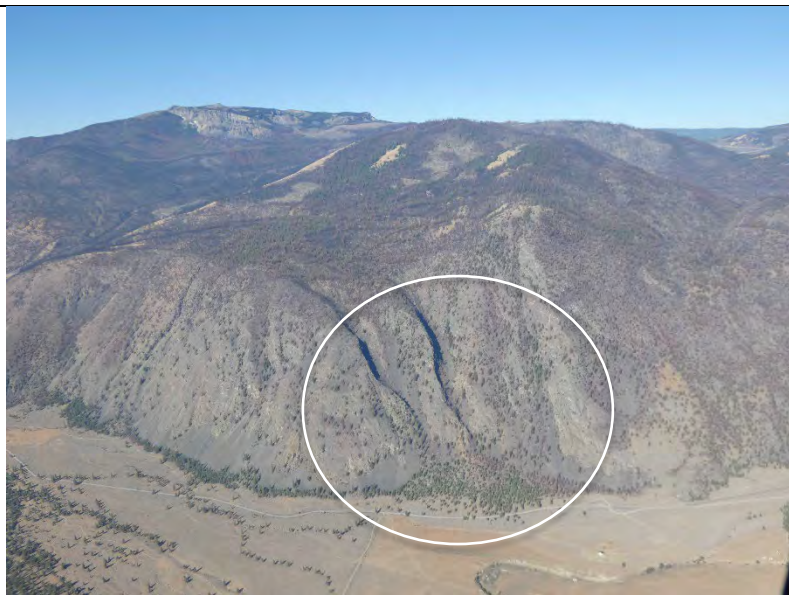
Photo 1: View of Similkameen Sub-Catchments 1 & 2 from the Similkameen River. Note burned areas on plateau, incised bedrock channels & fan area of Sub-Catchment 1 (circled).

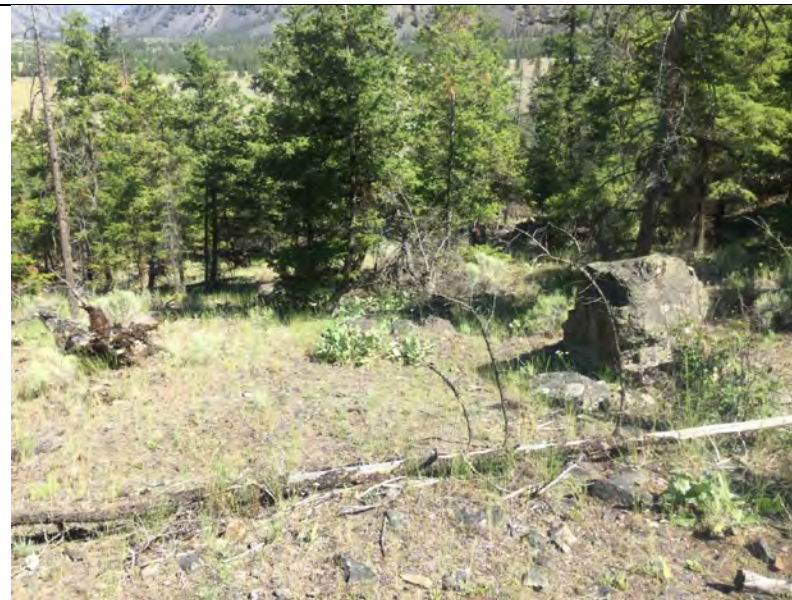
Photo 4: Large boulders on upper fan of Sub-Catchment 2. Forest is >100 years old.

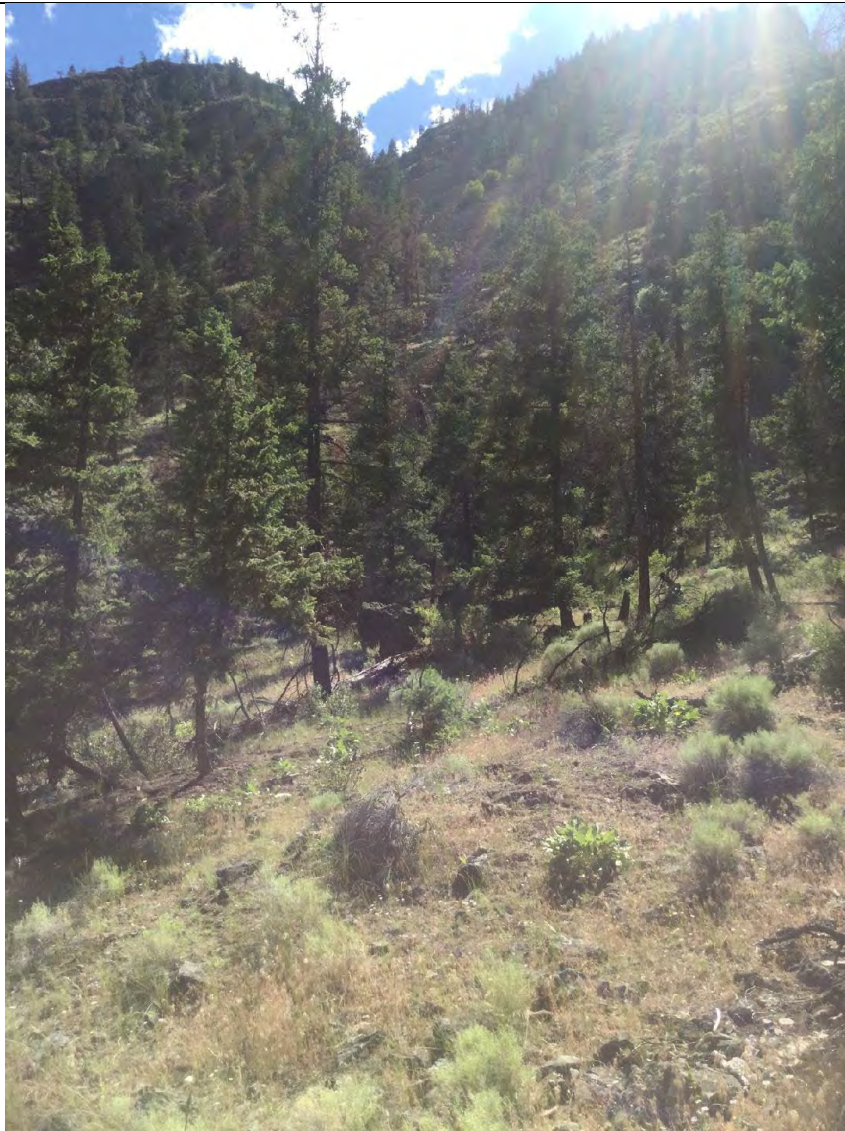
Photo 5: Sub-Catchment 2 fan, view upslope. Scattered cobble and boulder-sized material, few larger rocks.

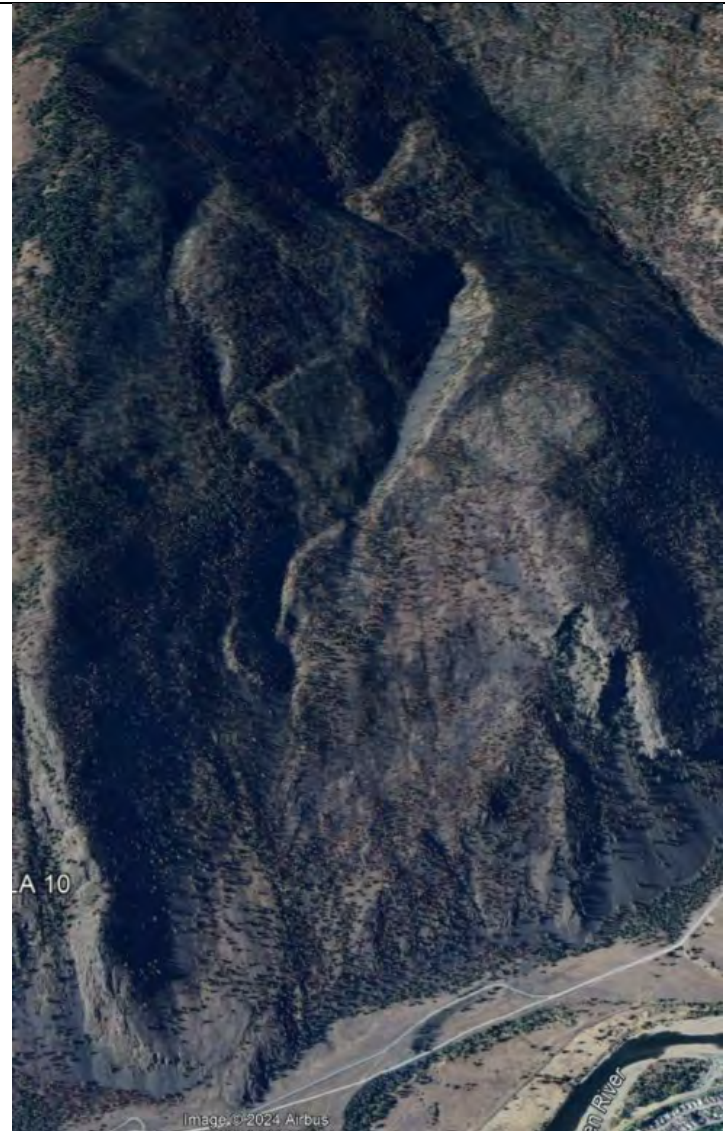
Photo 6: Oblique GoogleEarth image of Similkameen Sub-Catchment 1. Note abundant talus and lack of associated downslope fan (Low Hazard)

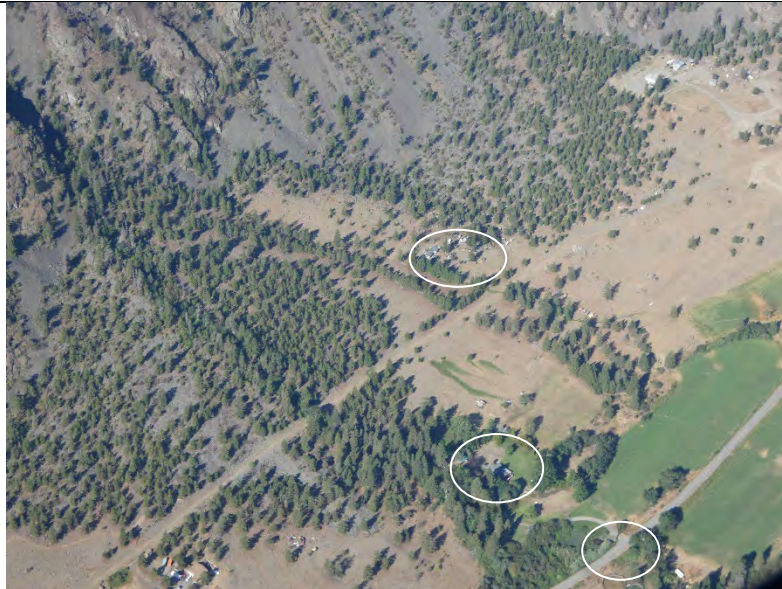
Photo 3: View of Bullock Creek fan area. Note two residences (circled), buried Fortis gas pipeline, and Ashnola Road with circled culvert.

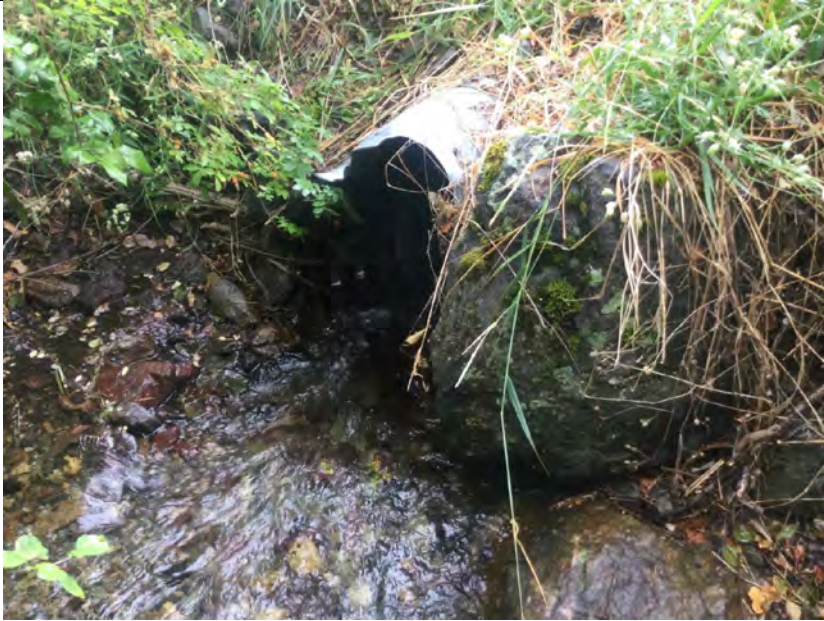
Photo 5: 600 mm diameter culvert at River Road, inlet damaged but free flowing. Some evidence of scour along streambanks but very little bedload movement.

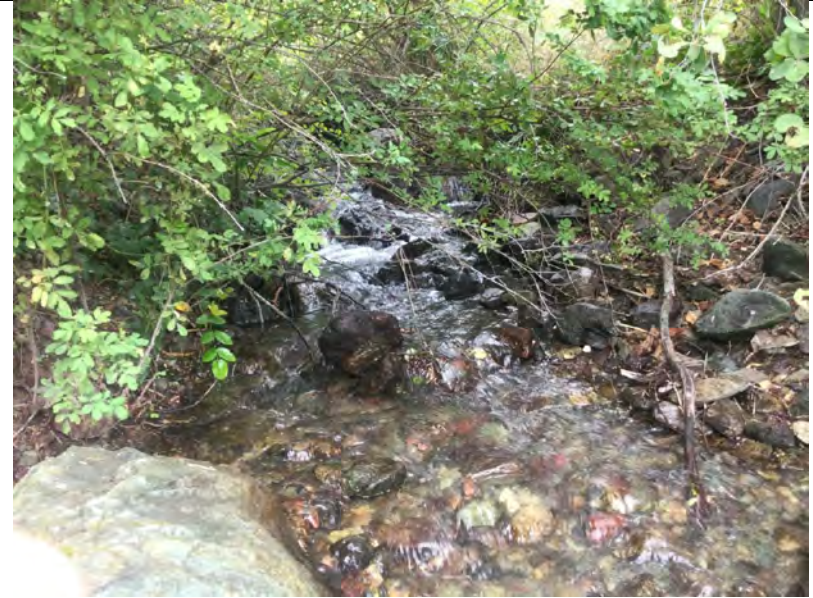
Photo 6: Watershed 2 stream channel view upstream from River Road. Note gravel to small cobble sized substrate.

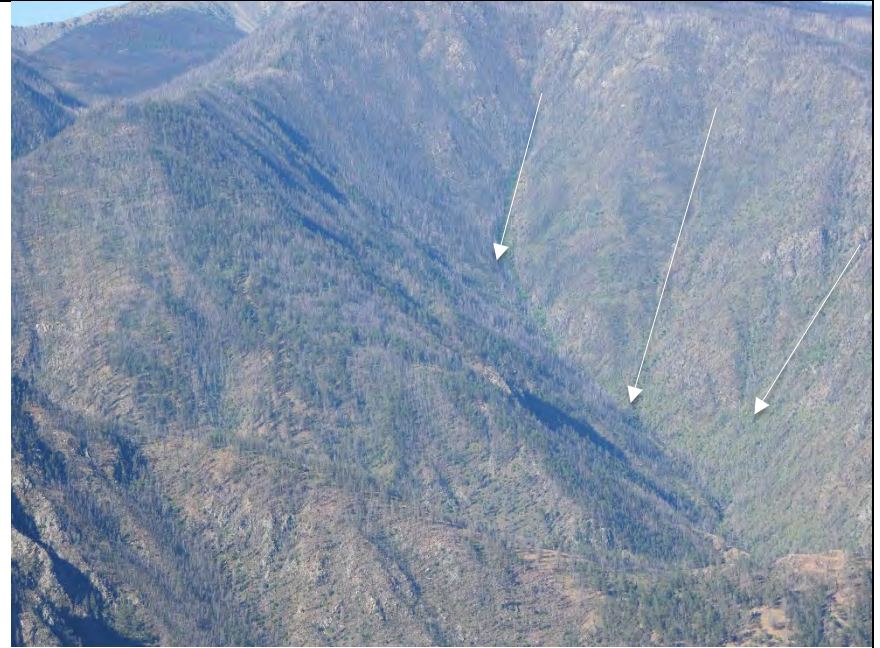
Photo 2: Helicopter overview photo of upper Barrington Creek watershed (north tributary) with evidence of instability along steep valley side slopes (arrows indicate flow paths).

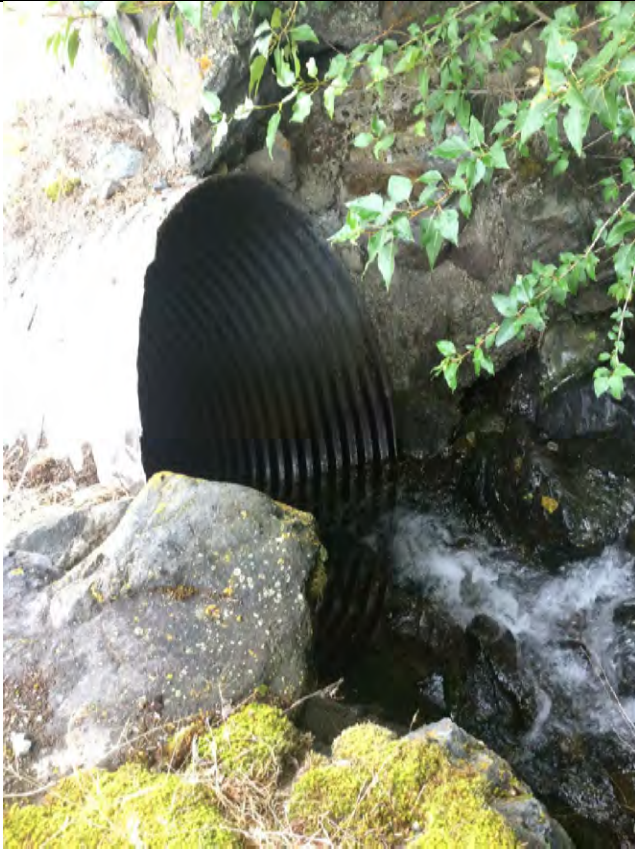
Photo 7: 5 ft (1,524 mm) diameter culvert encased in concrete at River Road is free flowing.

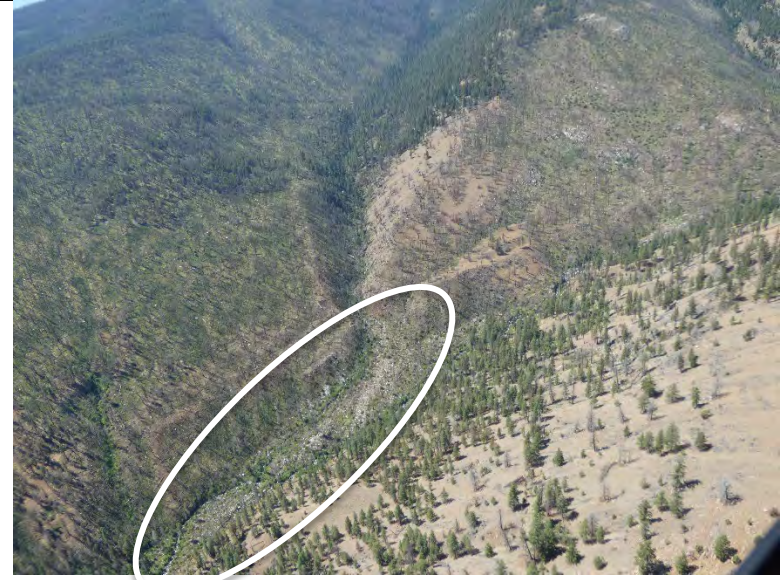
Photo 4: Zone of sediment deposition (indicated with circle) within the mainstem Susap Creek channel at, and downstream of, the confluence of Coulthard Creek.

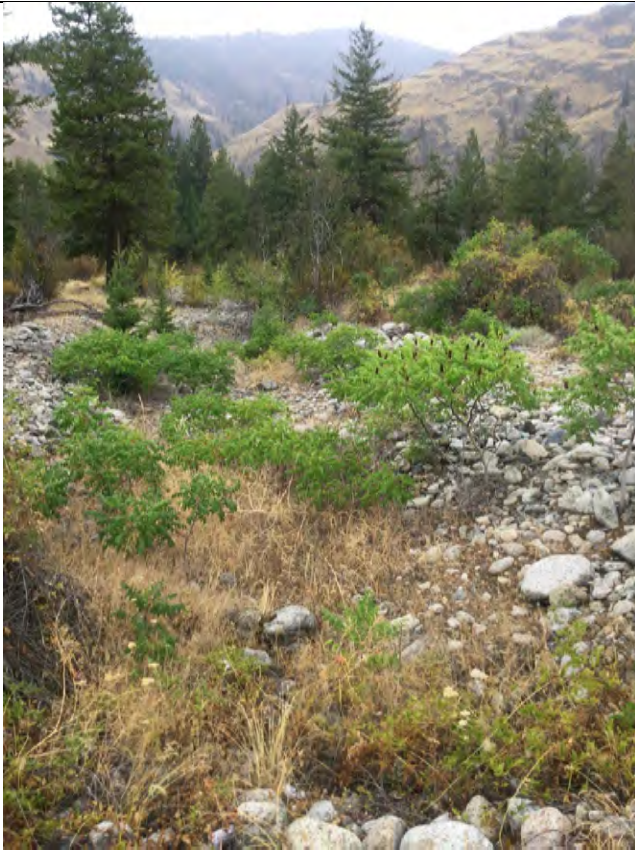
Photo 8: Avulsion channel (dry) on Susap Creek alluvial fan visible from Chopaka Road.

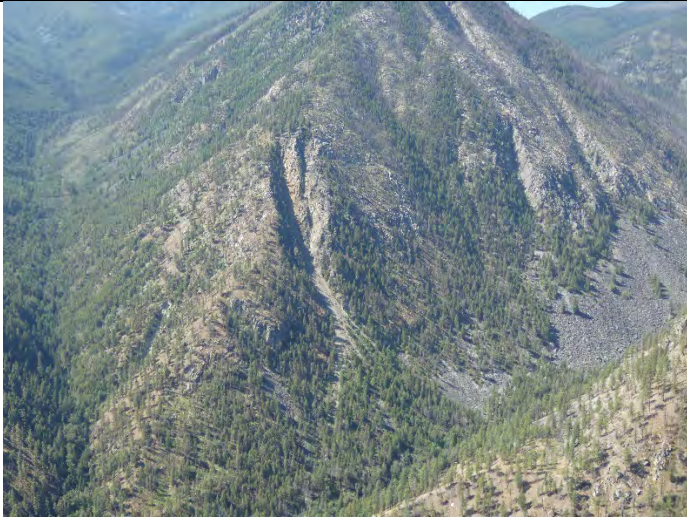
Photo 3: Middle reaches of Snehumpton Creek, showing connectivity with side slopes and abundant colluvium (talus) deposits and unstable rock gullies.

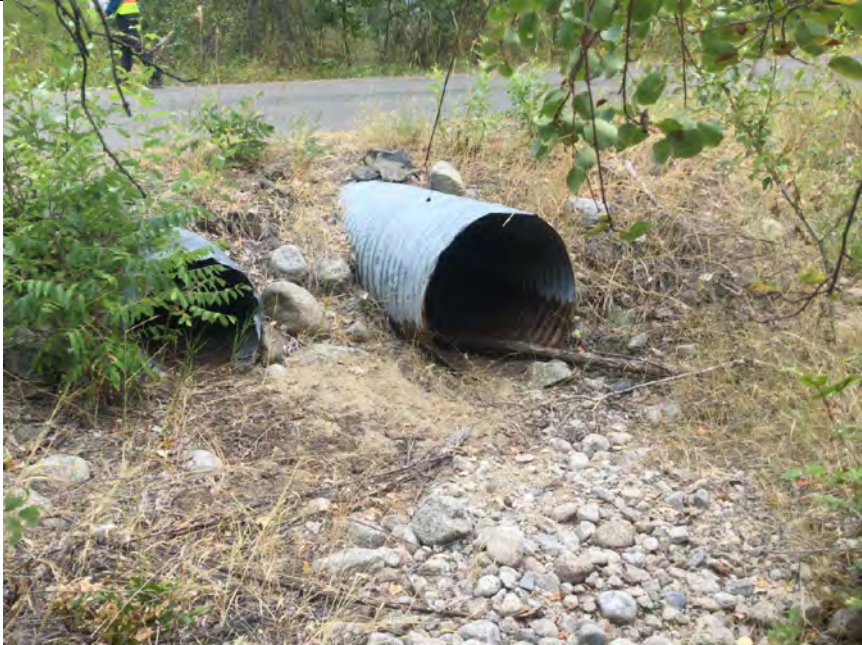
Photo 10: Two culverts on Chopaka Road at the seasonal channel in Photo 9 (600 mm and 800 mm diameter culverts).

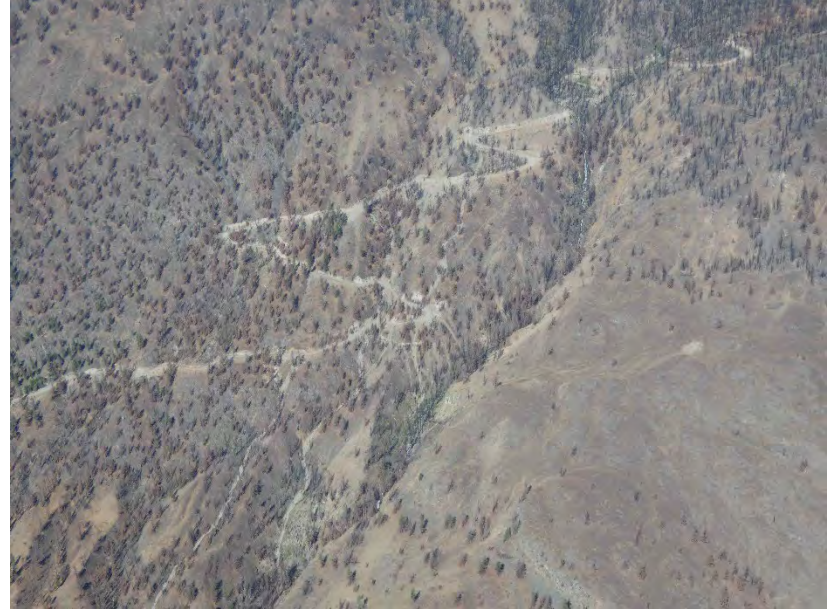
Photo 4: View of the Crater FSR with numerous drainage-related washouts and failures into Red Bridge Creek.

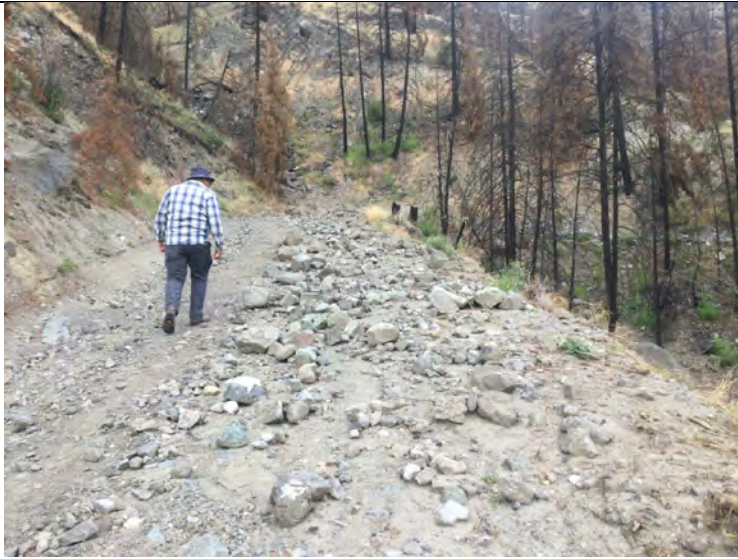
Photo 5: Washout along Crater Creek FSR at Red Bridge Creek.

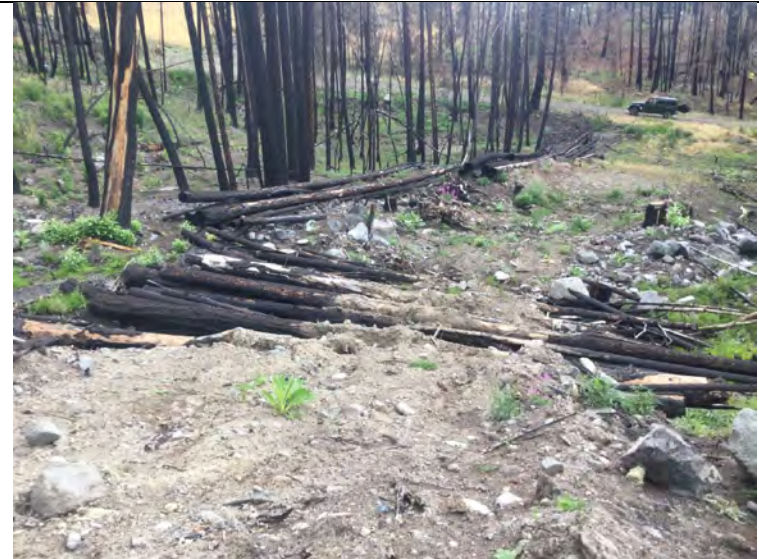
Photo 6: Corduroy stream crossing in area logged pre-wildfire (Red Bridge 1). Recommend rehabilitation of crossing due to anticipated increases in runoff.

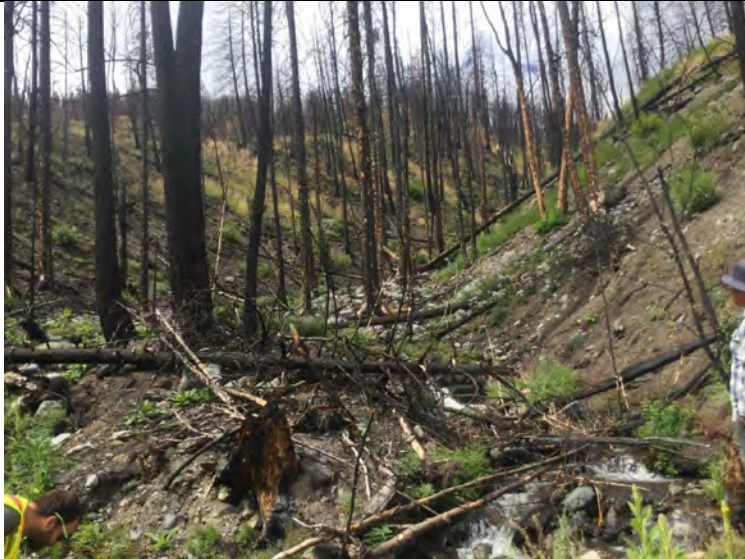
Photo 7: Red Bridge Creek, view upstream at FSR road crossing (Red Bridge 4) with existing 1000 mm culvert. Note burned steep side slopes.

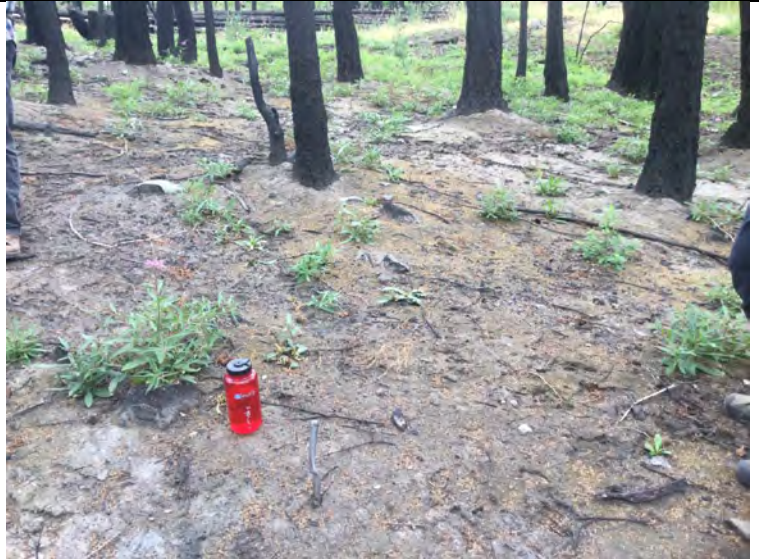
Photo 8: Area of high burn severity. Complete loss of organics and visible mineral soils. Lack of surface erosion on the low gradient slope area. High degree of water repellency soils in area.

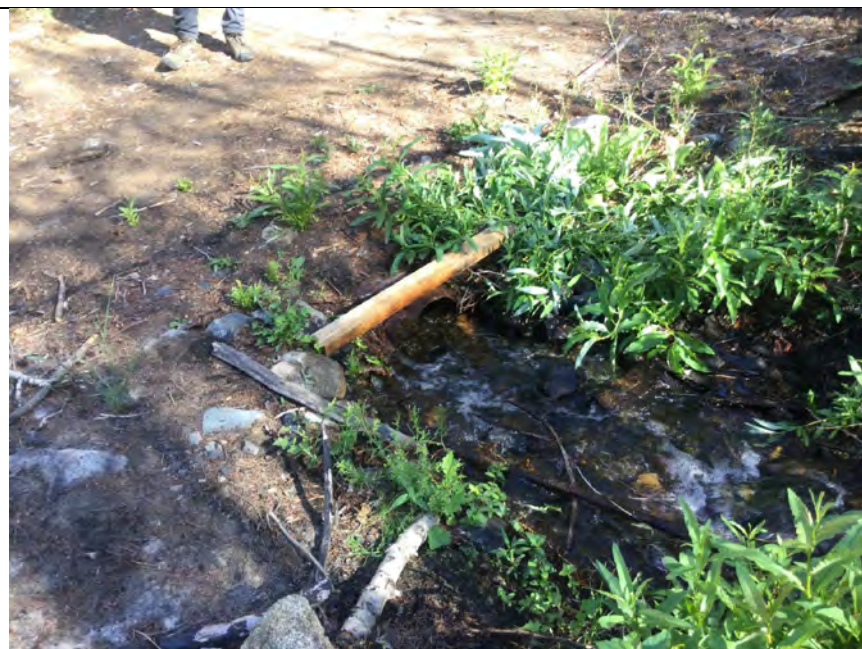
Photo 5: Webster Creek at Eart Creek Road, 500 mm diameter culvert is partly lugged with sediment. Ashnola River is 15 m downstream.

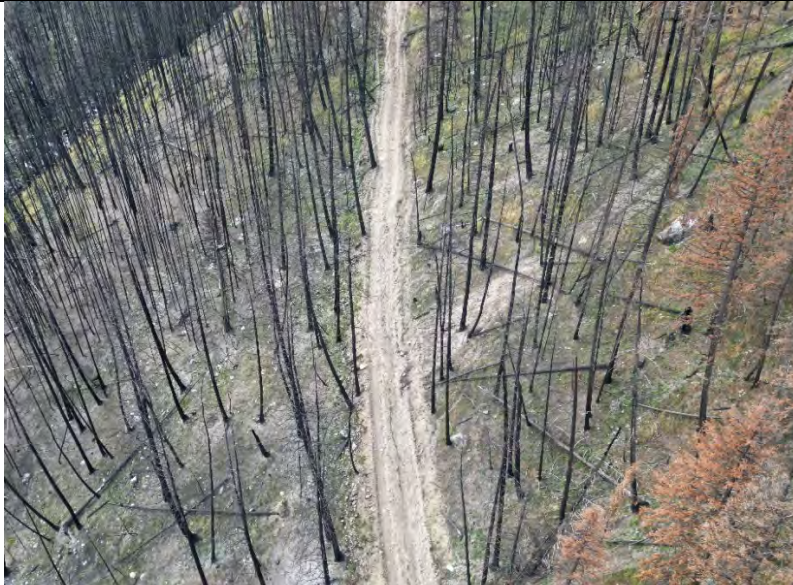
Photo 5: Fresh surface erosion on burned slopes intercepted at the road.

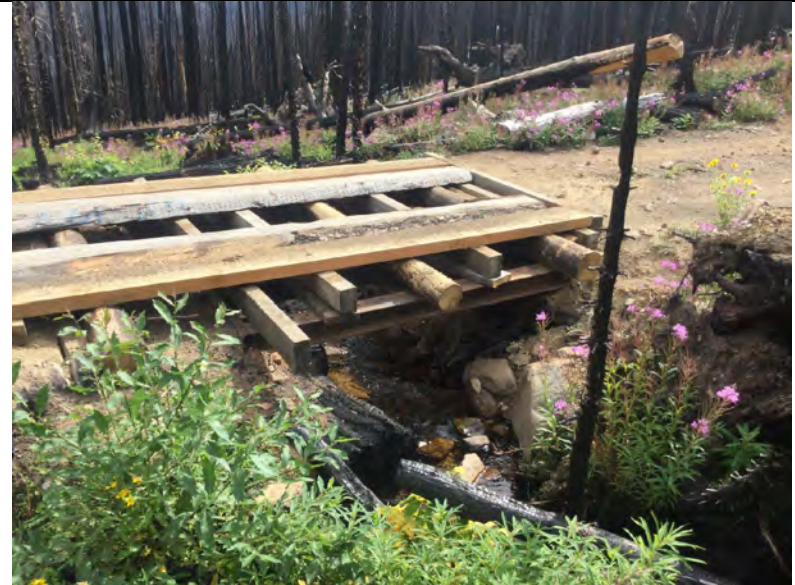
Photo 6: Scout Creek temporary bridge crossing along Lakeview Road (at ~12.5 km). One of two small bridge structures lost in the fire.

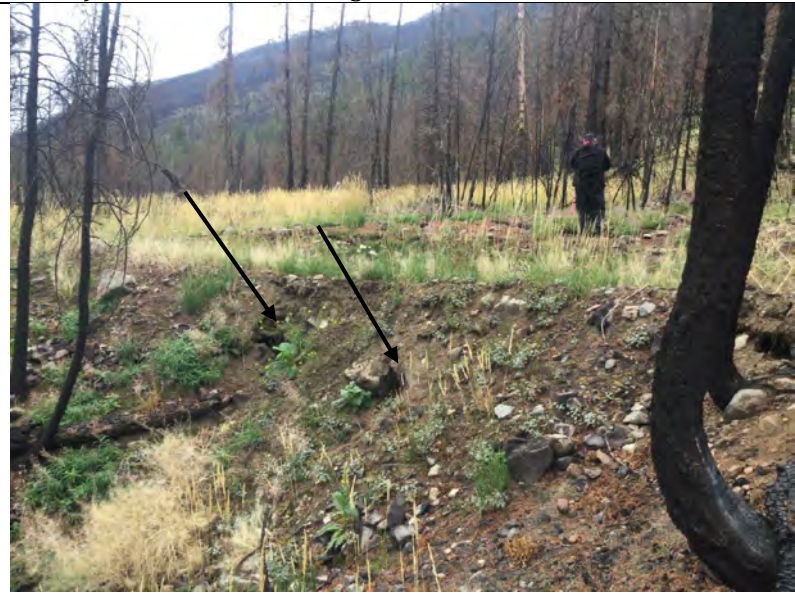
Photo 8: Burn holes (arrows) and deformed trees indicate slope instability along the lower part of Lakeview Road (~1.4 km).
