June 17, 2025

CGL Project: 24-0103

Reference: Shoudy Creek Watershed Post-Wildfire Natural Hazard Risk Analysis – 2024 Update
Similkameen Valley, BC

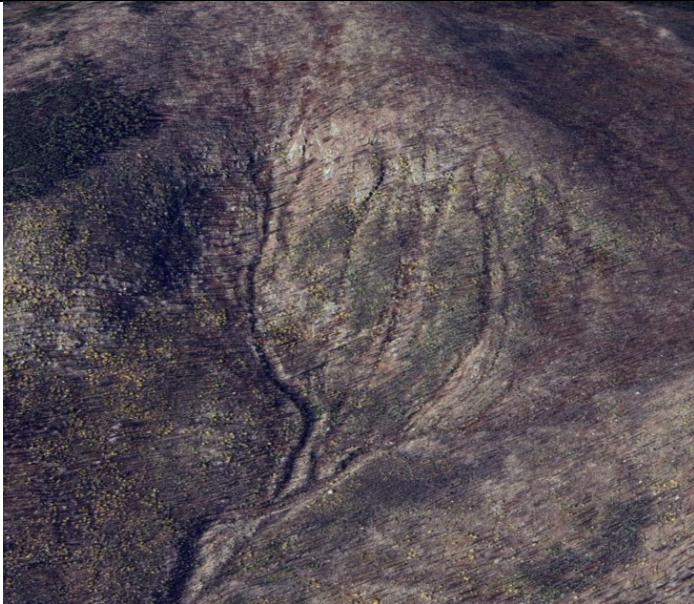
Upper Watershed Conditions (Photos 1 and 2) indicate that the wildfire-affected headwaters remain sparsely vegetated. Gullied channels are visible but do not appear to be scoured by runoff and have not generated any debris flow activity. Upper reaches of the mainstem channel are partly incised within unconsolidated glacial drift deposits. Exposed sediment along the crest of the slope indicates small-scale instability.

Photo 1: Overview of upper Shoudy Creek watershed, looking northeast. Note burned forest and gullied channels. (from GoogleEarth)

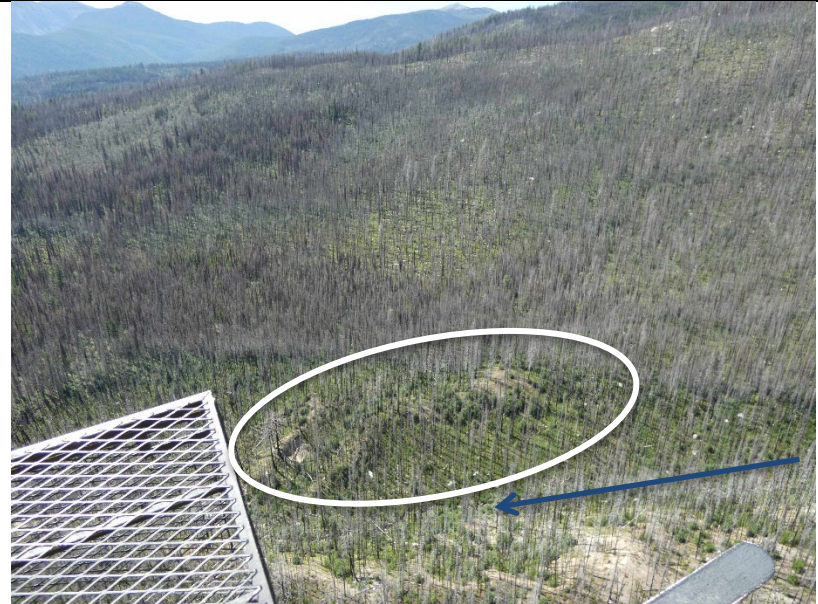
Photo 2: Burned headwaters of Shoudy Creek and observed terrain instability (circled) along incised reaches. Note, channel is visible at the bottom of photo (arrow).

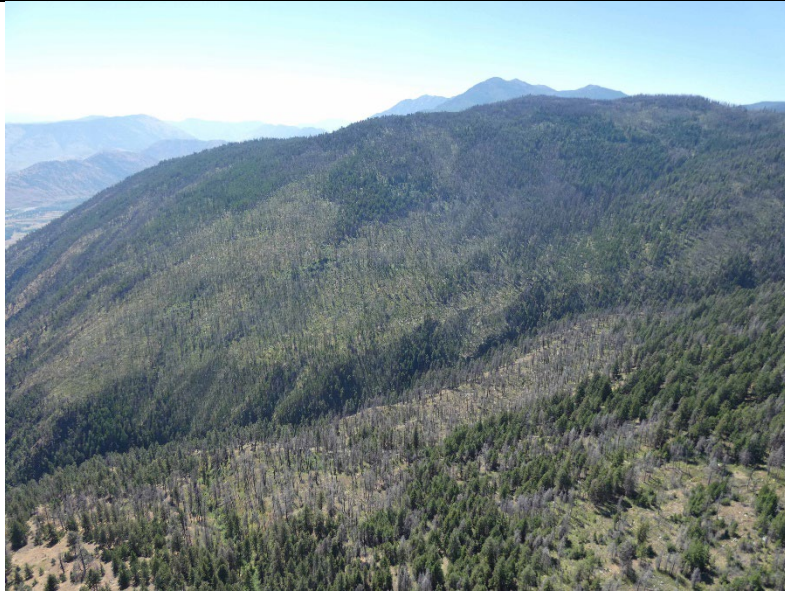
Middle Watershed Conditions, shown in Photos 3 and 4, indicate that the mainstem stream channel is well-confined within a narrow valley, incised within and flanked by steep side slopes. The steep valley side slopes are relatively short (200 to 400 m long) compared to the overall width of the catchment (~3 km). Of note, and of particular significance from a natural hazard perspective, is a large debris slide located approx. 800 m upstream of the fan apex on the south side of Shoudy Creek. The debris slide is visible on all historic imagery (predating 1969) and appears to be part of an active slide complex in bedrock, characterized by shallow, chronic slide activity with direct connectivity to the channel. This is a major source of sediment to Shoudy Creek that is readily transported downstream, and because the slide is so close to the fan, sediment reaches the fan in a short period of time.

Photo 3: View of mid-slope areas of Shoudy Creek showing tight connection of valley side slopes.

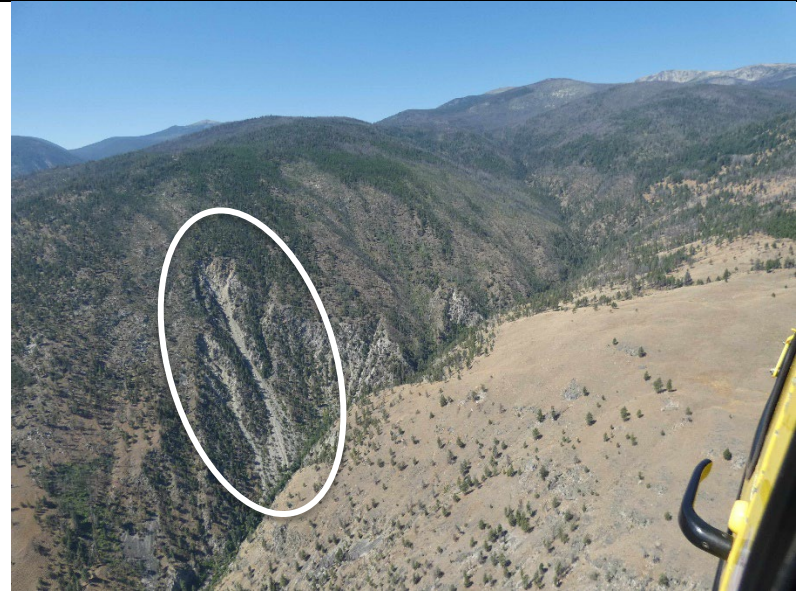
Geomorphic hazards influencing sediment delivery and downstream sediment transport continue to be significant for Shoudy Creek because they have a profound impact on downstream channel stability across the fan. The large, bedrock debris slide located ~800 m upstream of the fan apex, is a chronic and unmitigable source of sediment to Shoudy Creek. Sediment from the slide, and from the slopes adjacent to the slide, is deposited into the channel along a confined reach with an average channel gradient of 26%. Through this reach at the slide site, higher than usual post-wildfire stream flows will undercut and incise slide deposits. This represents an unlimited source of sediment to the fan.

Photo 4: View of large debris slide located ~800 m upstream of Shoudy Creek fan (circled). Recent instability indicated by fresh rock exposure.

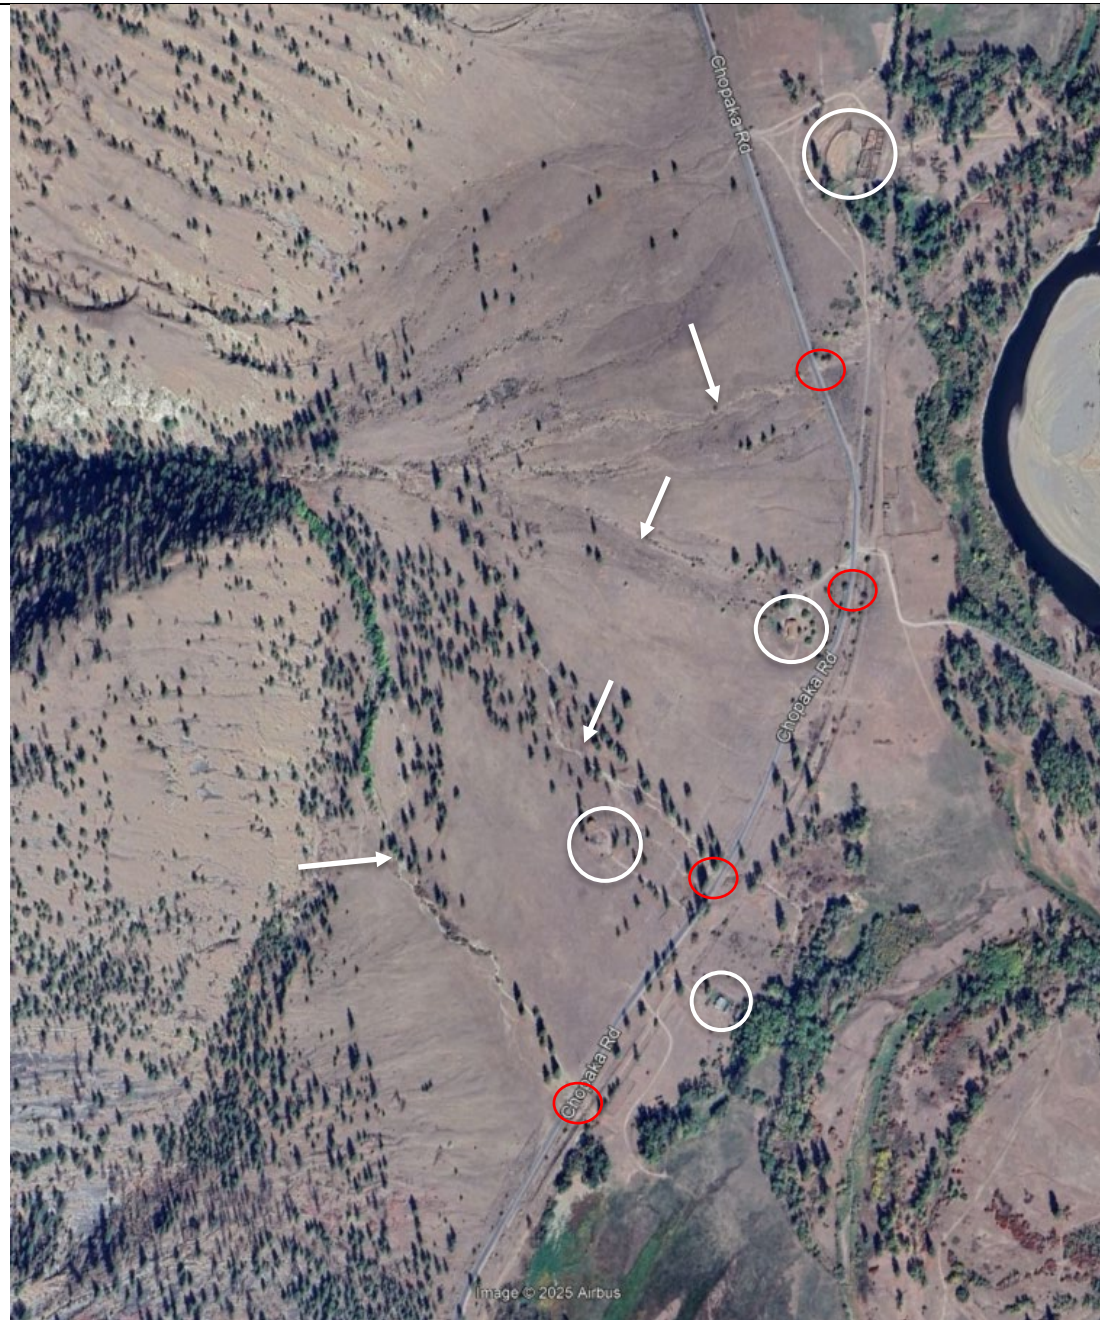
Fan Conditions (Photo 5) observed from an overview level, indicate that the relatively large fan (~70 ha) extends into the Similkameen Valley. The fan is sparsely vegetated grassland and there are multiple channels extending across the fan. Evidence of the recent (2023) sediment-laden flood activity is indicated by fresh sediment deposition and multiple scoured channels. The location of the residences and culvert washout locations on Chopaka Road are shown in Photo 5 and on Map 002 and Map 003.

Photo 5: Shoudy Creek fan area showing multiple channels (arrows) that experienced recent sediment-laden flooding resulting in impacts to Chopaka Road. Note residences and rodeo grounds (white circles). May 2023 washout locations shown in Photos 6 to 9 are circled in red. Source image from GoogleEarth. See area mapped in Map 002 and Map 003.

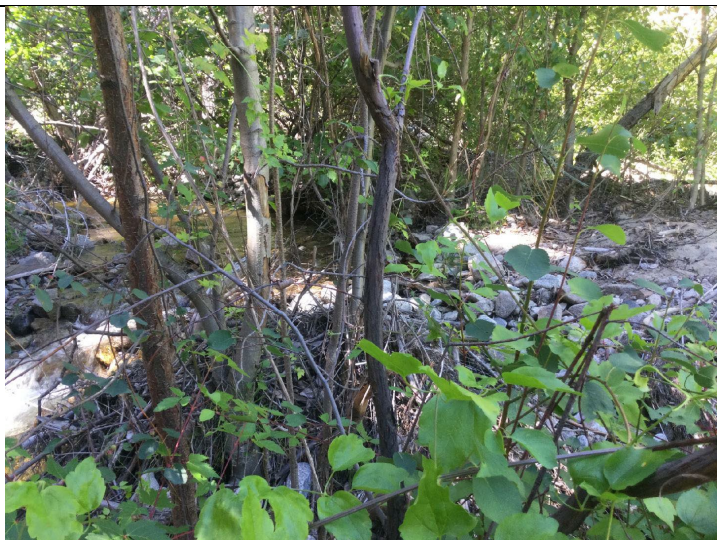
At the fan apex (Photo 6) the stream channel splits, with the current active flow directed southwards. The channel is wide and shallow with abundant coarse (sand, gravel and cobble) bedload. Deciduous shrub vegetation has grown in place of the burned forest and may influence the flow pattern through the reach. Overall, the channel is aggraded and unconfined, with a high level of instability.

Photo 6: Shallow stream channel at fan apex with abundant sediment (sand, gravel and cobble) and deciduous vegetation. Mature forest burned by 2018 fire. Photo taken at flow split at top of fan.

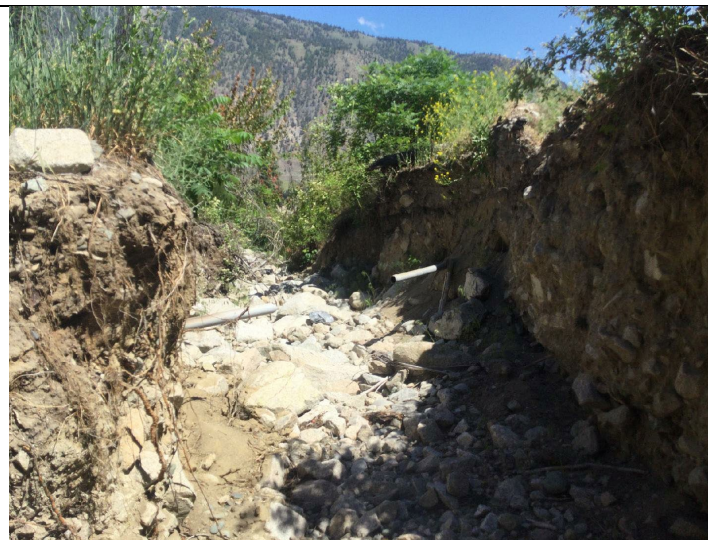
Photo 7: View downstream along dried up channel in upper part of fan. Note deep incision, vertical unconsolidated stream banks, and severed irrigation pipe.

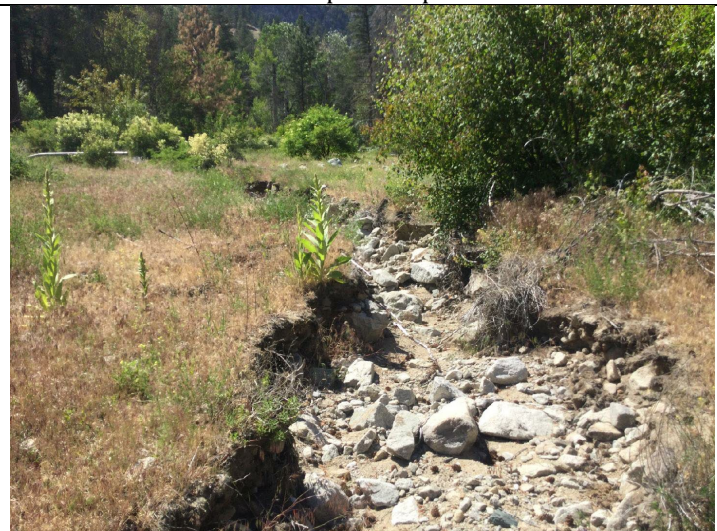
Photo 8: View upstream along historic channel on fan area. Note incised banks and abundant coarse bedload material.

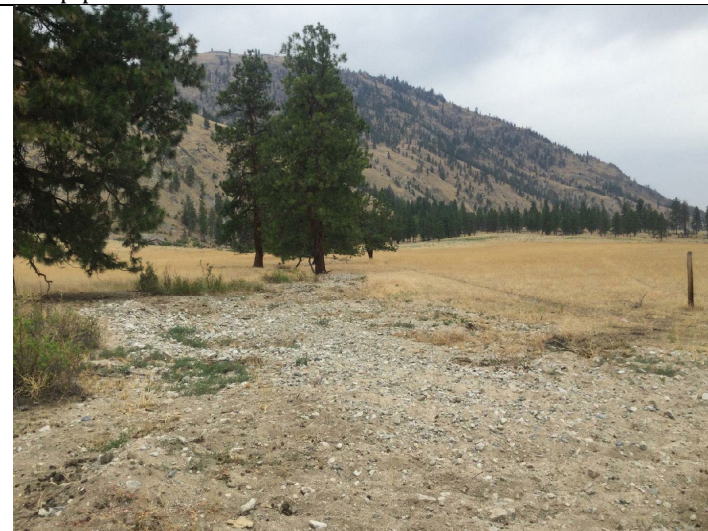
Photo 9: View upslope along fan showing shallow, sediment-laden, unconfined avulsion channel attributed to 2023 washout at Chopaka Road from Shoudy Creek. Southern-most washout location.

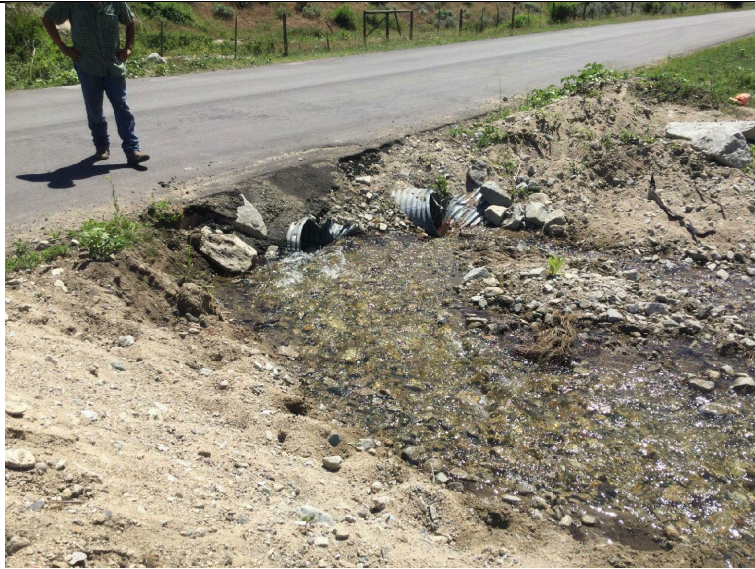
Chopaka Road and Downstream Conditions are shown in Photos 10 to 17. The current channel is flowing along the south edge of the fan and at Chopaka Road there are two (2) 600 mm diameter steel culverts. These culverts were plugged during the 2023 flood event, and it is apparent that some road repairs have been completed. The inlets of the culverts remain partly inundated with sediment and damaged from the clearing activity. Downstream from the culverts, Shoudy Creek flows through a 900 mm concrete culvert within an abandoned railway embankment. The stream channel downstream from the embankment is heavily aggraded, with high erosion and instability of the embankment fill materials. GoogleEarth imagery indicates that the channel flows parallel to the embankment for ~1.4 km before reaching an irrigation ditch that eventually enters the Similkameen River.

Photo 10: Current path of dominant flow (photo taken in June 2024). At 2023 washout location, inlet of two 600 mm diameter culverts on Chopaka Road.

2. Improve drainage along Chopaka Road. Better defined roadside ditches along Chopaka Road and oversized cross-drains that accommodate increased flows and allow sediment transport are recommended. The oversized culverts, or arch culverts, would replace the existing structures shown on Maps 002 and 003 and additional cross-drains may be suitable at the other avulsion sites located to the north along the fan. It is recommended that a Qualified Professional be engaged to determine appropriate sizing and placement. Annual inspection and monitoring are recommended after significant rainfall or snowmelt events, with subsequent maintenance of drainage structures as required to ensure clear passage.

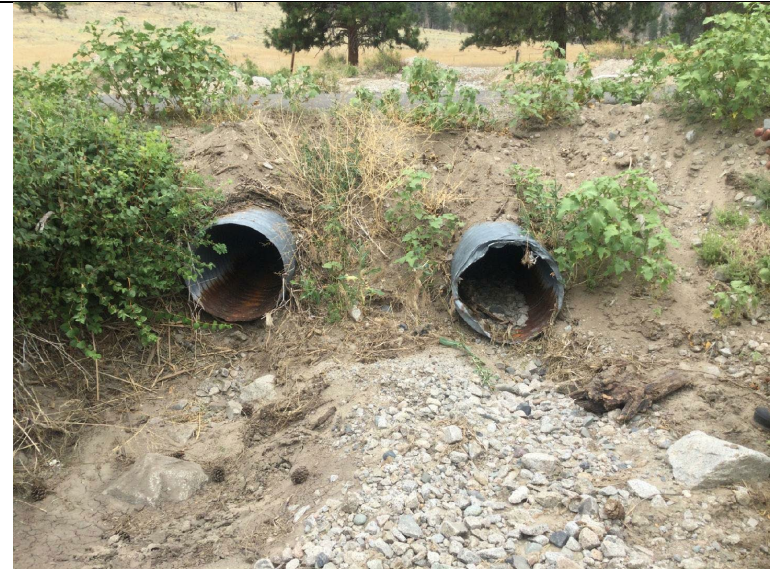
Photo 11: Outlet of two 600 mm diameter culverts on Chopaka Road.

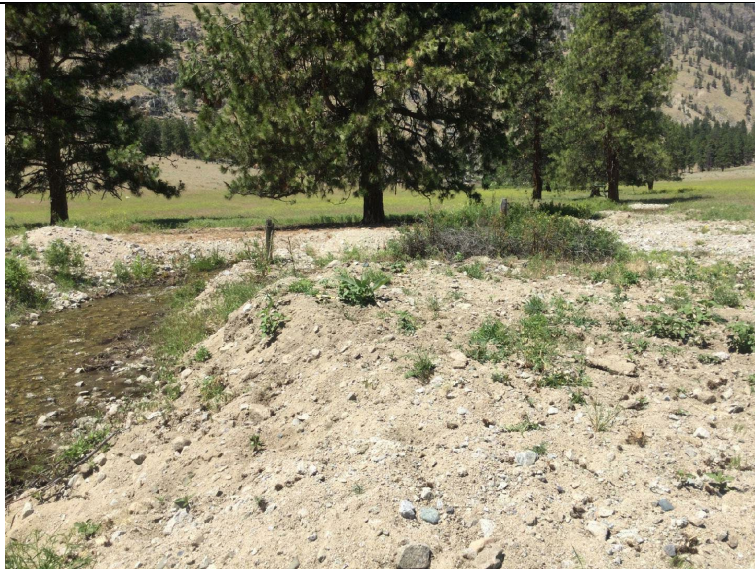
Photo 12: View upslope along Shoudy Creek fan showing shallow, sediment-laden channel at Chopaka Road (June 2024). Note sandy gravel soils.

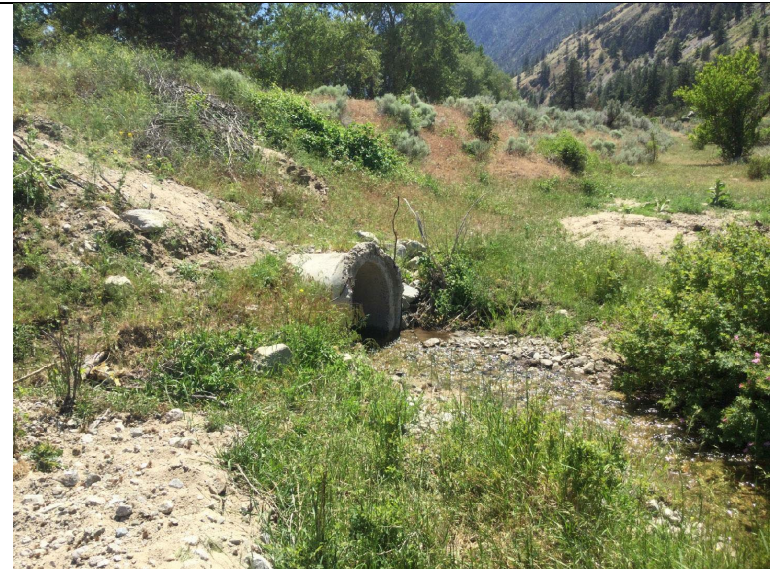
Photo 13: Immediately downstream from Chopaka Road, Shoudy Creek flows through a 900 mm diameter concrete culvert passing through old rail embankment.

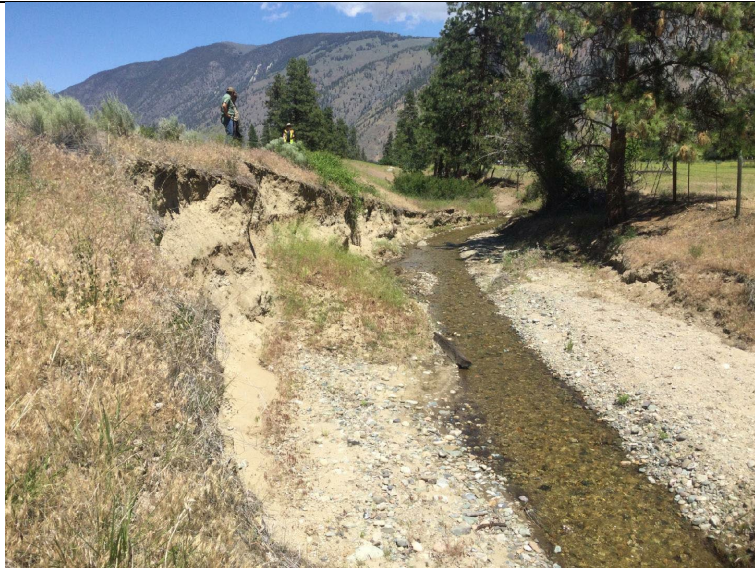
Photo 14: Downstream side of rail embankment (left) on Shoudy Creek showing high erosion and instability.

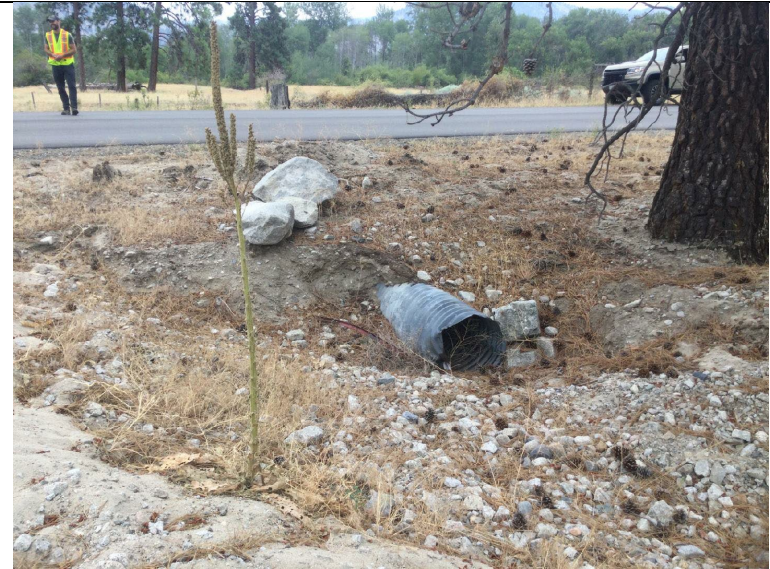
Photo 15: View of 600 mm diameter culvert at Chopaka Road along abandoned channel that was inundated during 2023 flood event.

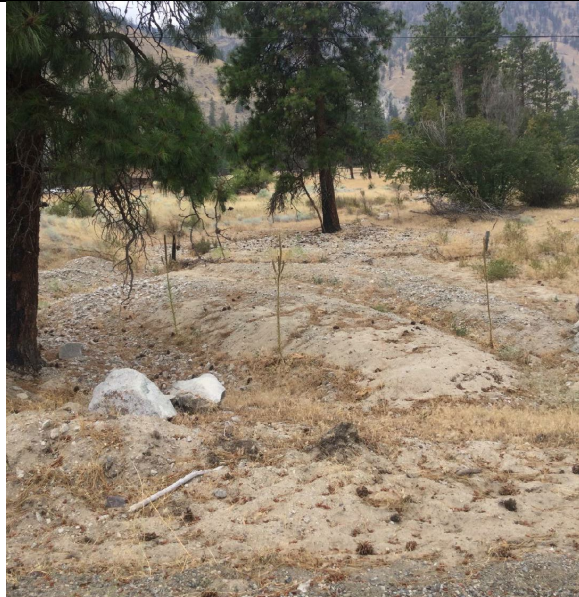
Photo 16: View upstream from 600 mm culvert. Note abundant sediment (gravely sand) associated with 2023 debris flood event.

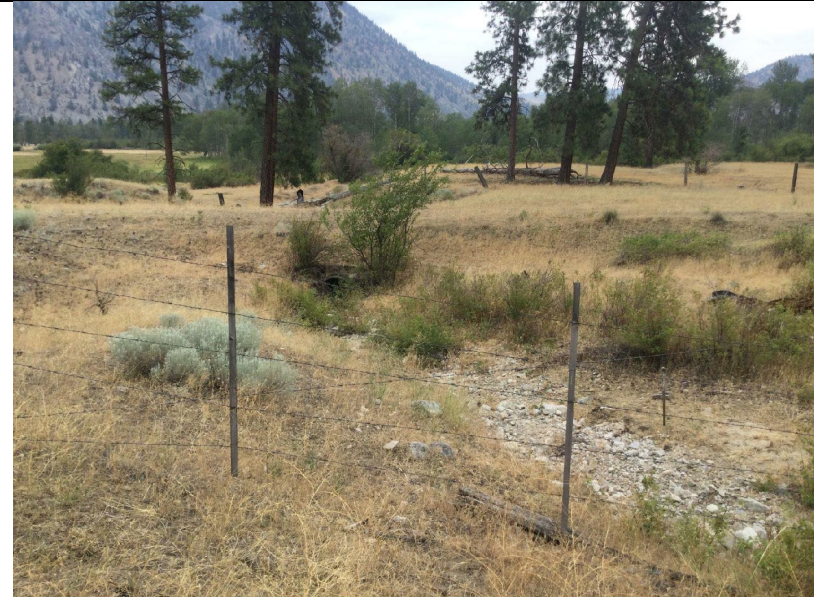
Photo 17: 900 mm diameter concrete culvert under old railway embankment downstream from culvert in Photo 17.
