Park Rill Flood Response Feasibility Study

Dated: April 30, 2019
Ecora File No.: CP-18-568-RDO

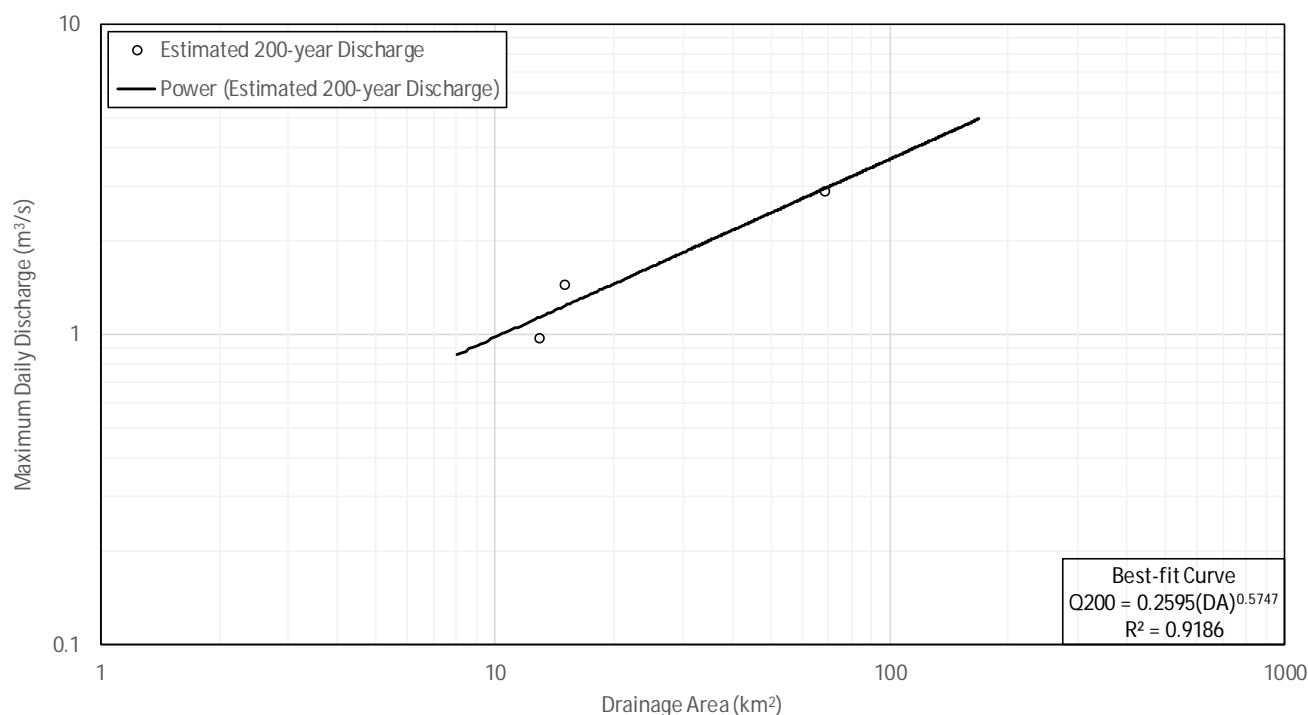
Plot 1 1 in 200-year Maximum Daily Discharge Regional Analysis Results

The 1 in 200-year maximum daily flows were plotted against drainage area to derive a best-fit curve between the two variables. Limited scatter is observed in the plotted results. The results of the regional analysis are shown in Plot 1.

The 1 in 200-year annual maximum daily flow estimate for Park Rill Creek at the mouth is 4.9 m³/s, corresponding to a drainage area of 165 km². It should be noted that the period of record available for the selected regional stations is short, with only 8 years of data available for Keremeos Creek; however, frequency analysis of the available data generally indicated well-fitting trendlines and these stations are expected to best represent hydrological conditions at Park Rill Creek. Based on Ecora's observations of Park Rill Creek in 2018, the resulting 1 in 200-year maximum daily flow estimate appears to be reasonable.

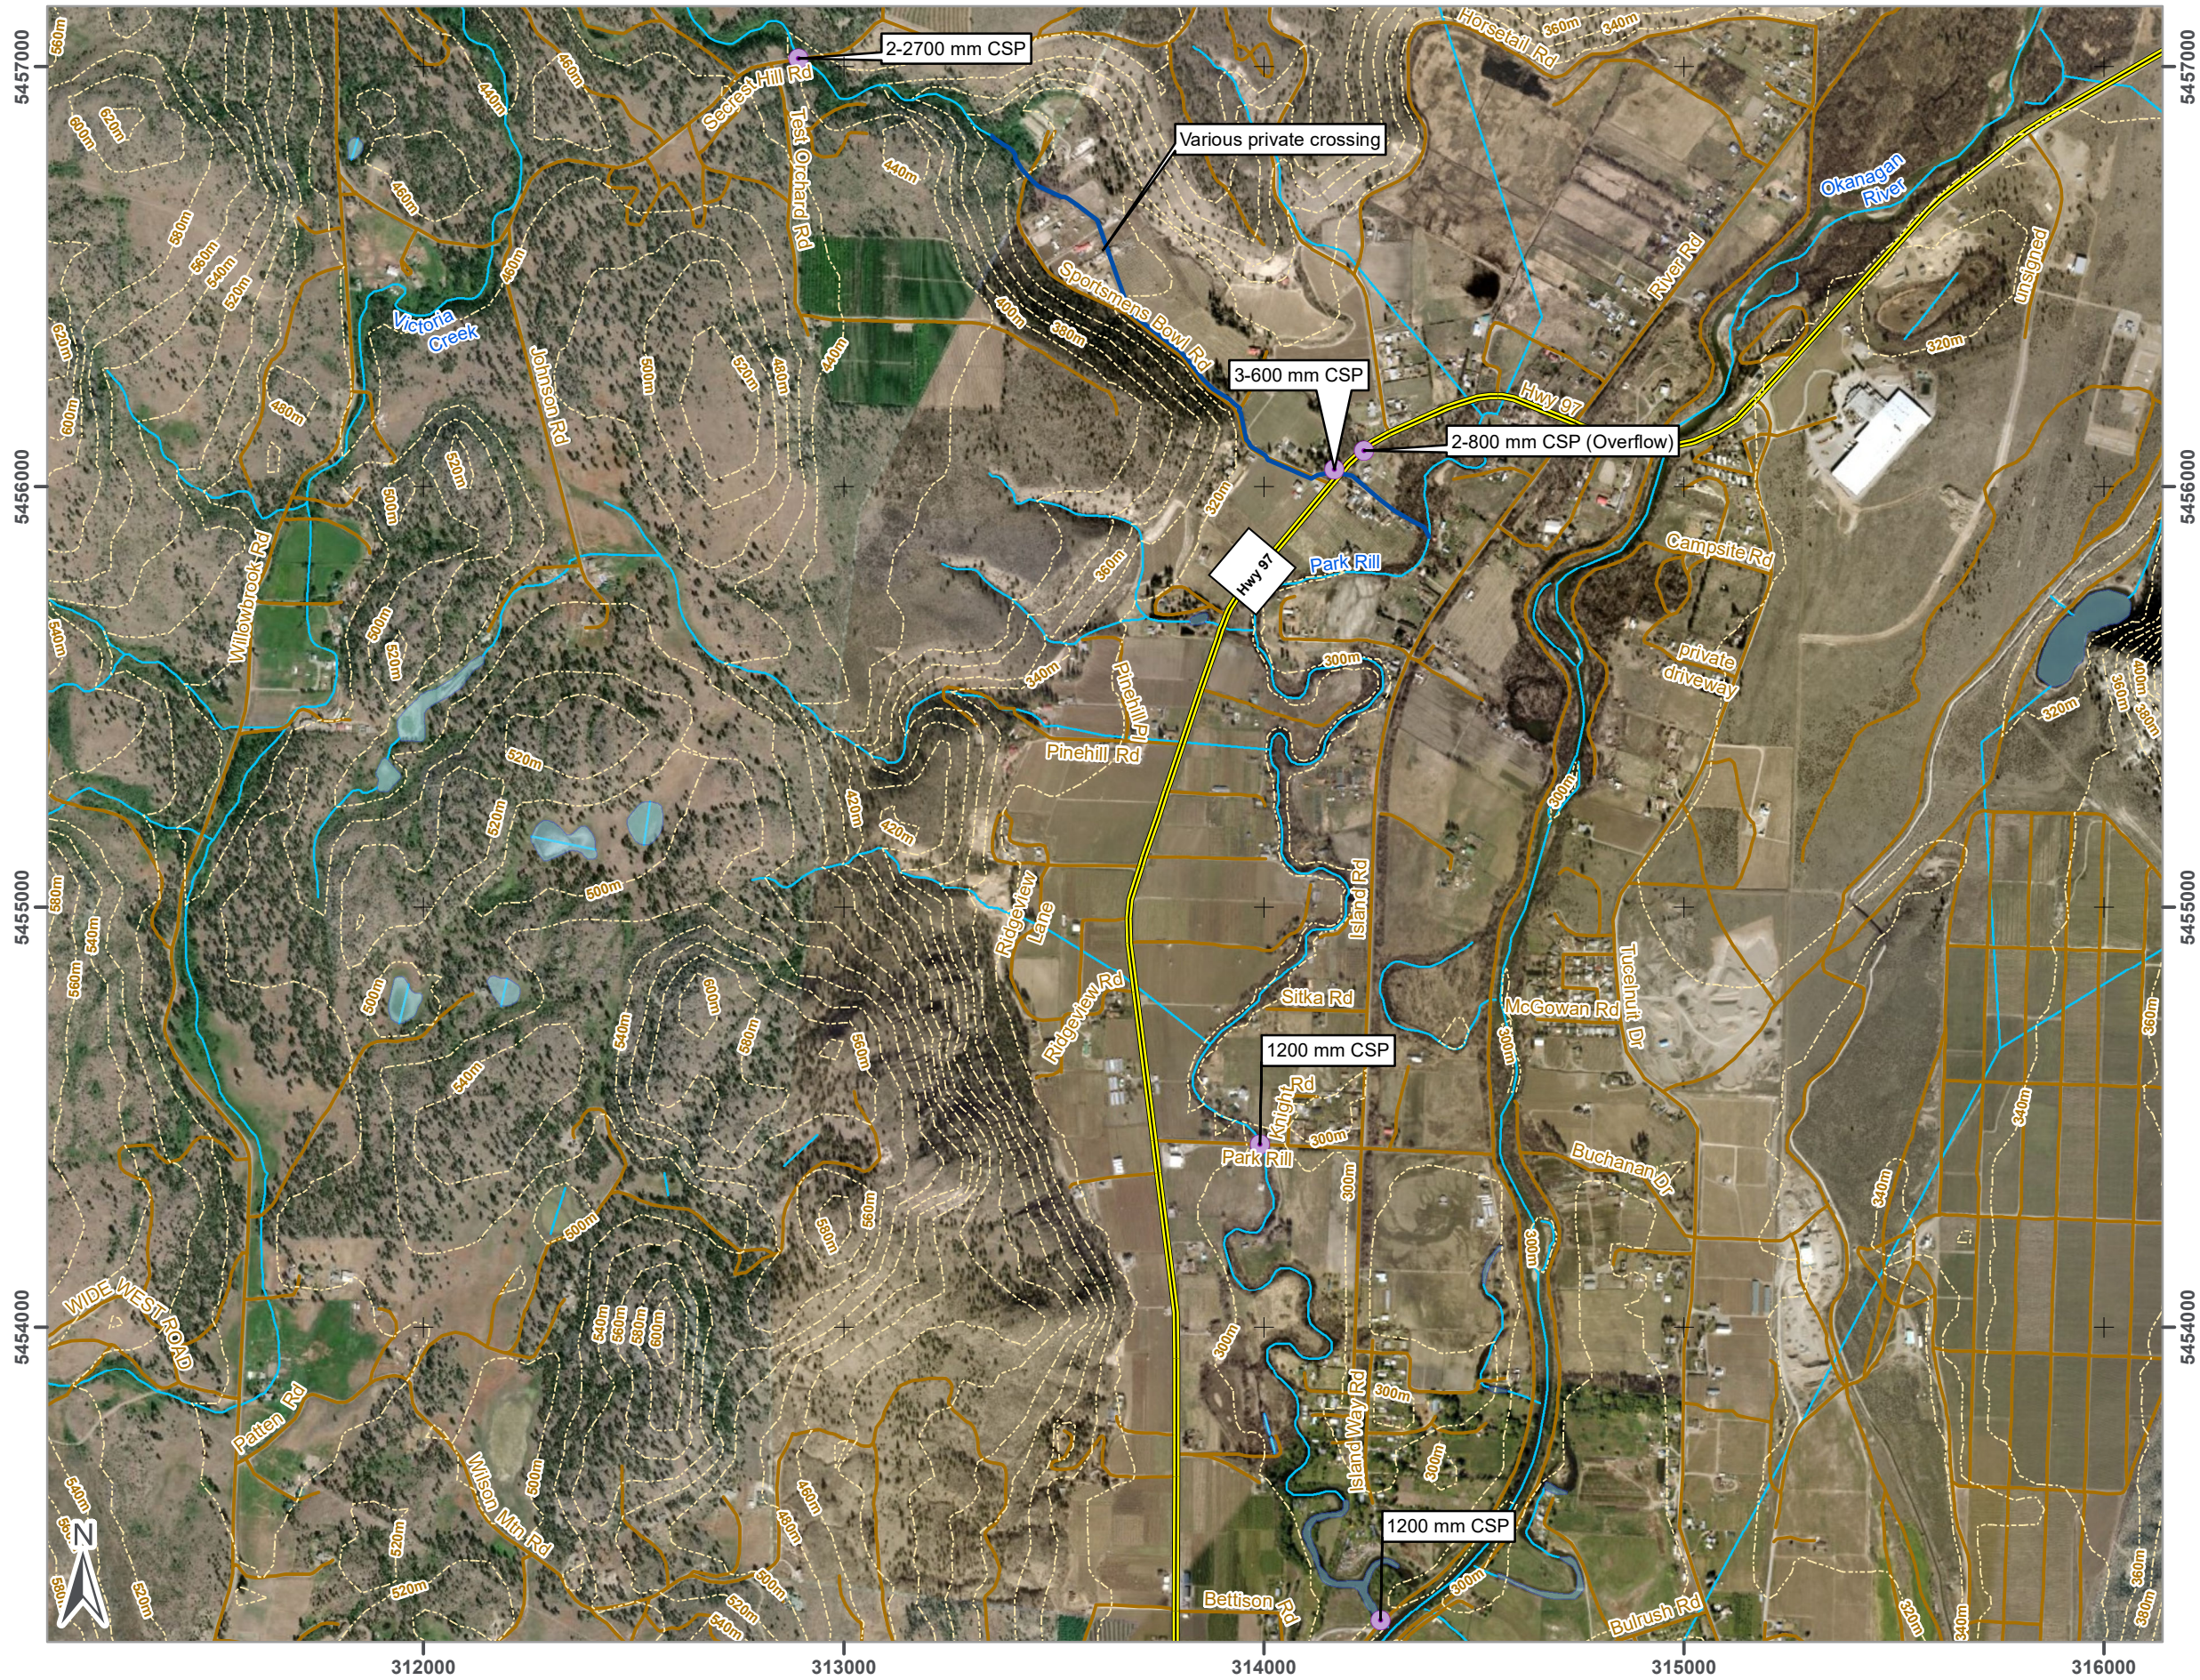
Figure 2.0

HYDRAULIC STRUCTURES IN REACH 1 AND REACH 2

- Park Rill Creek at Park Rill Road – Consists of a 1200mmØ corrugated steel pipe (CSP) culvert with beaver caging extended upstream from the culvert inlet. It is noted that this culvert did not have the capacity to discharge the 2018 freshet flows, which caused flooding on adjacent properties.

- Park Rill Creek outlet to Okanagan River – Consists of a 1200mmØ CSP culvert. It is noted that this culvert did not have the capacity to discharge the 2018 freshet flows and was in backwater from high flow in the river. Four diesel pumps were installed to pump into the Okanagan River. Additionally, it was noted that there is currently no flap gate on this outlet culvert, and during high flow events, the Okanagan River can backflow into Park Rill Creek.

- Secrest Hill Road Crossing – Consists of two 2700mmØ CSP culverts with headwalls, installed in Spring 2019.
- Highway 97 Road Crossing – Consists of three 600mmØ CSP culverts with two overflow 800mmØ culverts, installed in 2018 that are currently blocked. The two 800mmØ are intended to be used only if the three 600mmØ culverts do not have the capacity to convey the Park Rill Creek flows, as they currently discharge directly towards a dwelling and a temporary channel must be constructed if they are to be used. It is noted that the combined capacity of these five culverts is less than the capacity of the upstream Secrest Hill Road culverts.

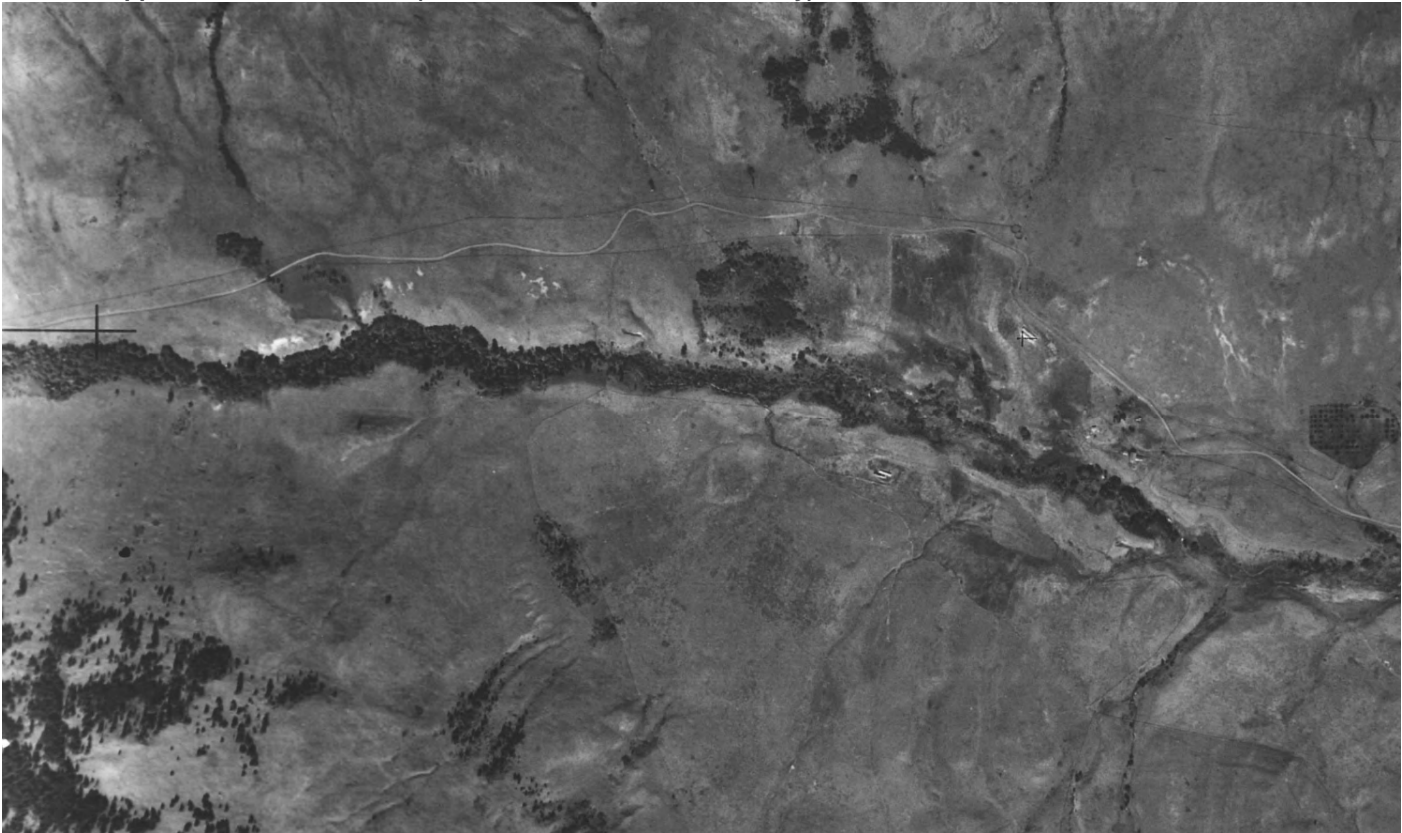
Photo 15: 1938 (BC101:26)

Year	Air Photo Details	Comments
Near White Lake Ranch (see Figure 3)		
1938	BC101:26. Medium Scale.	The Park Rill Creek channel appears relatively undisturbed through this reach, with heavy vegetation along the alignment.
1963	BC4184:139. 1:16,000. August 30, 1963.	White Lake Road has been widened and re-aligned, north of the channel. New buildings have been constructed along the downstream end of the photos, and a new access trail has been constructed just south of the channel alignment.
1985	BCC363-038. 1:15,000. July 14, 1985.	New buildings and roads have been developed, including an access road constructed crossing the Park Rill Creek channel. There is ponding observed behind this access road.
2007	BCD07022-066. 1:27,000. July 1, 2007.	Another access road has been developed across Park Rill Creek, upstream of the one observed previously. Ponding is still present behind the further downstream access road.

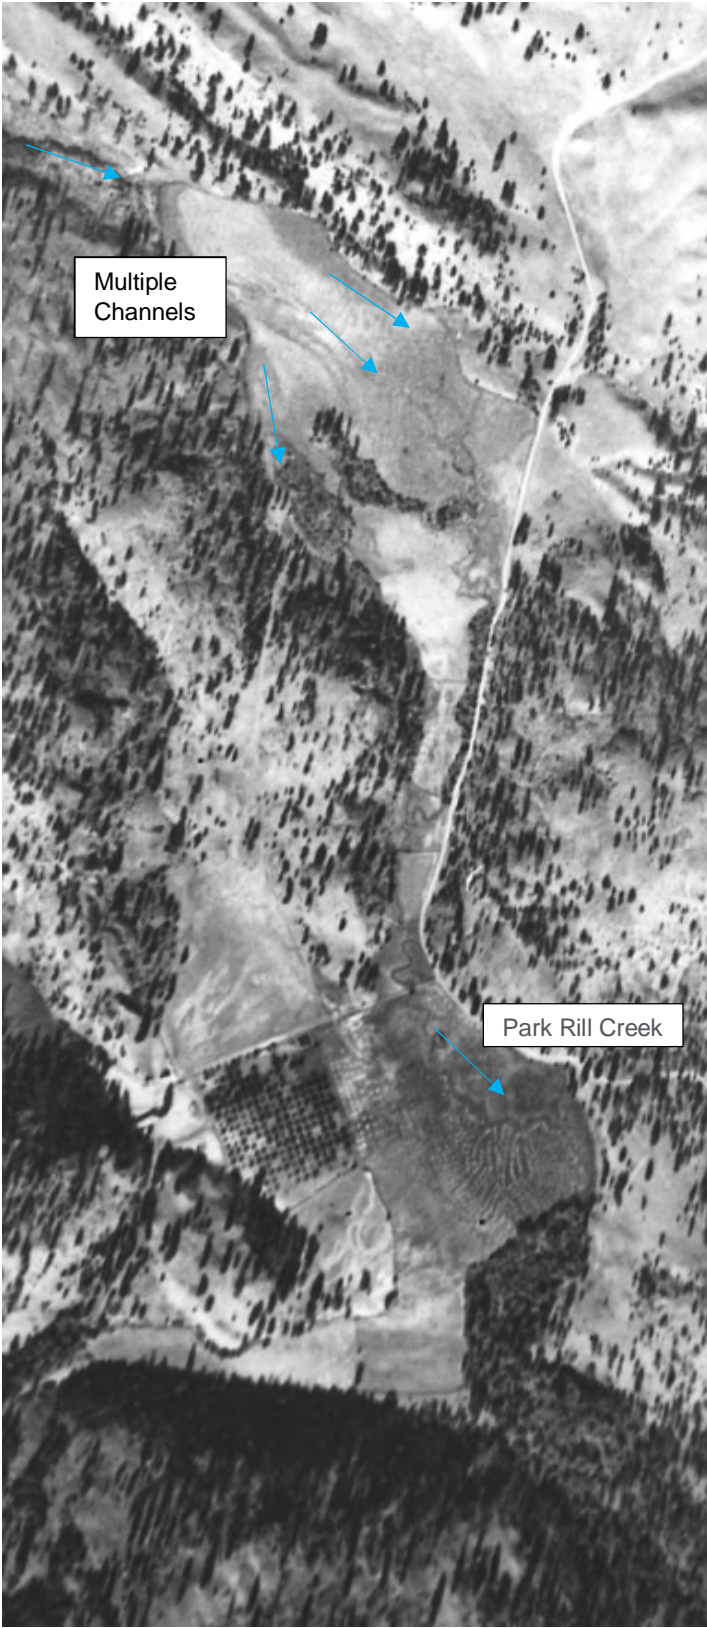
Photo 19: 1938 (BC128:48)

Near Willowbrook Road (see Figure 3)		
1938	BC128:48. Medium Scale.	Park Rill Creek discharges through several channels in this area which meander through the fields west of White Lake Road.
1963	BC4174:078. 1:16,000. August 16, 1963.	Cultivation over the central channels in the upstream section is observed, and the channel is re-aligned and straightened through the remainder of this area.
1996	BCC96025-026. 1:15,000. July 13, 1996.	The upstream channels have been re-aligned and straightened, and the downstream channel has been re-aligned again with surrounding areas cultivated. A residential home and access road have been constructed, located within a historical flow path.
2007	BCD07040-219. 1:27,000. July 26, 2007.	One central, straightened Park Rill Creek channel has been constructed through this section.

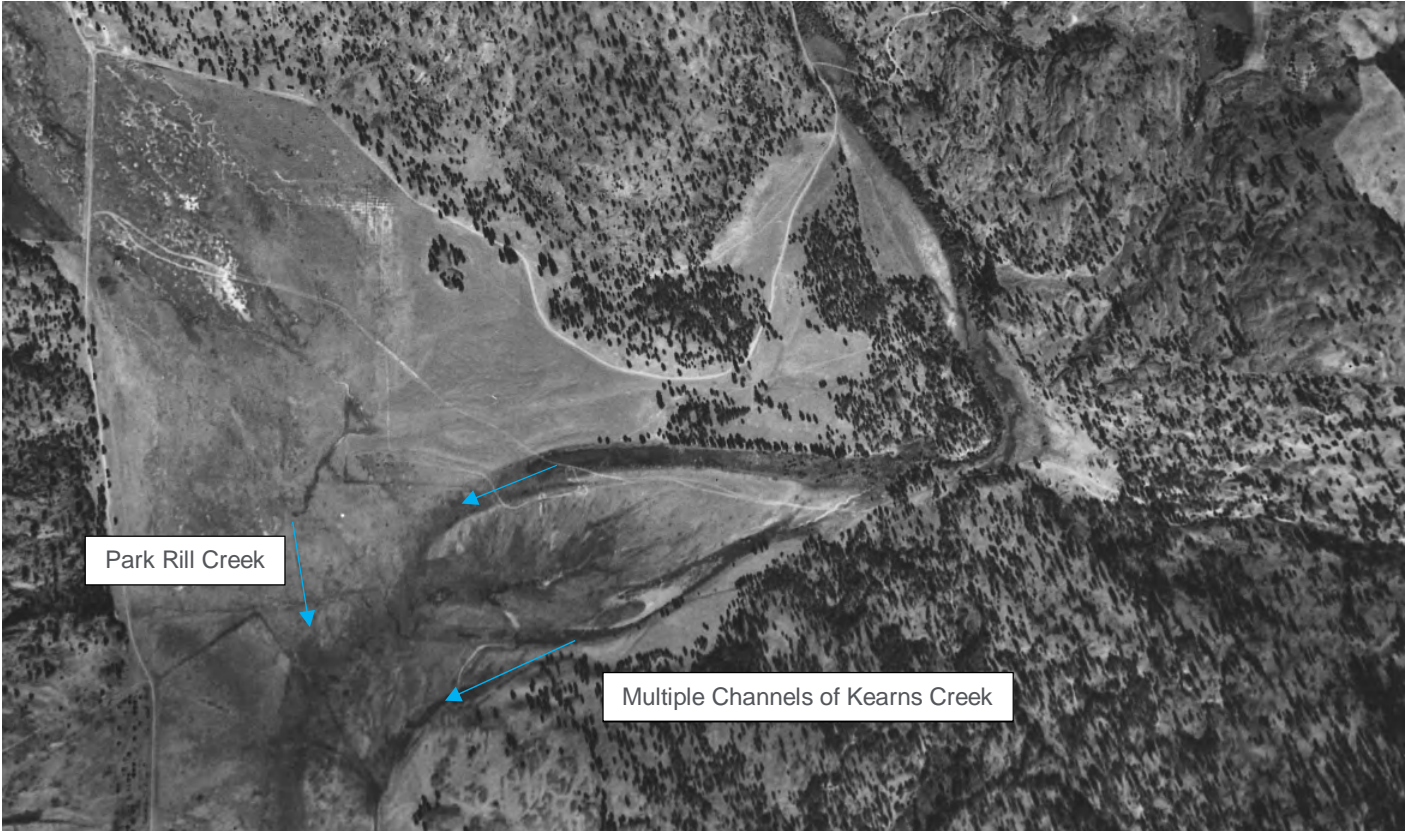
Photo 23: 1938 (BC101:26)

Year	Air Photo Details	Comments
At Willowbrook (see Figure 3)		
1938	BC101:260. Medium Scale.	Multiple channels of Kearns Creek are observed that are not clearly defined. Park Rill Creek in this area is also not clearly defined.
1963	BC4184:044. 1:16,000. August 30, 1963.	Access roads have been constructed through this area, and the area has been cultivated. Park Rill Creek has been re-aligned and straightened, and Kearns Creek appears to be limited to only its southernmost existing channel.
1985	BCC363-191. 1:15,000. July 14, 1985.	The community of Willowbrook has been constructed, which includes roadways and residential development. The Park Rill Creek channel has been re-aligned and contains a 90-degree bend just east of the White Lake Road crossing. Kearns Creek has been straightened and re-aligned, and ponded water is observed just east of the community.
2007	BCD07040-221. 1:27,000. July 26, 2007.	Further cultivation and development have occurred in this area. Park Rill Creek has been re-aligned again downstream of Jones Way, and ponded water is still observed just east of the Willowbrook Community.

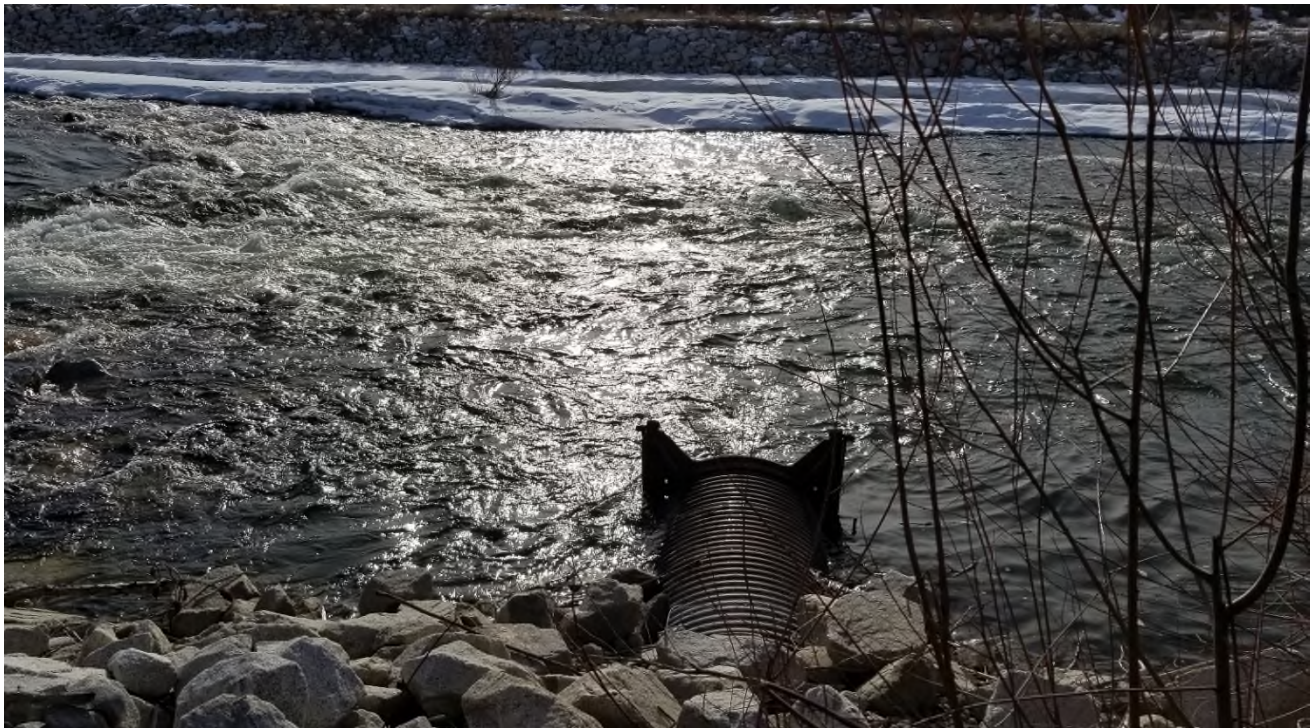
Photo 1 View of Okanagan River and Park Rill Culvert Outlet (March 14, 2019)

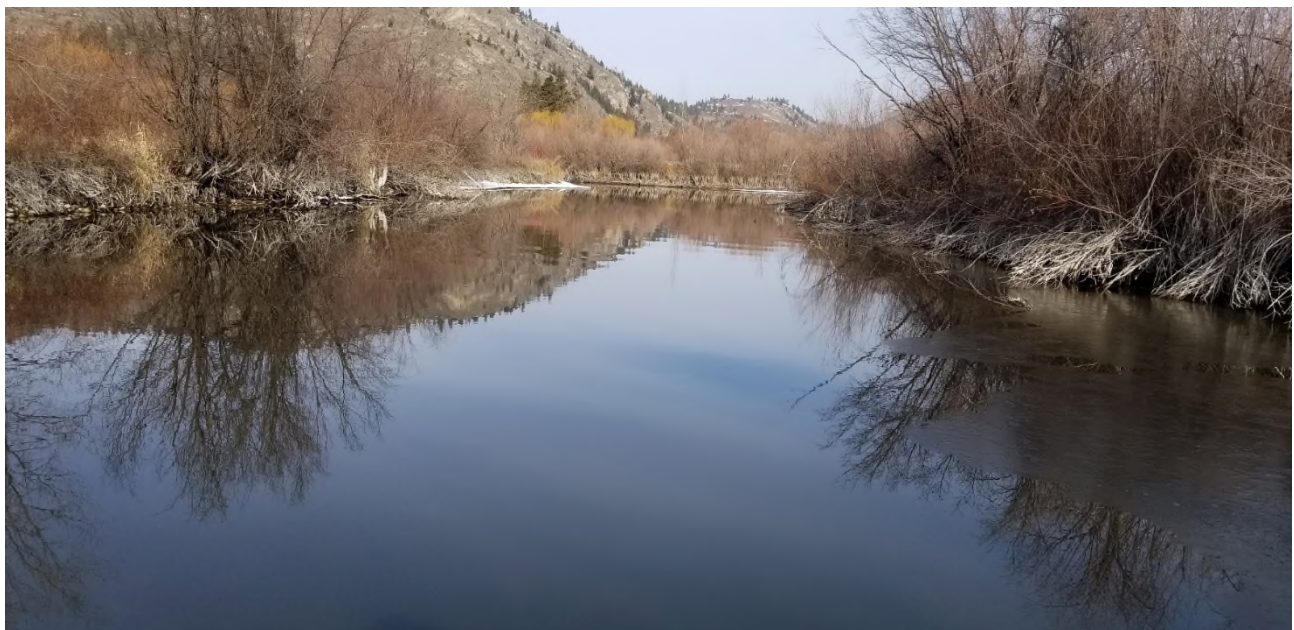
Photo 2 Looking upstream at Park Rill Creek from outlet culvert (March 14, 2019)

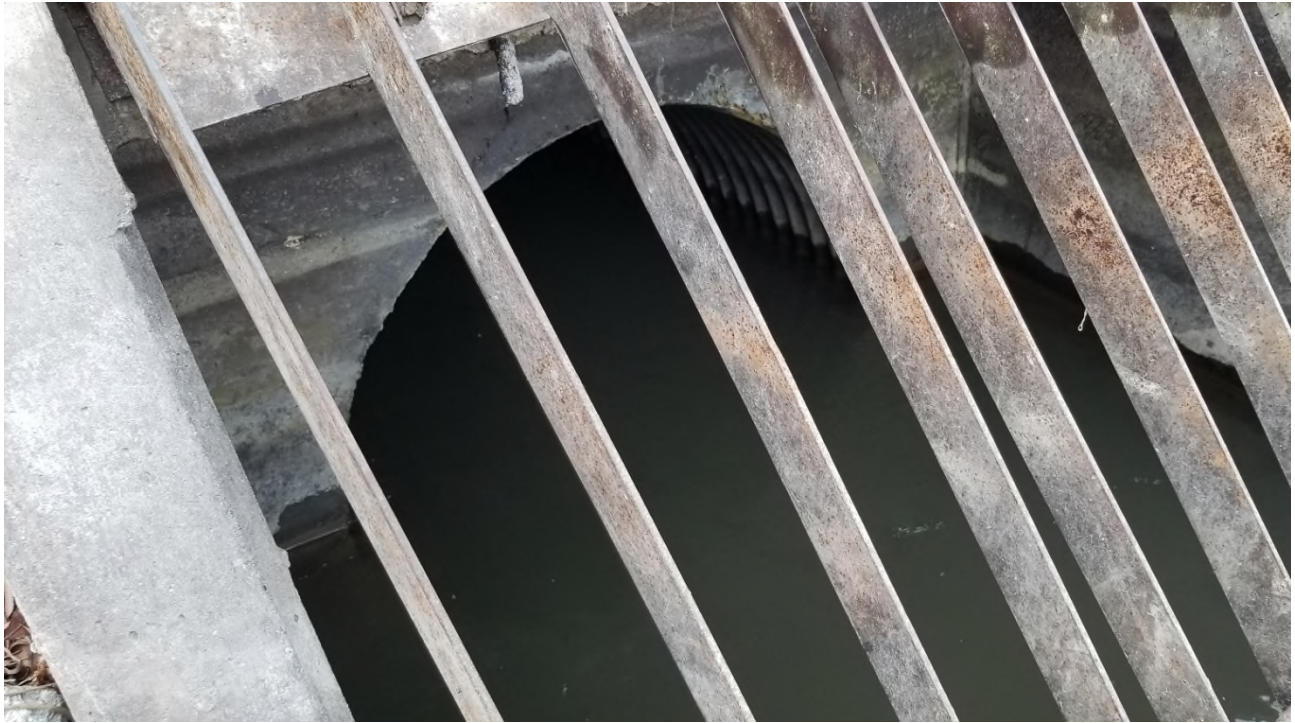
Photo 3 Inlet of Park Rill Outlet Culvert with Grate and Headwall (March 14, 2019)

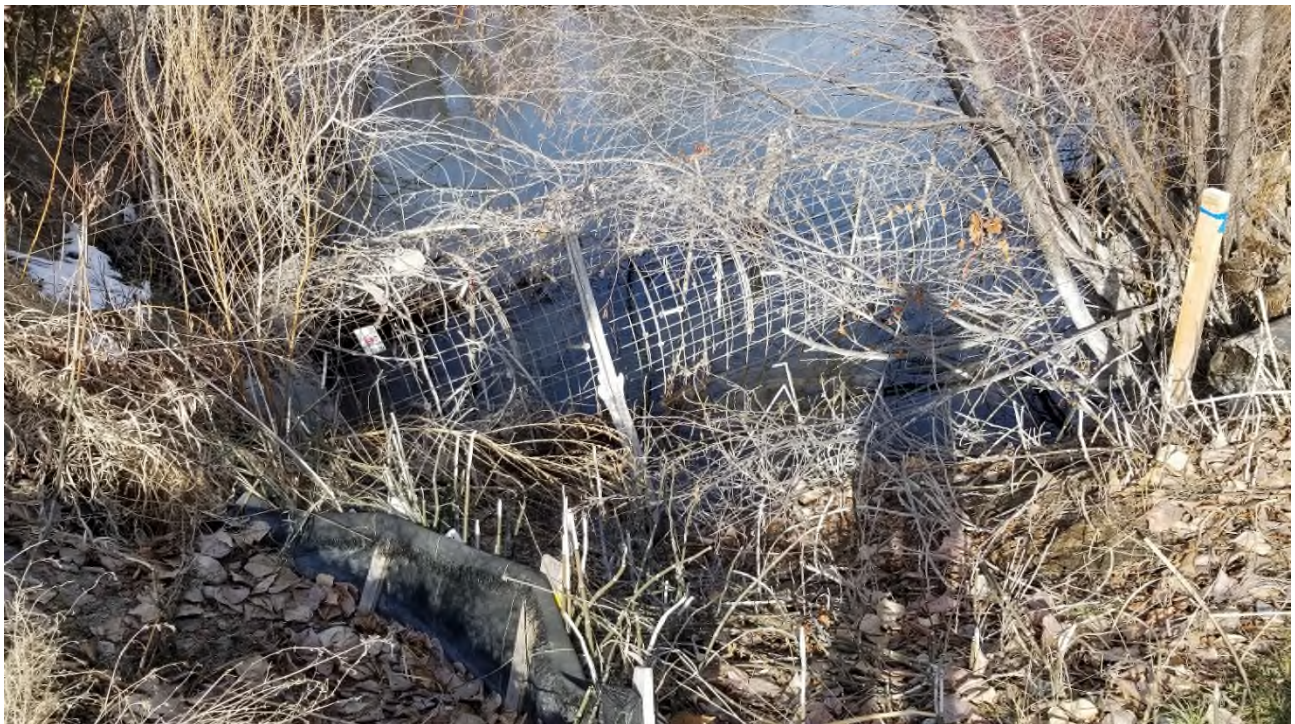
Photo 4 Looking at Inlet to Park Rill Creek at Park Rill Road Culvert (March 14, 2019)

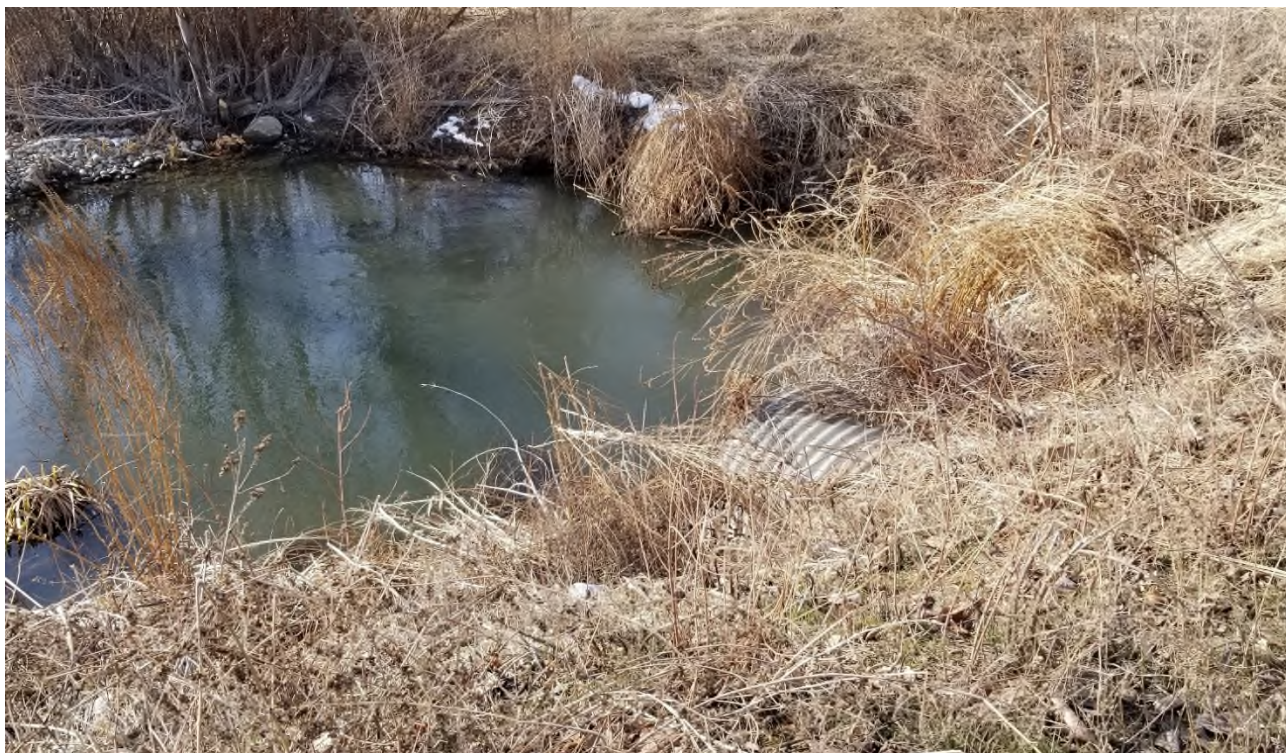
Photo 5 Looking at Outlet of Park Rill Creek culvert at Park Rill Road (March 14, 2019)

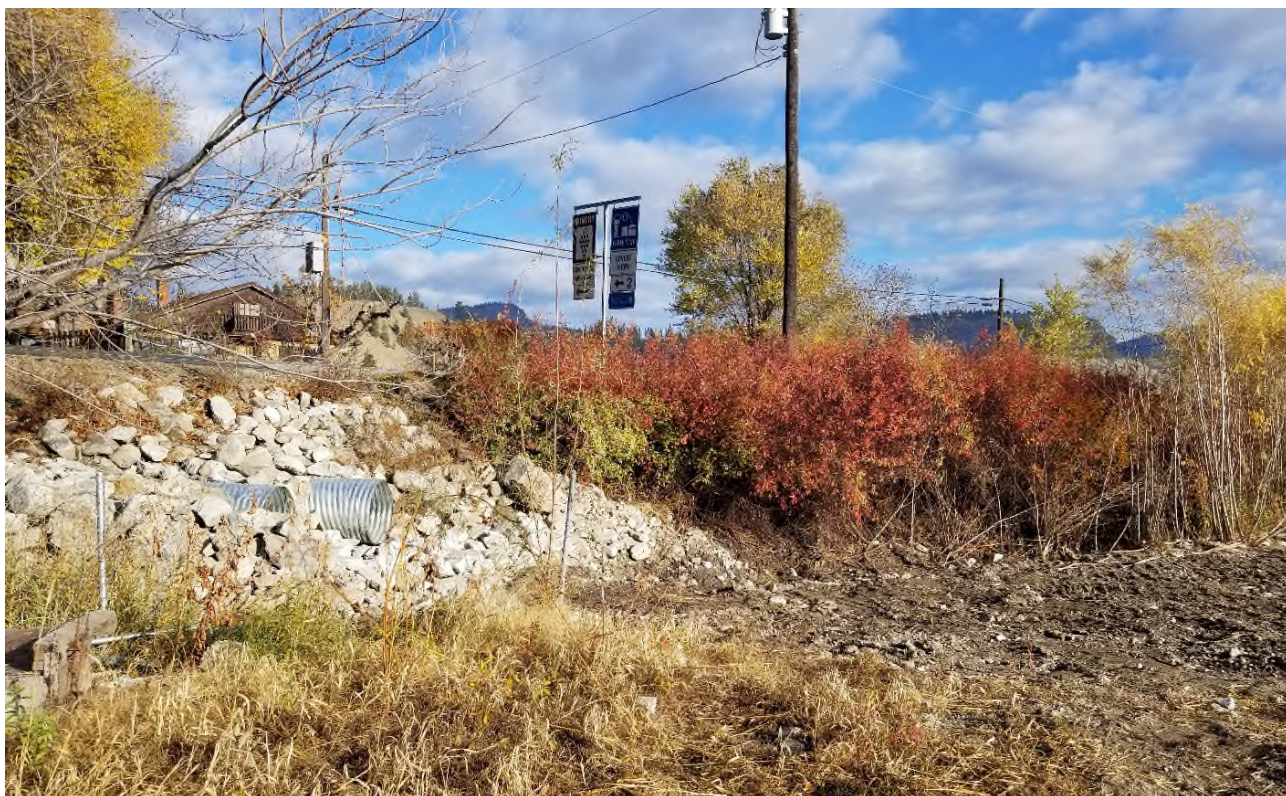
Photo 8 Looking at outlet of 2-800 mmØ culverts at Highway 97 (October 23, 2018)

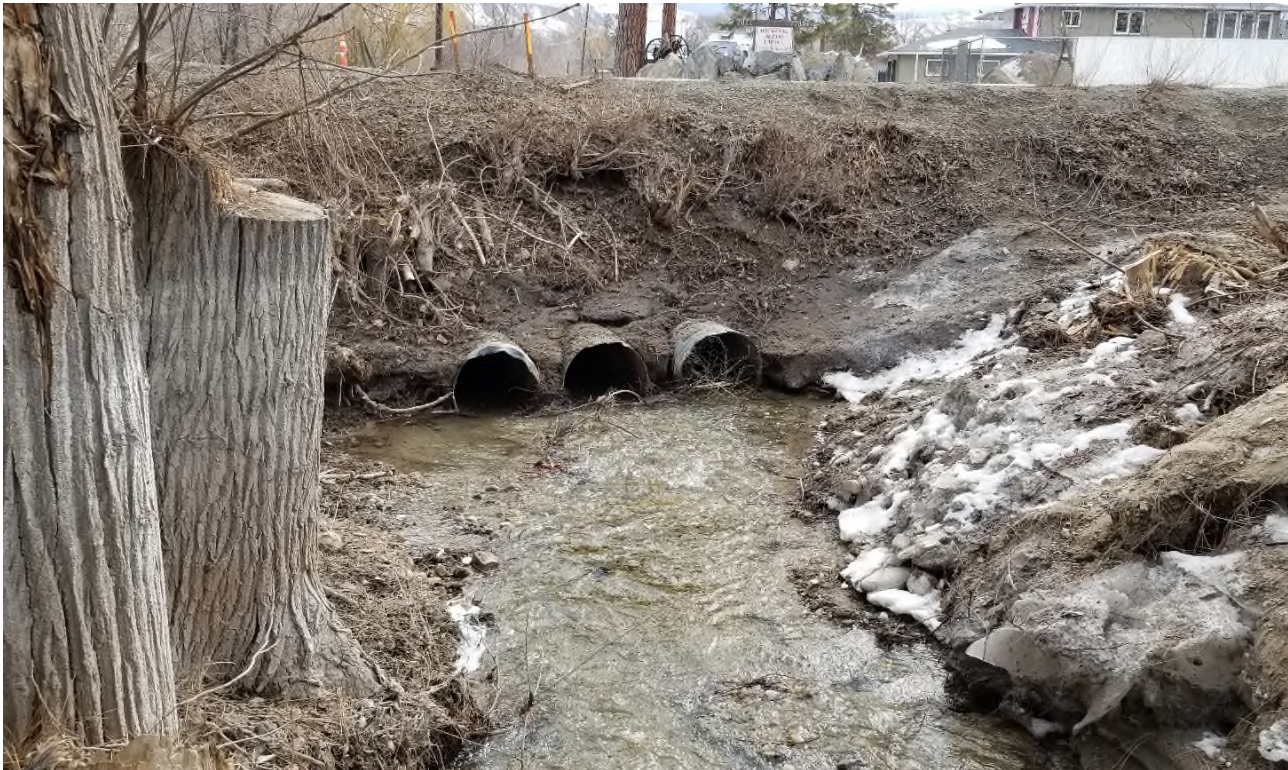
Photo 9 Looking downstream at 3-800 mmØ culverts at Highway 97 (March 14, 2019)

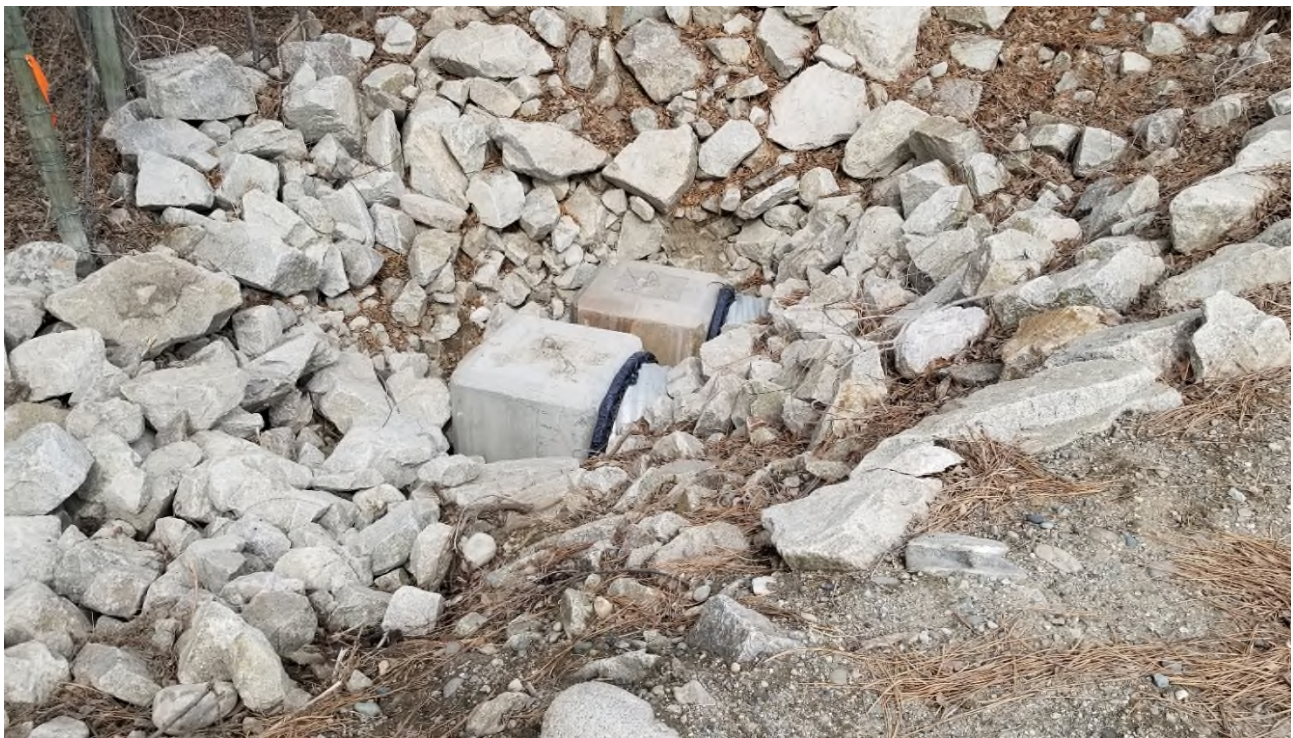
Photo 10 Inlet of 2-800 mmØ culverts at Highway 97 (March 14, 2019)

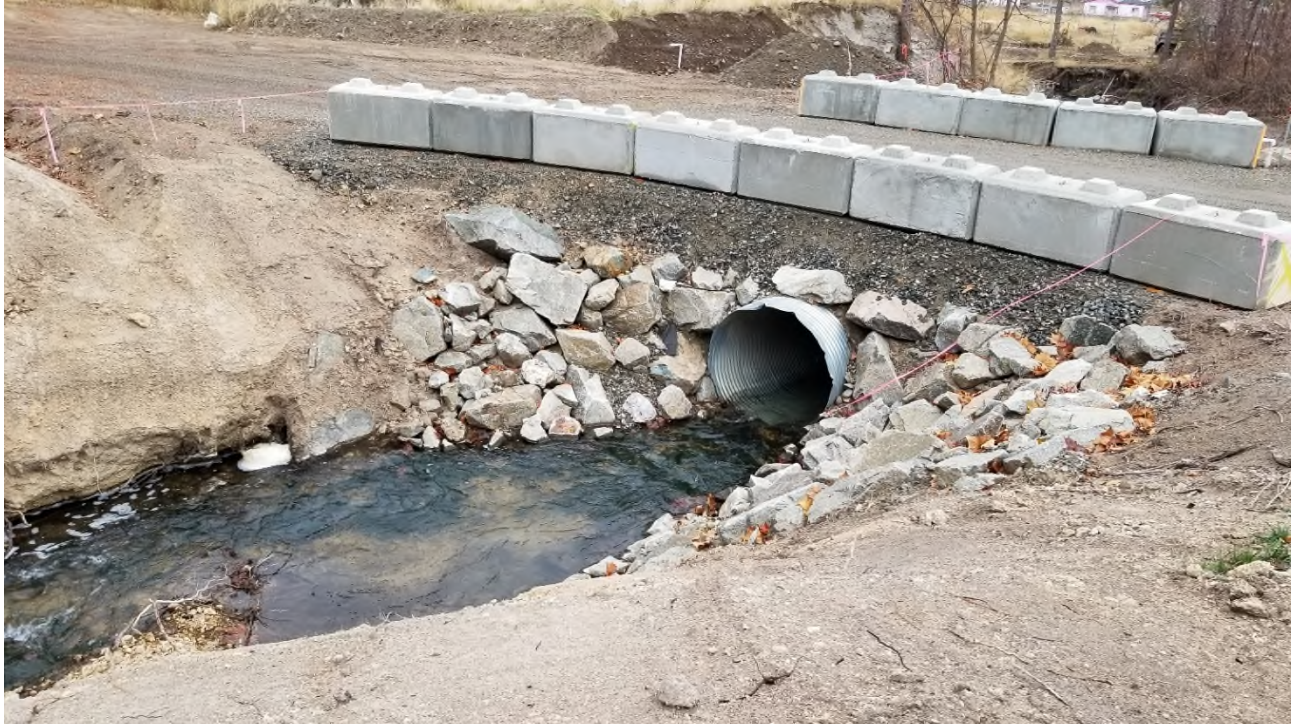
Photo 13 Looking at culvert inlet at SOSA access road (October 23, 2018)

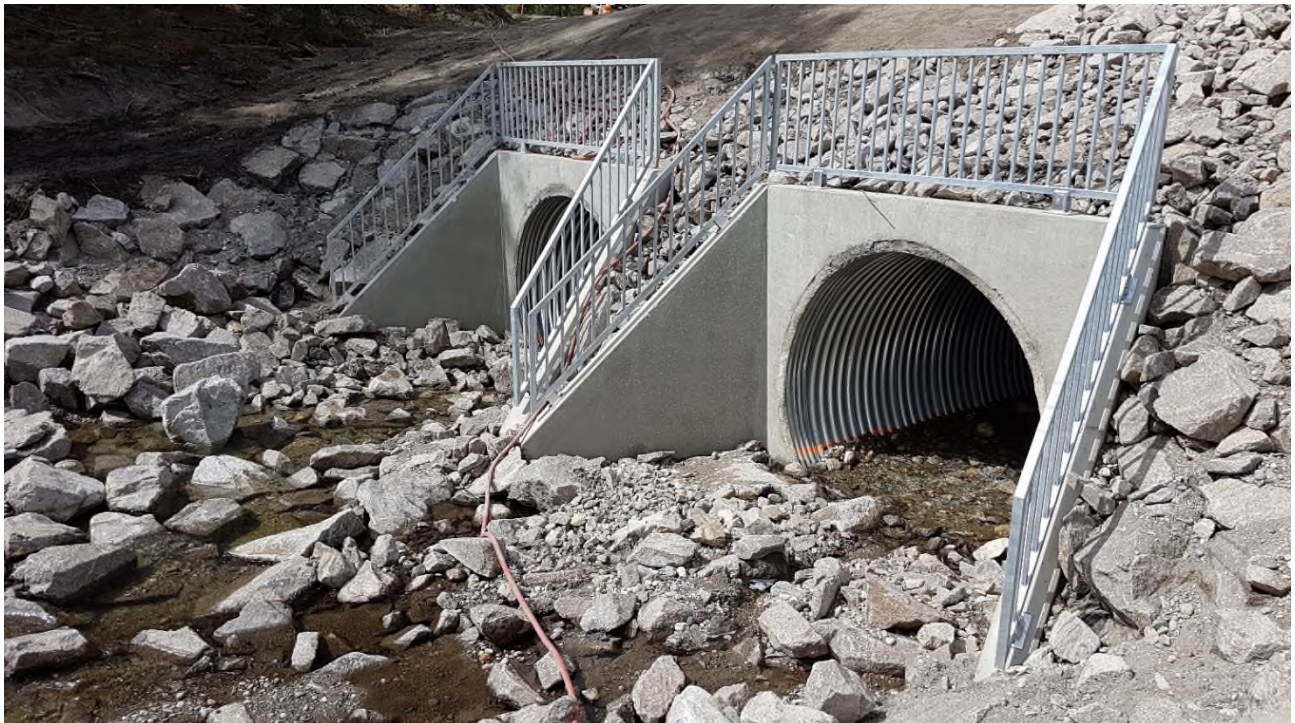
Photo 14 Inlet of 2-2700 mmØ culverts at Secret Hill Road

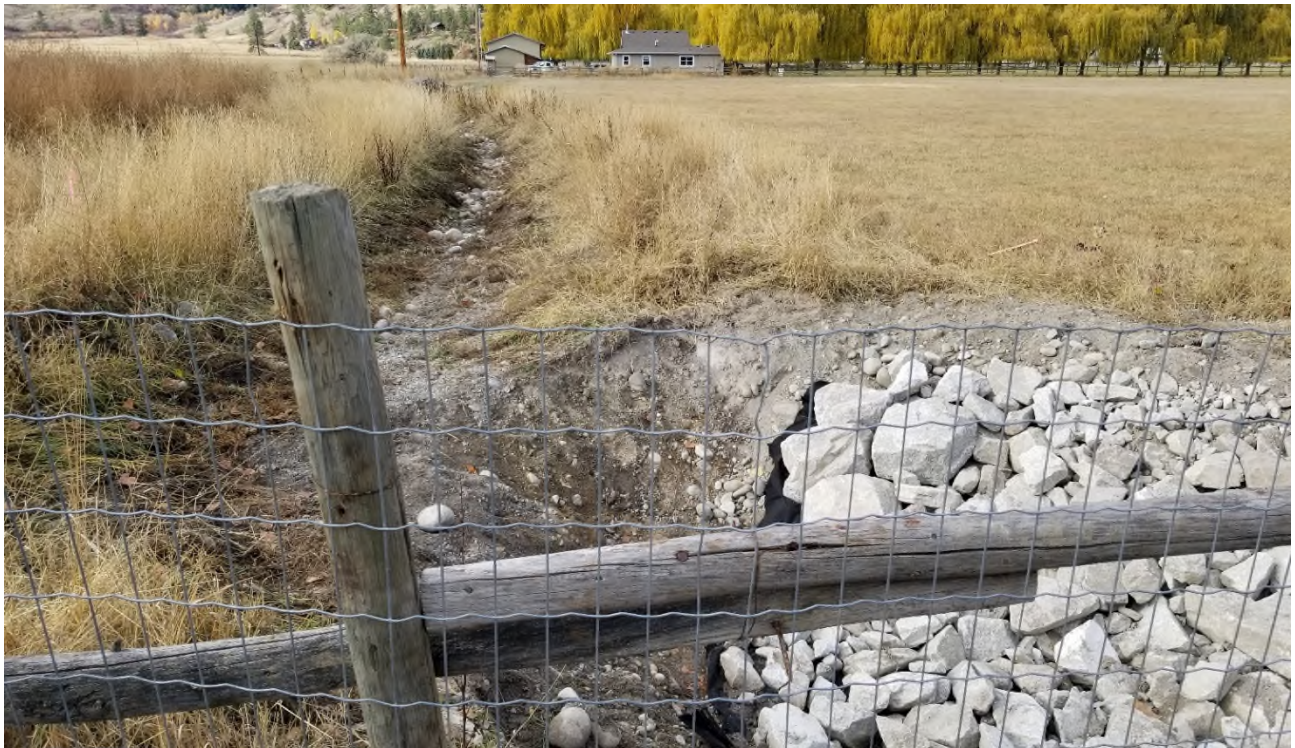
Photo 18 Looking downstream at Kearns Creek from Myers Road culvert in Willowbrook (October 30, 2018)

During a site visit on October 30, 2018, Ecora observed that the channel downstream of the new Kearns Creek box culvert crossing at Myers Road in Willowbrook is constricting the flow and will very likely cause further backwatering and flooding on Kearns Creek upstream of the new culvert unless the channel capacity downstream is improved. When the new large box culvert was installed, it was set significantly lower than the original culvert so the outlet elevation is lower than the Kearns Creek channel downstream (refer to Photos 1 & 2). A review of the channel between Myers Road and Goldtau Road by Ecora confirmed that if the channel was lowered and the capacity was increased, it would allow the Kearns Creek freshet flows to pass through Willowbrook with limited obstruction and would significantly reduce the risk of backwatering and localized flooding upstream of Myers Road, as occurred in 2018.

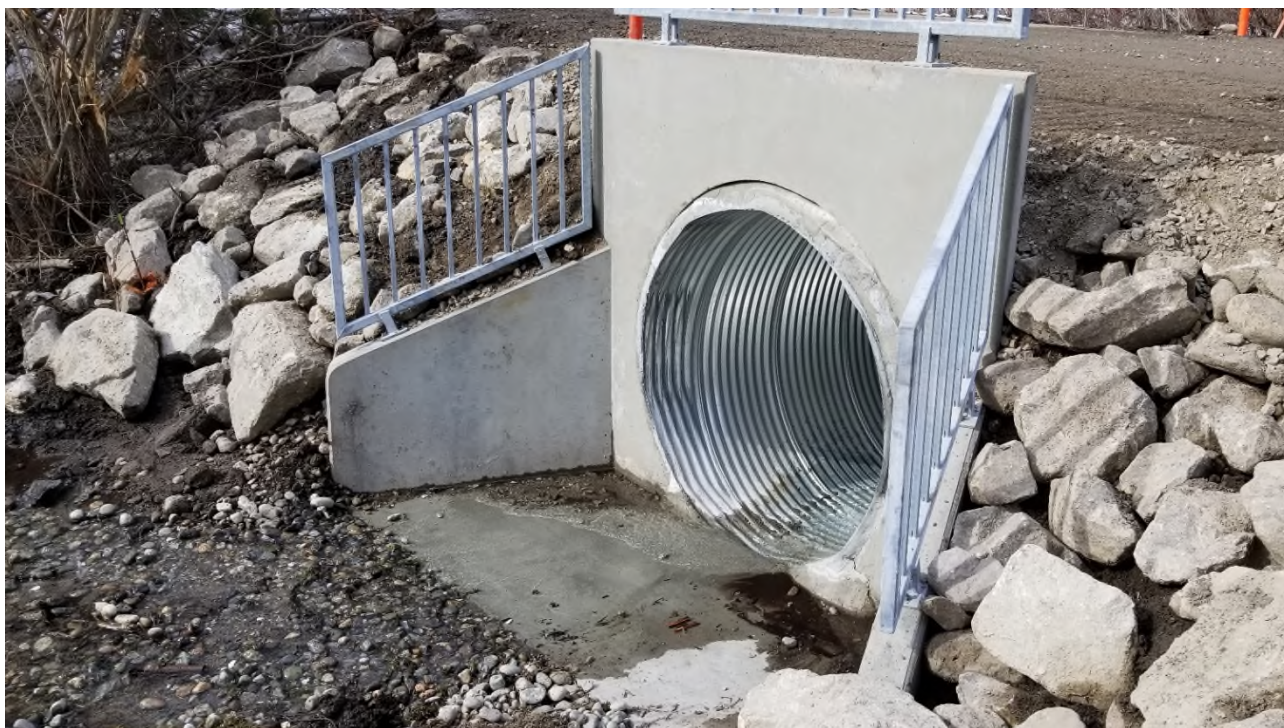
Photo 20 Inlet of Victoria Creek culvert at Secret Hill Road (March 14, 2019)

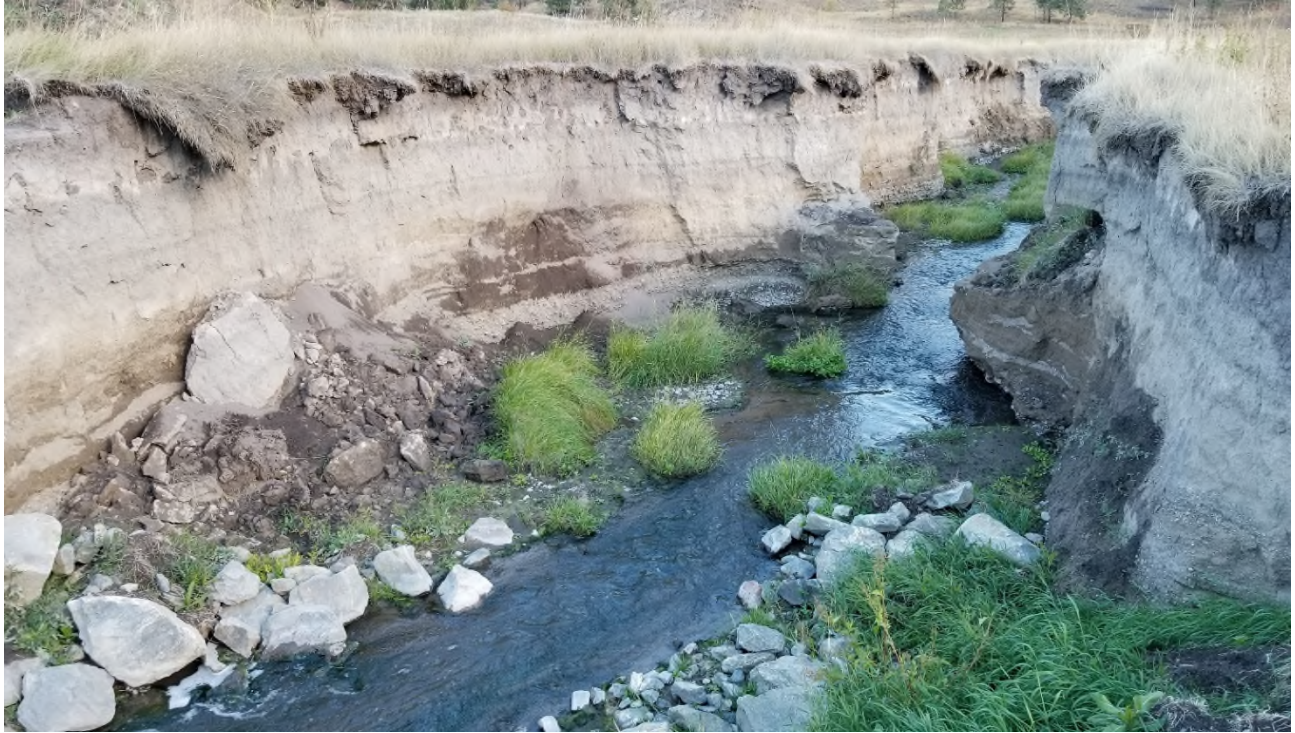
Photo 21 Looking downstream at Park Rill Creek after 2018 erosion at 4493 Willowbrook Road (October 10, 2018)

On October 10, 2018, Caleb Pomeroy, Sarah Nhan, and Michael Laws carried out a site visit to 4493 Willowbrook Road, where the property owner has noticed significant erosion in the Park Rill Creek channel that runs through his property. The property owner suspects that pumping from Twin Lakes in 2018 has created a significant gulley in his property, which was observed to be greater than 3m deep in areas and approximately 300m in length.
