Park Rill Flood Response Feasibility Study

Dated: April 30, 2019
Ecora File No.: CP-18-568-RDO

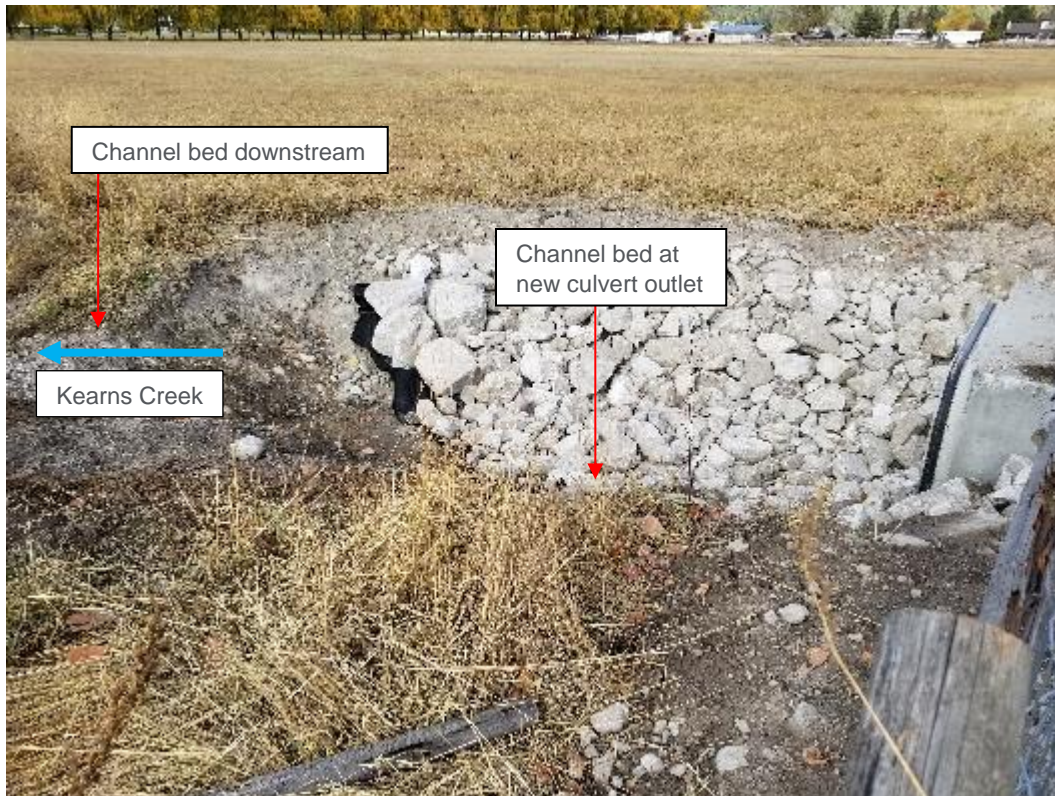
Photo 1. Myers Road new box culvert outlet, looking north

During a site visit on October 30, 2018, Ecora observed that the channel downstream of the new Kearns Creek box culvert crossing at Myers Road in Willowbrook is constricting the flow and will very likely cause further backwatering and flooding on Kearns Creek upstream of the new culvert unless the channel capacity downstream is improved. When the new large box culvert was installed, it was set significantly lower than the original culvert so the outlet elevation is lower than the Kearns Creek channel downstream (refer to Photos 1 & 2). A review of the channel between Myers Road and Goldtau Road by Ecora confirmed that if the channel was lowered and the capacity was increased, it would allow the Kearns Creek freshet flows to pass through Willowbrook with limited obstruction and would significantly reduce the risk of backwatering and localized flooding upstream of Myers Road, as occurred in 2018.

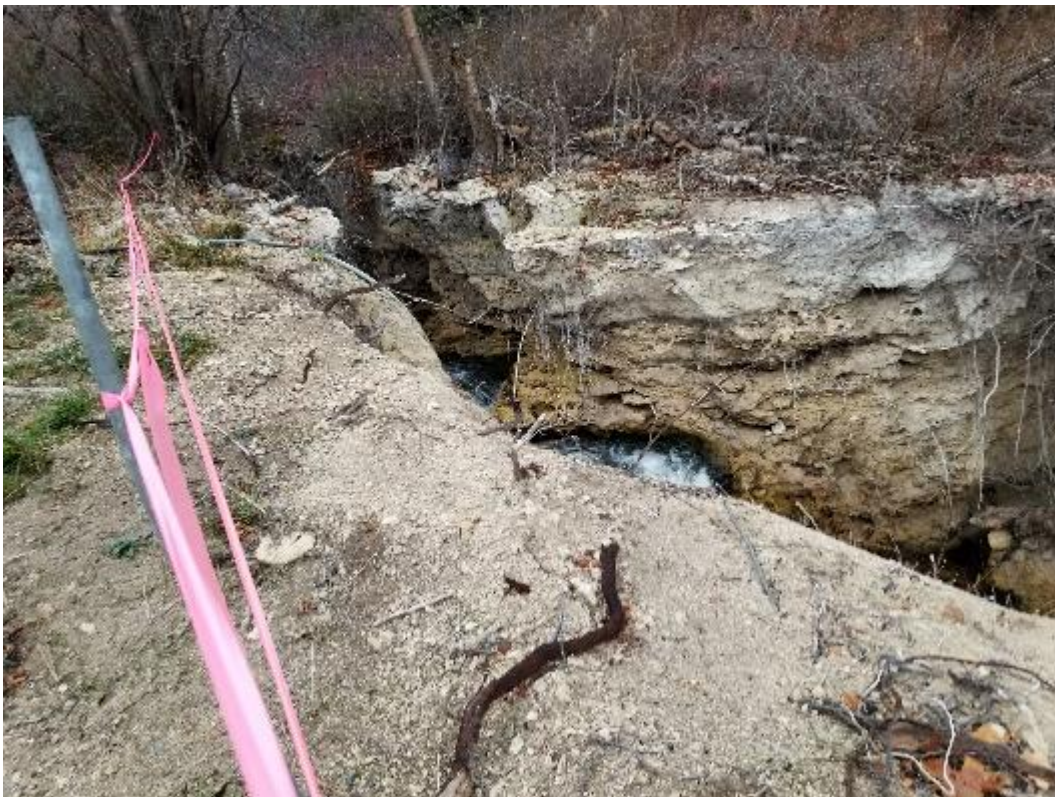
Photo 3. Park Rill Creek channel – post 2018 flood, upstream of SOSA access road

- Based on the existing conditions within this reach of the creek, high flow events have potential to cause debris flows through the channel when the debris jams wash out. If debris is washed downstream, it is expected that it will be trapped in the narrower sections of the channel, specifically in the gulley near the SOSA access road.

- The terrain is comprised steep slopes with some flatter sections with dense vegetation throughout, and the creek is restricted by steep valley walls on both sides. Due to the nature of this terrain, access by heavy machinery and personnel is generally not recommended.

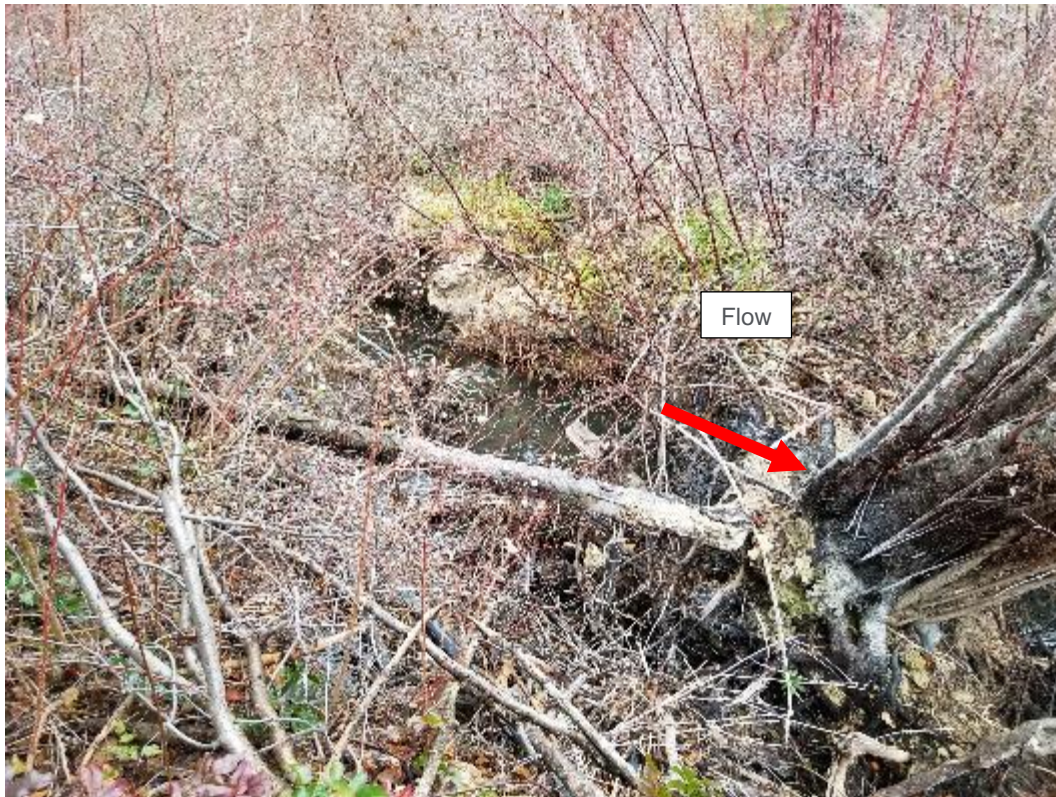
Photo 4. Willow located within channel

- At the channel avulsion site, a willow is located within the channel and the channel has undermined the tree roots. The willow will eventually fall over blocking the channel and could initiate a debris flow. Photo 4 shows a view of the willow and the channel.

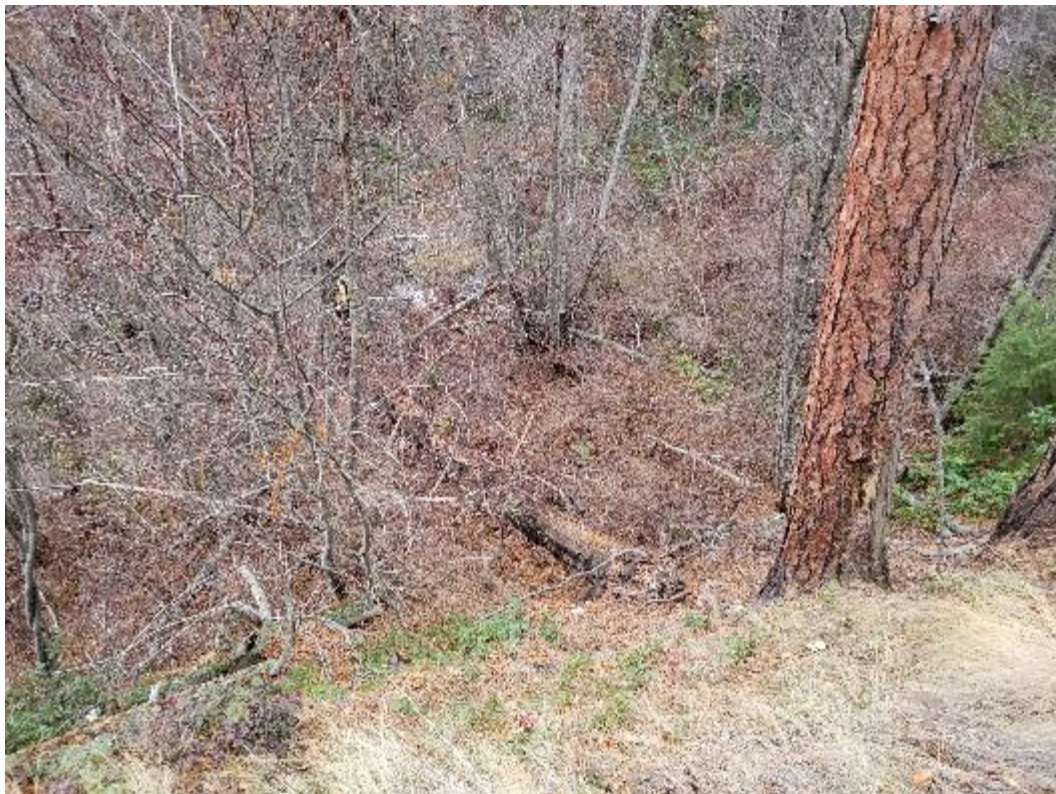
Photo 5. View of Northeast Channel looking north that is now cut off and dry

- The former northeast channel is now permanently cut off from flows, except during very high flow periods, due to the downcutting of the avulsion channel, as shown in Photo 5.

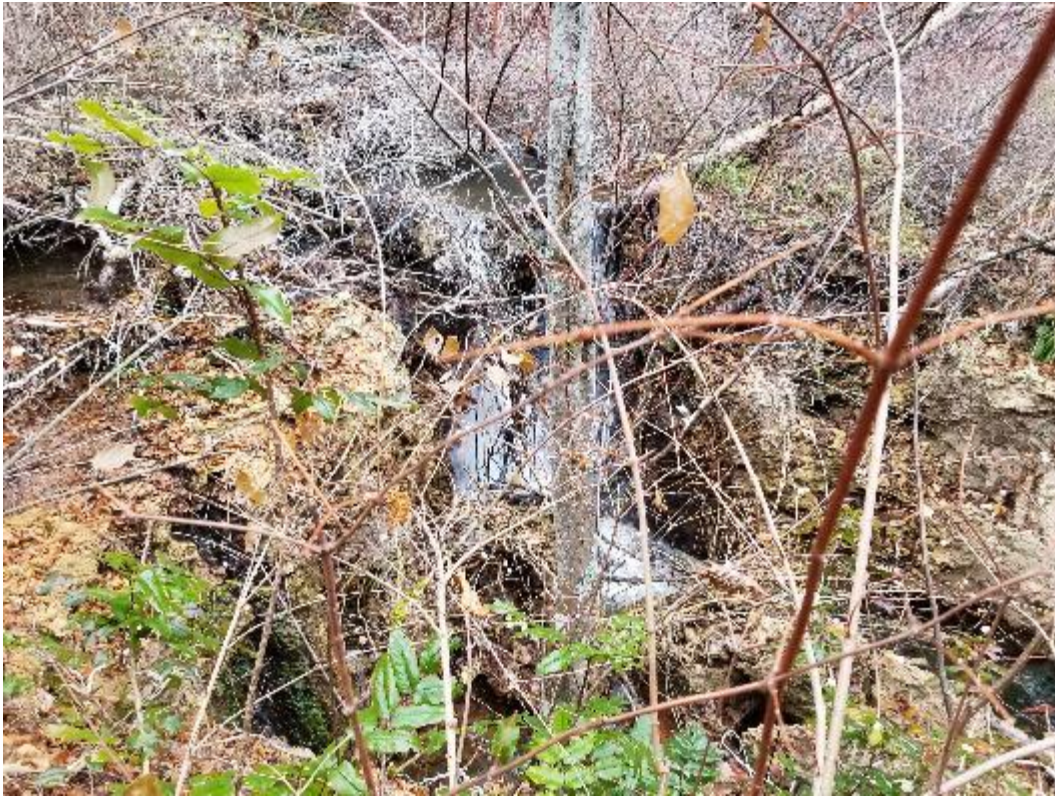
Photo 6. Breach with flow retained by debris

- Along this reach, there are several waterfall-type areas with extremely steep channel gradients interspersed between flat sections of channel. Some of these steep reaches appear to be caused by debris build-up within the channel. Photo 6 shows a waterfall where channel appears to be controlled by a debris build-up, and Photo 7 shows a flat area just upstream of the drop-off.

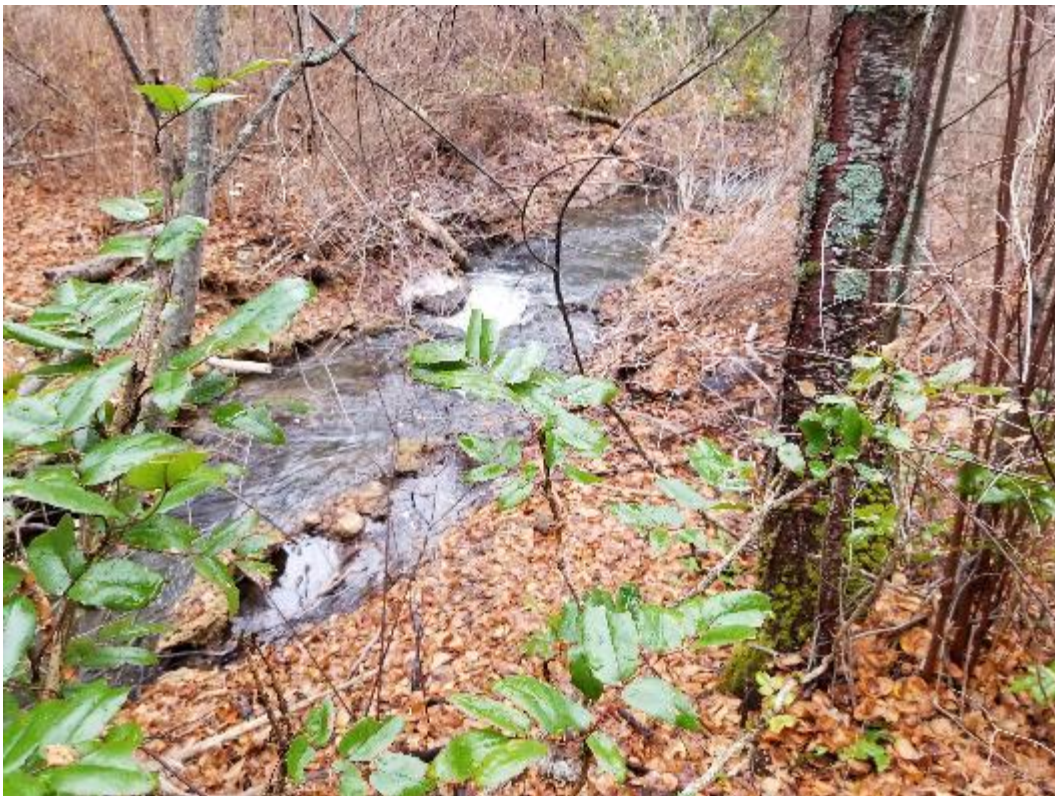
Photo 7. Flat creek channel upstream of the breach

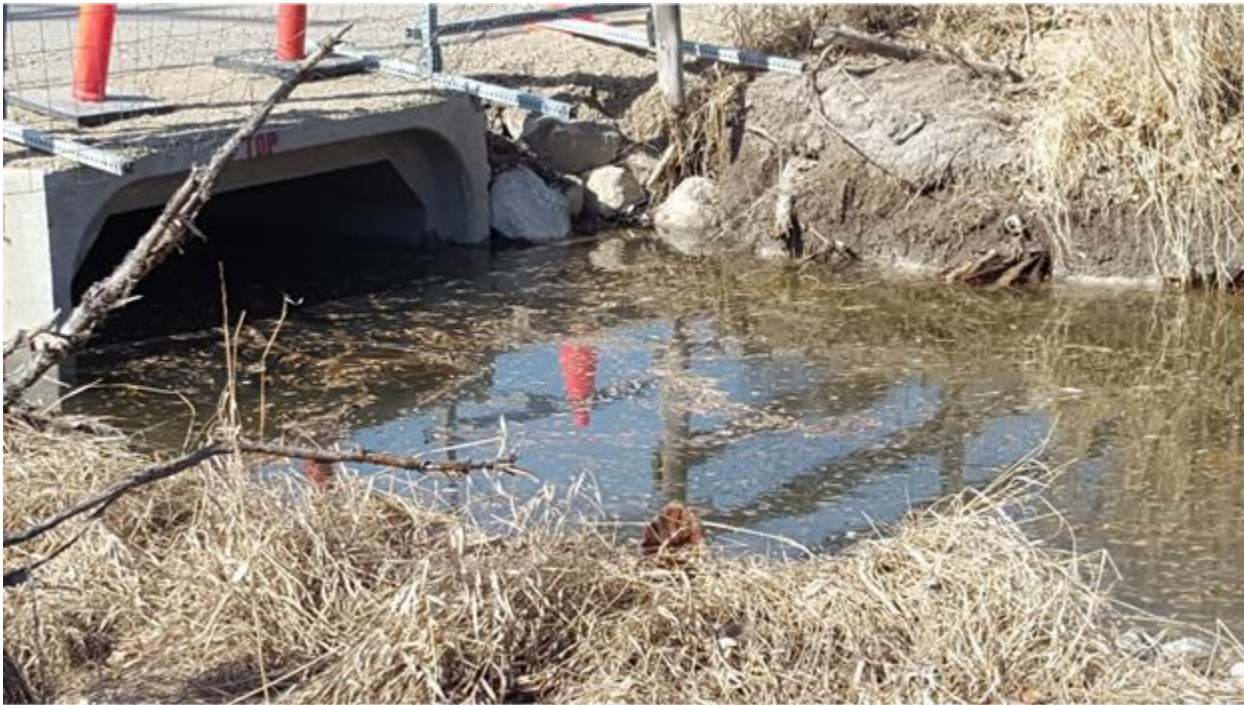
Kearns Creek at Myers Road culvert - view from upstream (flow goes from right to left). March 22, 2019.

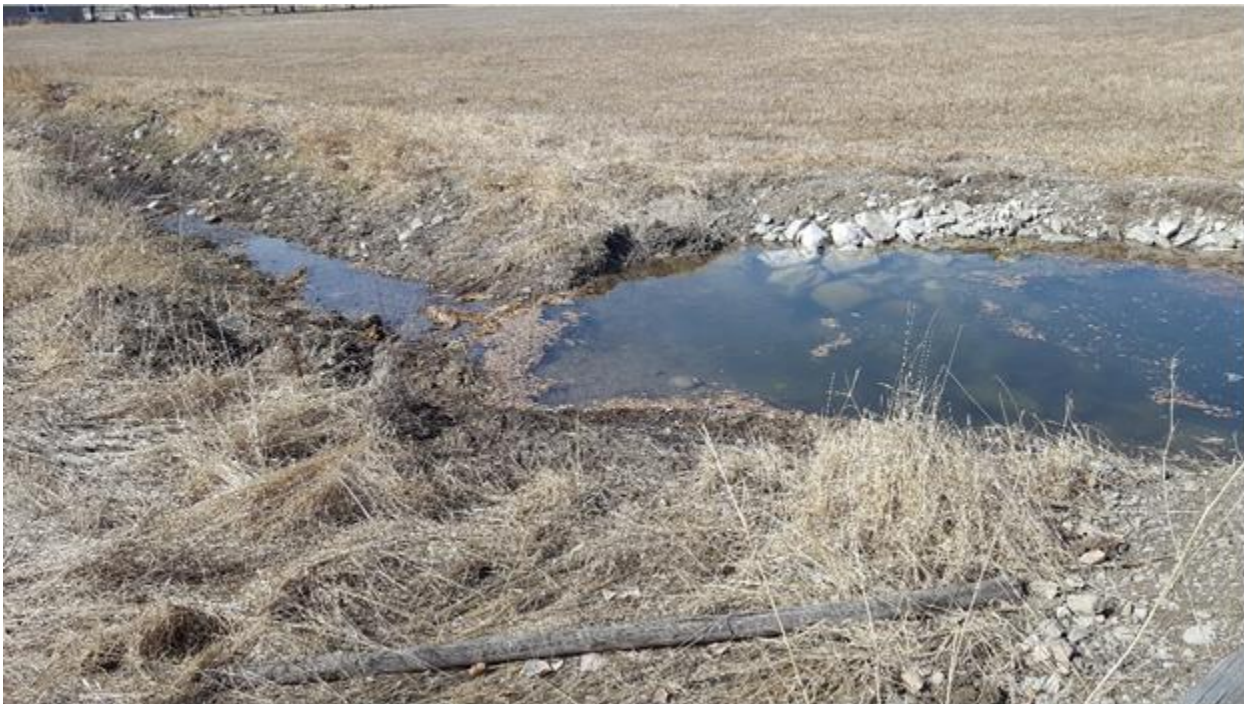
Pooling just downstream of the Myers Road culvert where flow is currently obstructed. March 22, 2019.

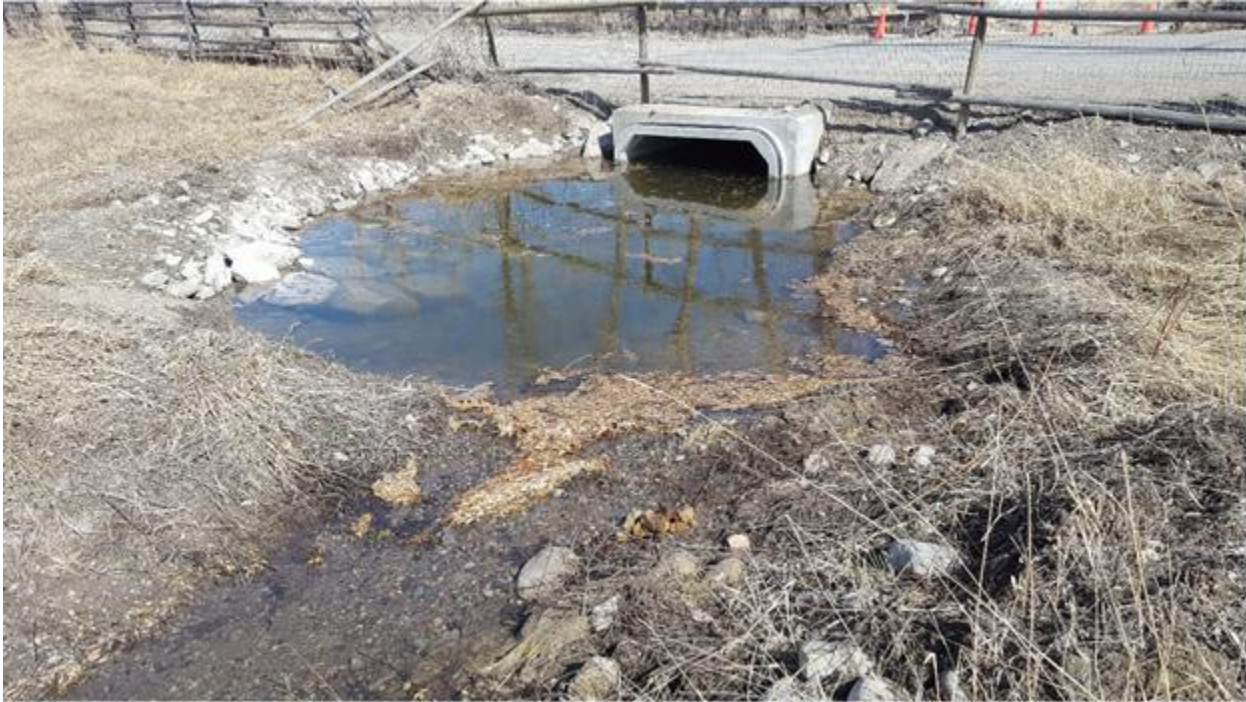
Looking upstream at the Myers Road outlet – water appears to seep into the ground. March 22, 2019.

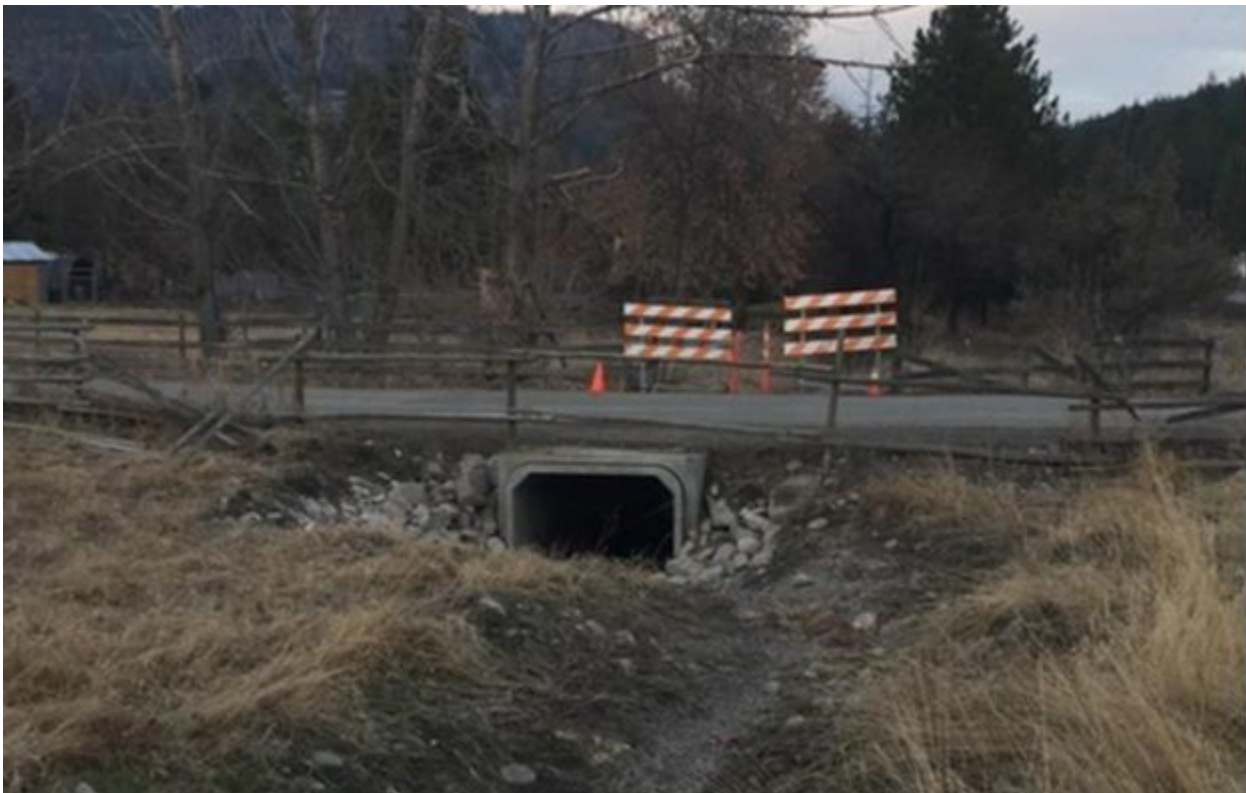
Looking upstream at Myers Road outlet – water has seeped into ground and the area is now dry. March 25, 2019.
