POST-WILDFIRE NATURAL HAZARDS RISK ANALYSIS OF THE 2023 CRATER CREEK WILDFIRE (K52125)

Dated:	June 17, 2025
Presented To:	Ministry of Forests – BC Wildfire Service
Attention:	Mr. Trevor Bohay & Mr. Gareth Wells
CGL Project #	24-0103
Version:	Final - Issued for Use

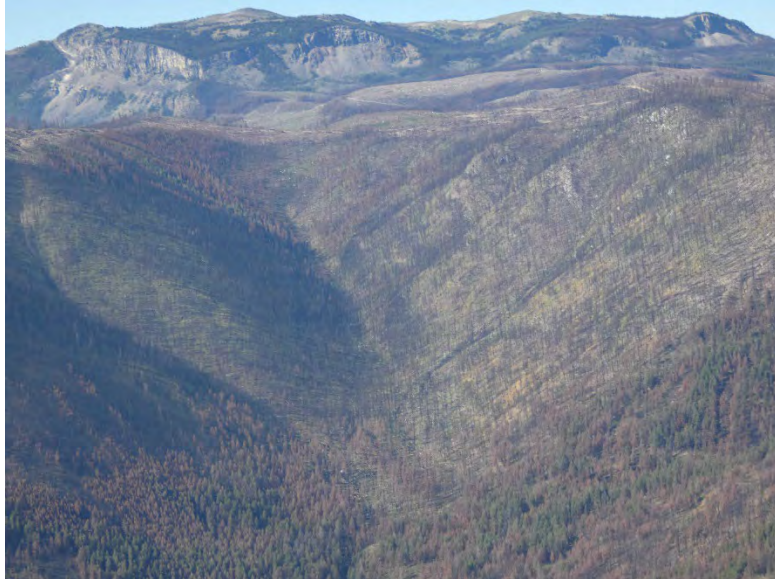
Photo 3: View of upper Rattlesnake Creek Tributary.

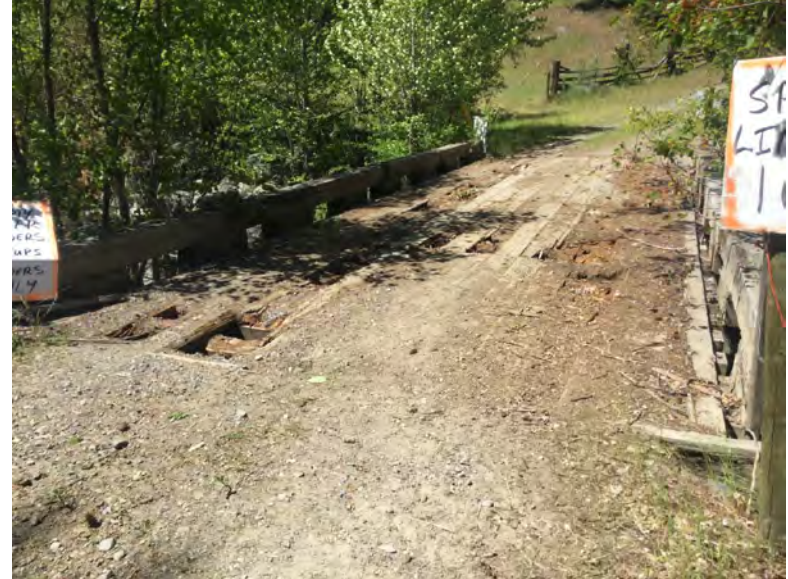
Photo 4: Bridge across Paul Creek (at ~2.5KM Paul Creek Road) is not passable.

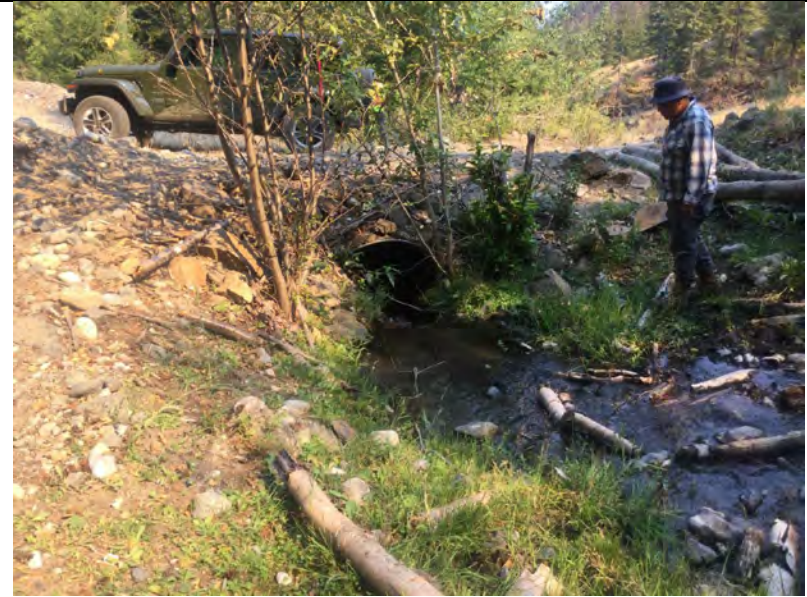
Photo 6: Culvert (1000 mm) inlet at Rattlesnake Creek crossing along Paul Creek Road. Outlet is partially obstructed by road grading sediment.

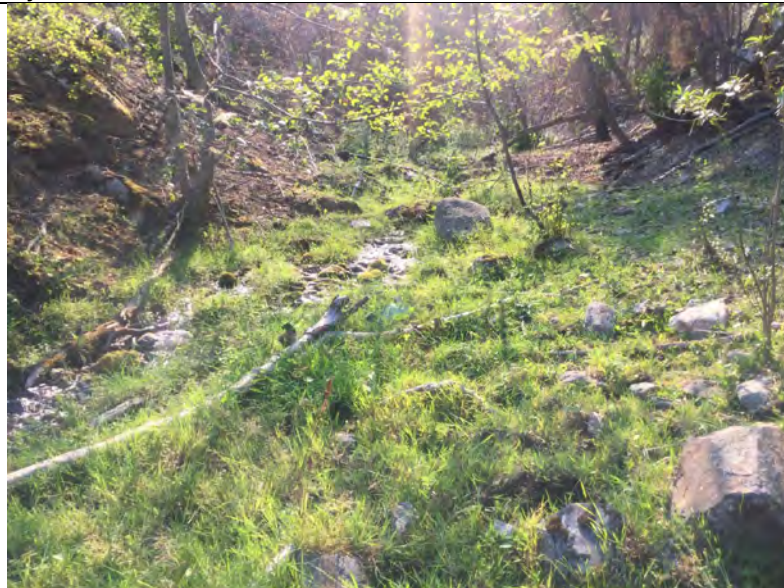
Photo 7: Rattlesnake Creek, view upstream from Paul Creek Road culvert. Evidence of livestock access to channel.

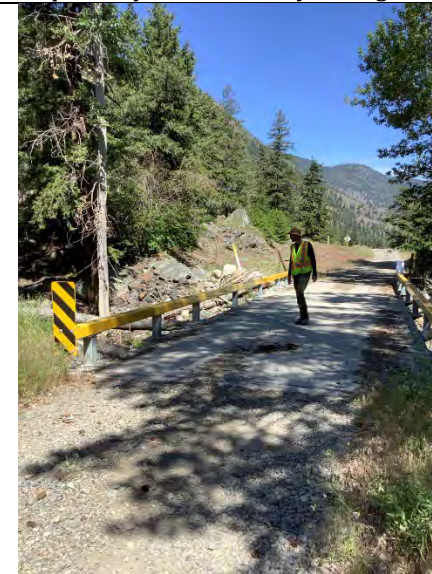
Photo 8: Bridge across Paul Creek at top of fan (access through Ashnola 10 IR in the Similkameen Valley)

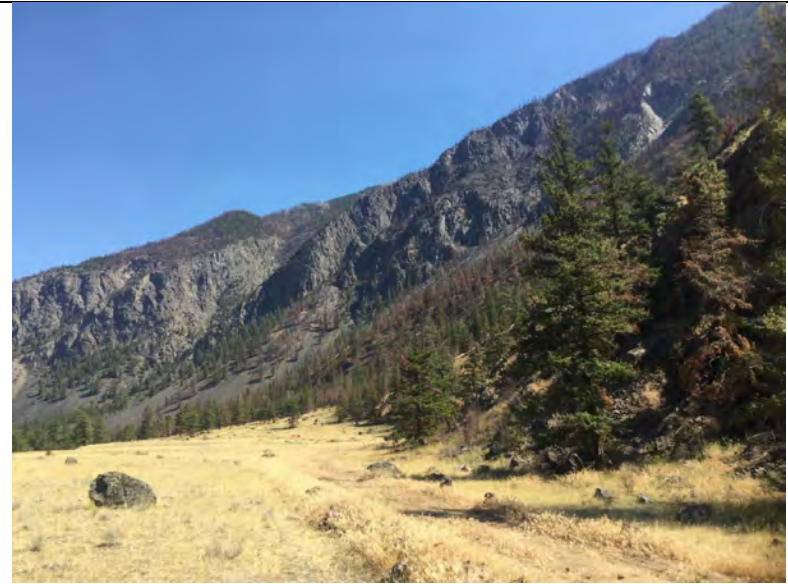
Photo 8: Face Unit east of Ashnola River along the Similkameen (west of Tweddle Creek). View east showing extensive talus slopes below steep bedrock bluffs. Rockfall activity indicated by scattered boulders across glaciofluvial terrace along toe of slope.

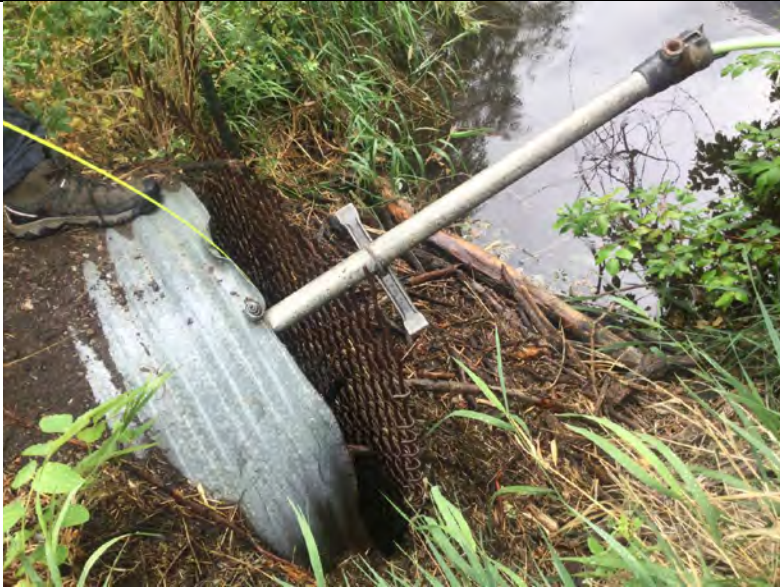
Photo 5: Culvert (4 ft (1220 mm) diam.) at Ashnola Road with upstream ponding associated with partial obstruction of flow.

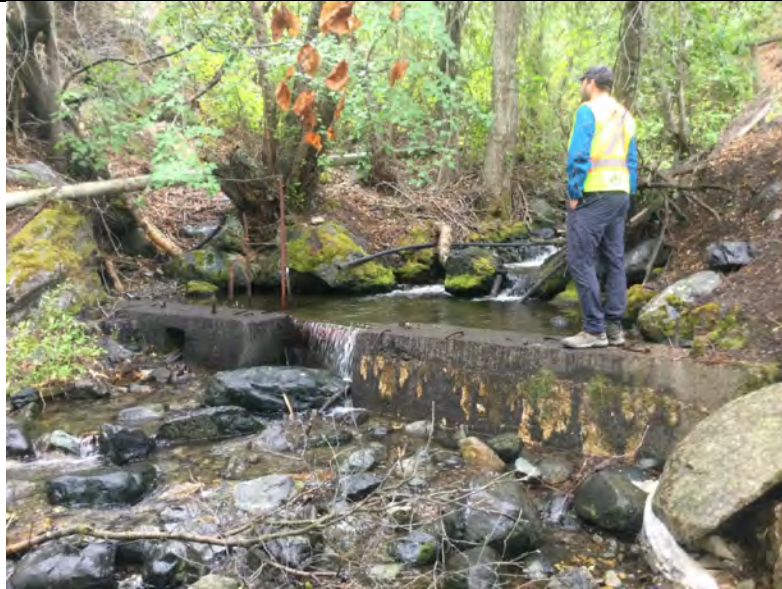
Photo 5: Barrington Creek POD weir. No accumulated sediment in upstream weir structure.

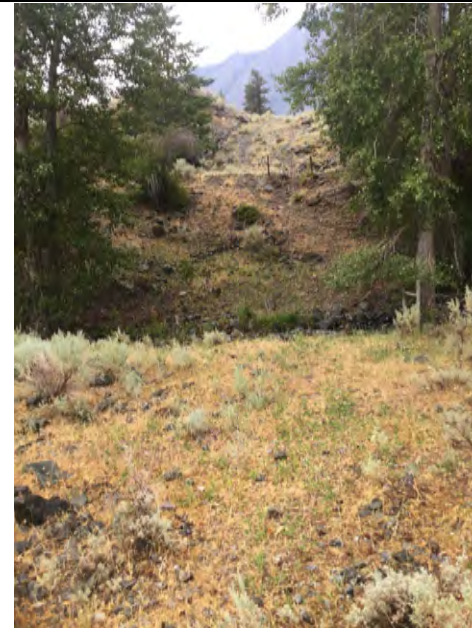
Photo 6: Buried Fortis gas pipeline under Barrington Creek.

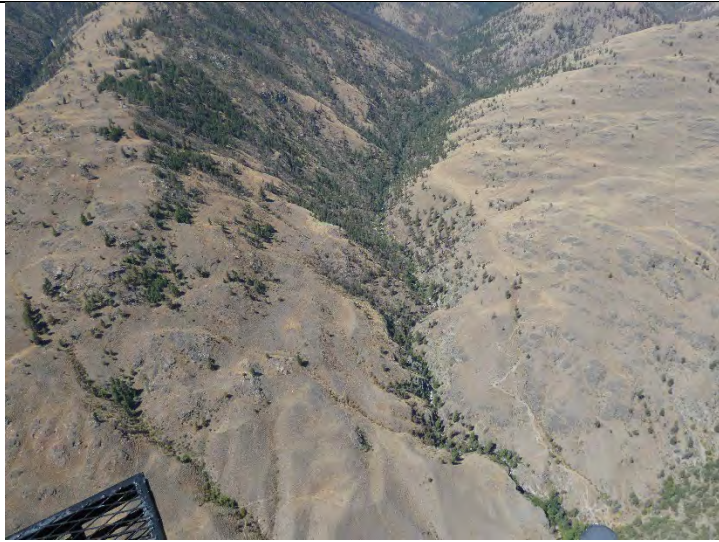
Photo 5: Bedrock-controlled incised lower reaches of Susap Creek, above the fan.

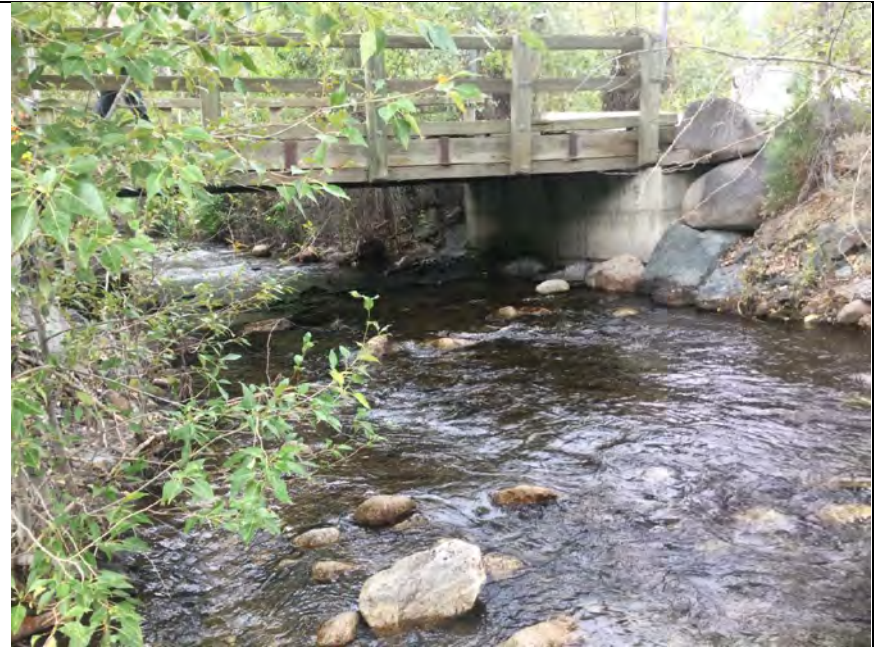
Photo 9: Wooden bridge (7.5 m long) with concrete abutments over Susap Creek at Chopaka Road.

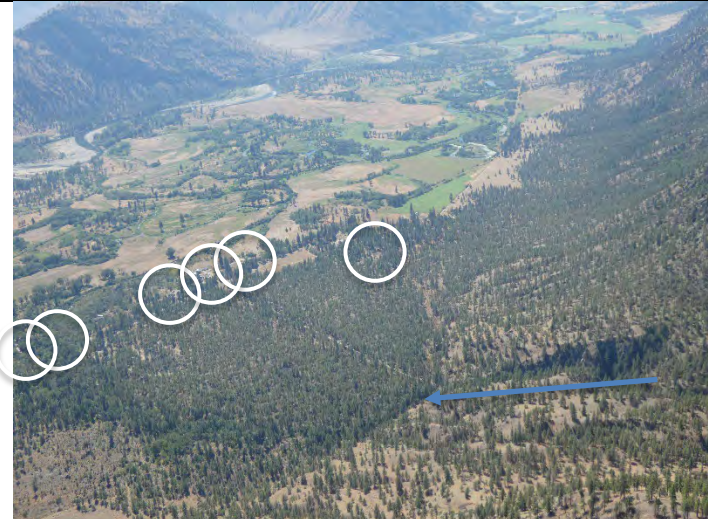
The Snehumption Creek alluvial fan is a large and mostly forested fan within Chopaka 7 & 8 IR within the Similkameen River valley (see Photo 4). There is evidence of irrigation and water intake infrastructure (trails) and there are abundant bouldery deposits on the fan surface, suggesting past-debris flood activity. However, the channel appears to be fairly well-incised and stable. There is at least one seasonal channel that may be associated with an upstream irrigation diversion (see Photo 9) but little evidence of historic channel avulsion.

Photo 4: View of the Snehumpton Creek alluvial fan located within the Similkameen River valley. Residences on the fan and along Chopaka Road are circled. Snehumpton Creek is indicated with an arrow.

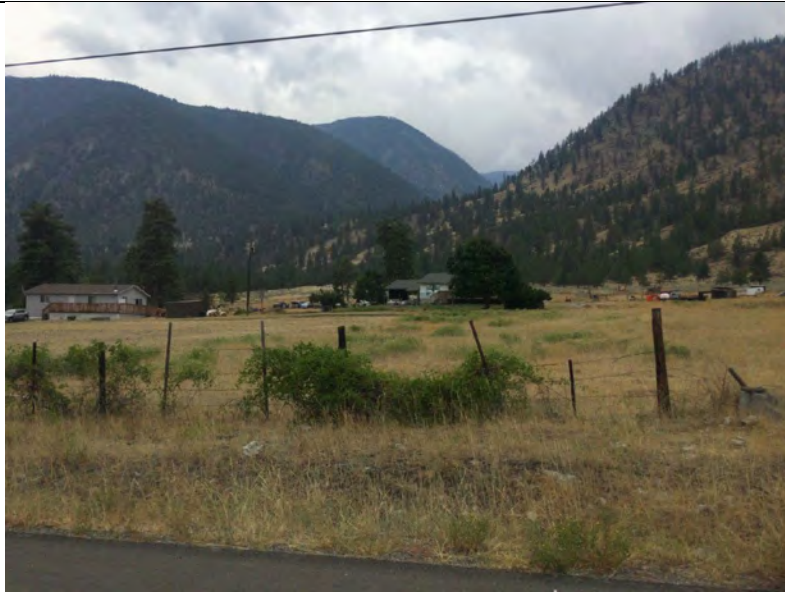
Photo 5: View of Snehumption Creek fan from Chopaka Road to the north .

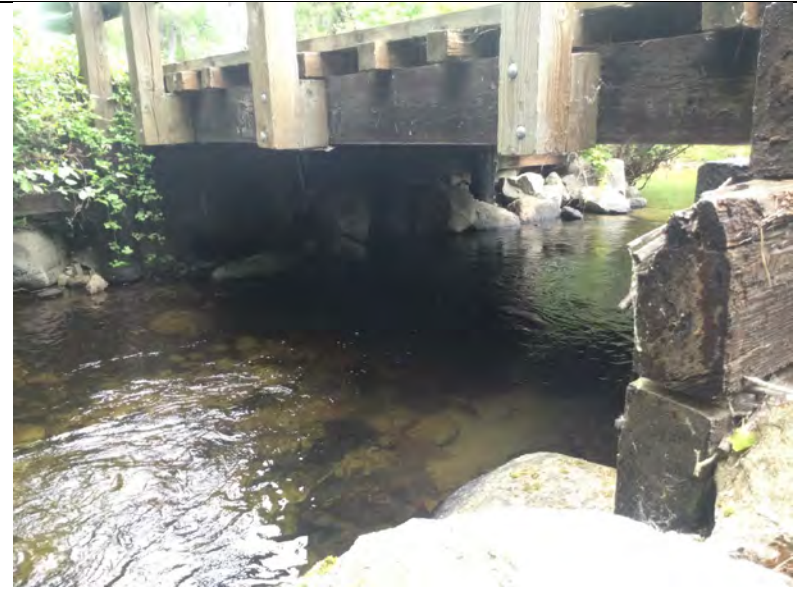
Photo 6: View of 6.3 m long timber bridge over Snehumption Creek at Chopaka Road.

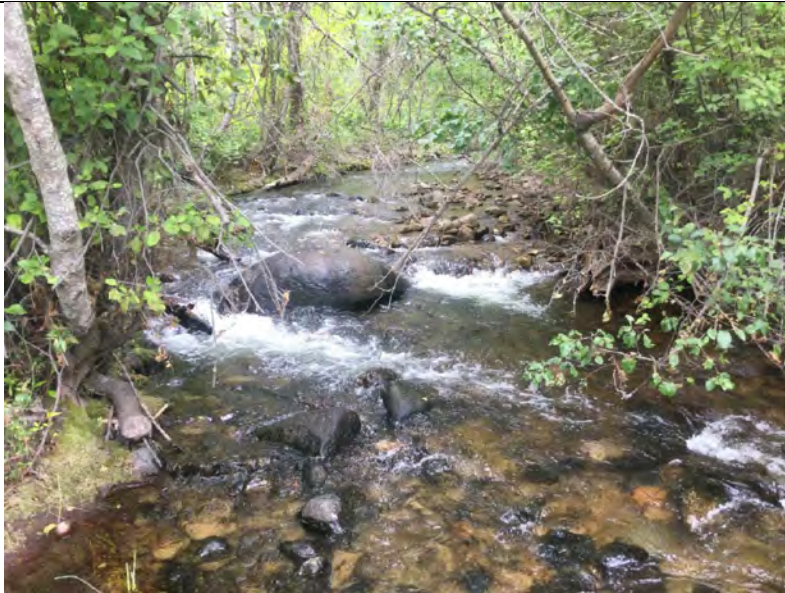
Photo 8: View upstream on Snehumption Creek from the Chopaka Road bridge. Relatively stable channel with cobble-boulder substrate and stable, vegetated streambanks.

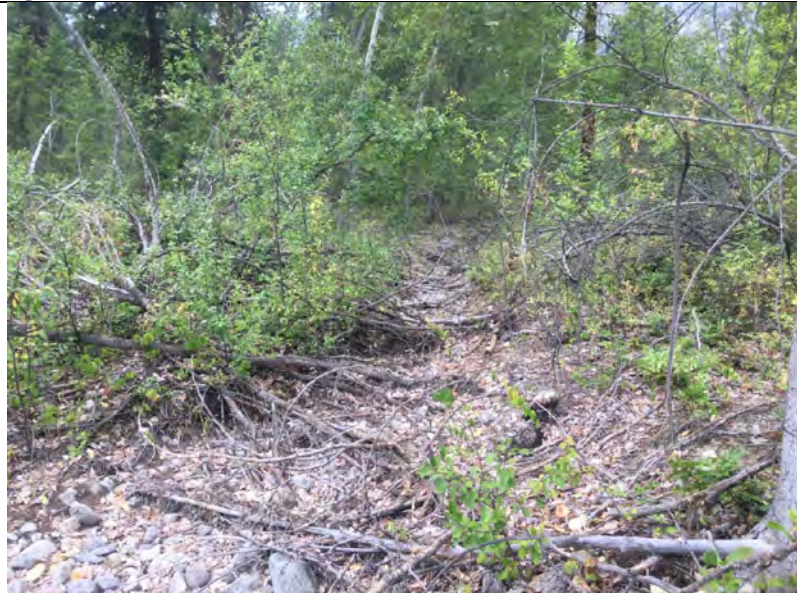
Photo 9: Small (1.5 m wide) seasonal channel on the Snehumption Creek fan, potentially associated with upstream irrigation diversion.

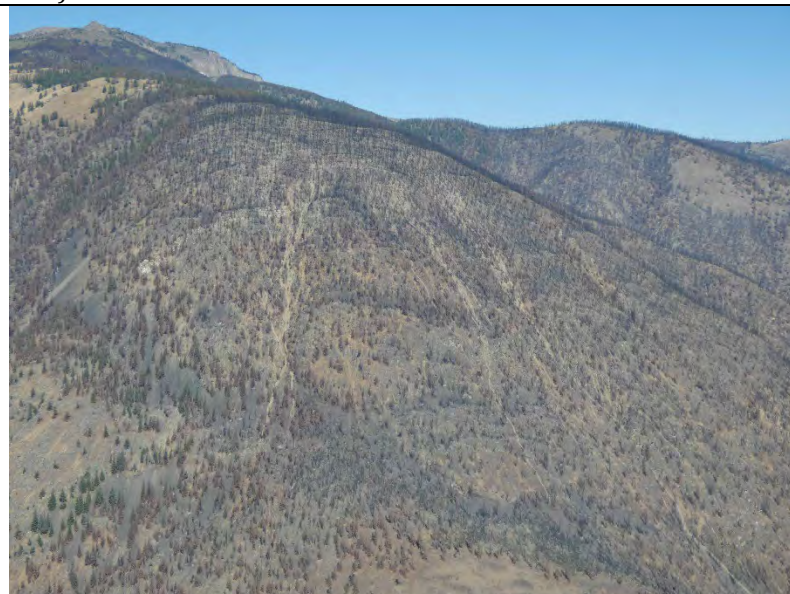
Photo 4: **Ashnola Face Unit 2** slopes above Ashnola Road. Note gullies subject to sediment-laden flows likely attributed to post-wildfire runoff.

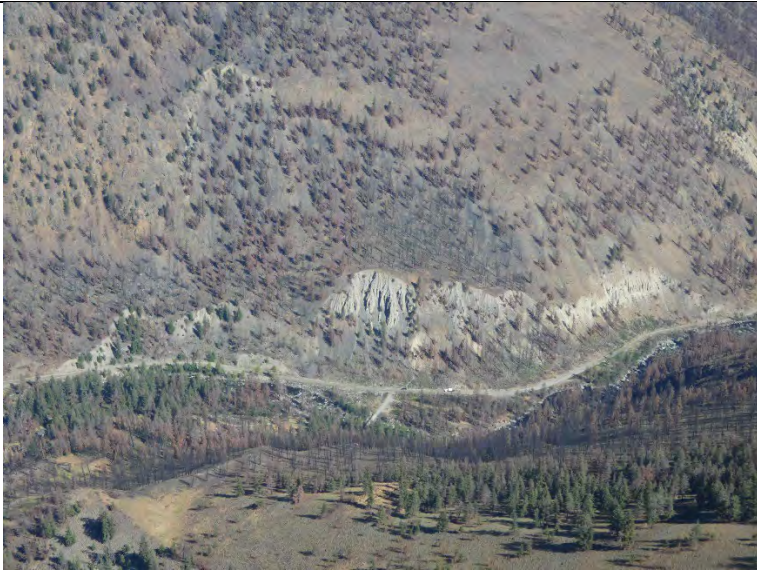
Photo 5: **Ashnola Face Unit 2** near Ewart Creek Road bridge. View of west slopes above the Ashnola Road, which are potentially unstable unconsolidated over-steepened glacial drift deposits prone to ravelling (shallow debris slides and rockfall).

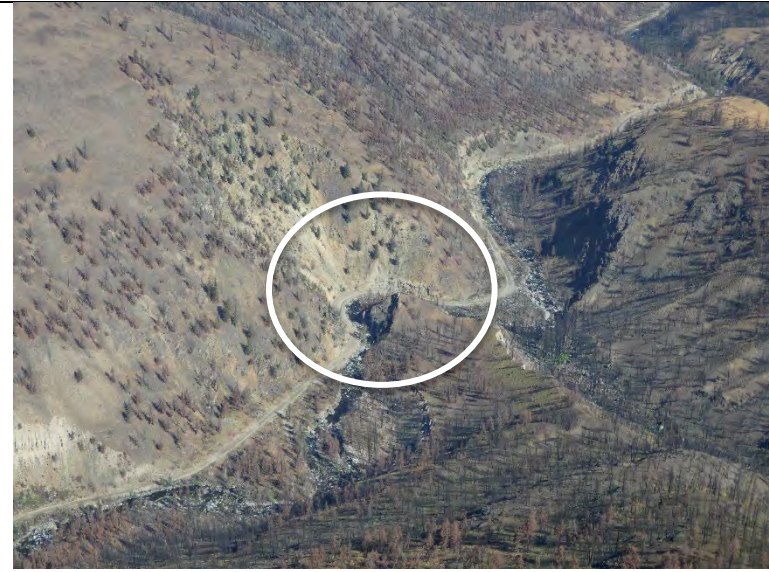
Photo 6: **Ashnola Face Unit 3** on the west side of Ashnola River. Photo at confluence of Ewart Creek. Note exposed and ravelling unconsolidated sediments above the road and tight, bedrock-controlled section of valley through which road and river are contained (circled).

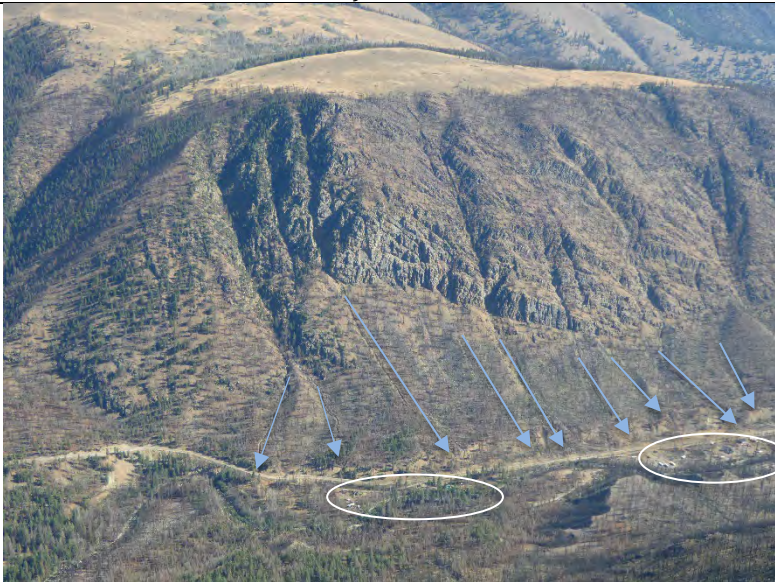
Photo 7: **Ashnola Face Unit 3**, east of Meausette Creek. Evidence of multiple post-wildfire runoff flow paths along slopes above Ashnola Road (arrows). Structures/residences and Cathedral Park base camp circled.

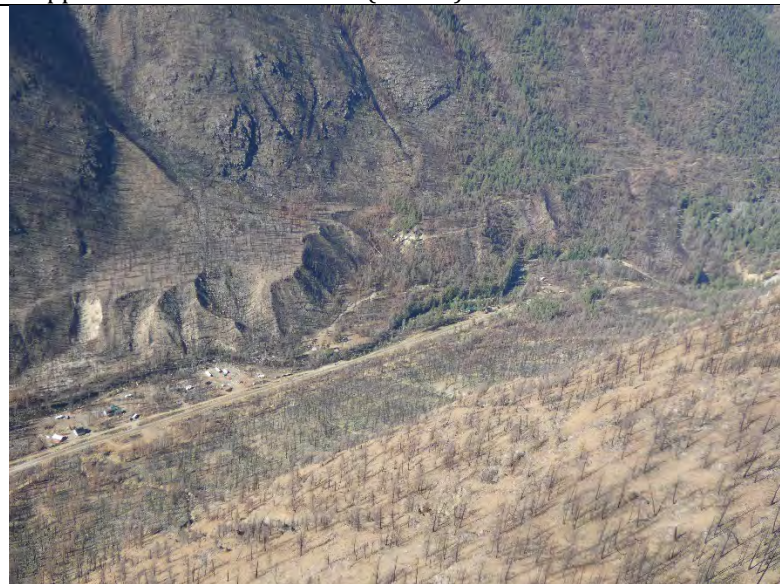
Photo 11: **Ashnola Face Unit 4**. Structures/residences and Cathedral Park base camp are visible. Note, large raised fan associated with debris-flow prone catchment and gullied slopes along edge of terrace within the valley.

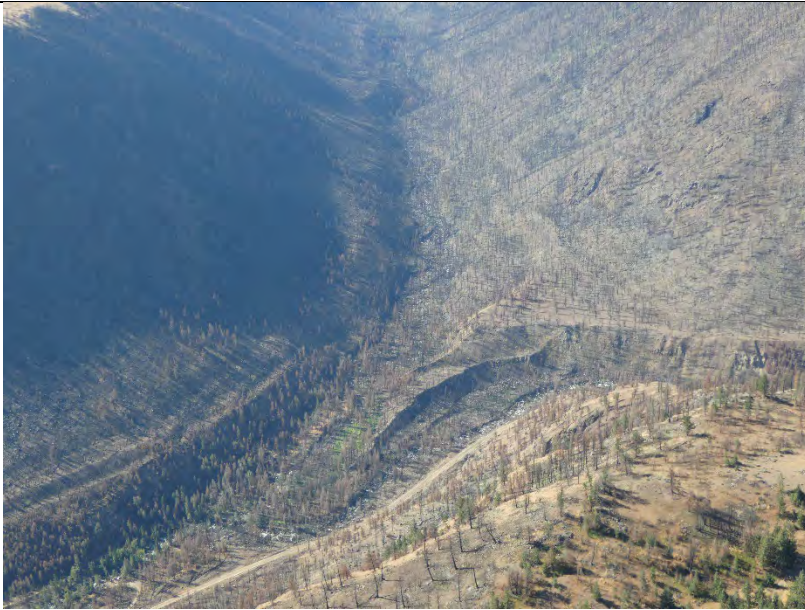
Photo 5: Confluence of Ewart Creek at the Ashnola River. Note raised fan deposits. Ashnola Road along bottom of photo. Ewart Creek Road is along base of slope next to Ewart Creek.

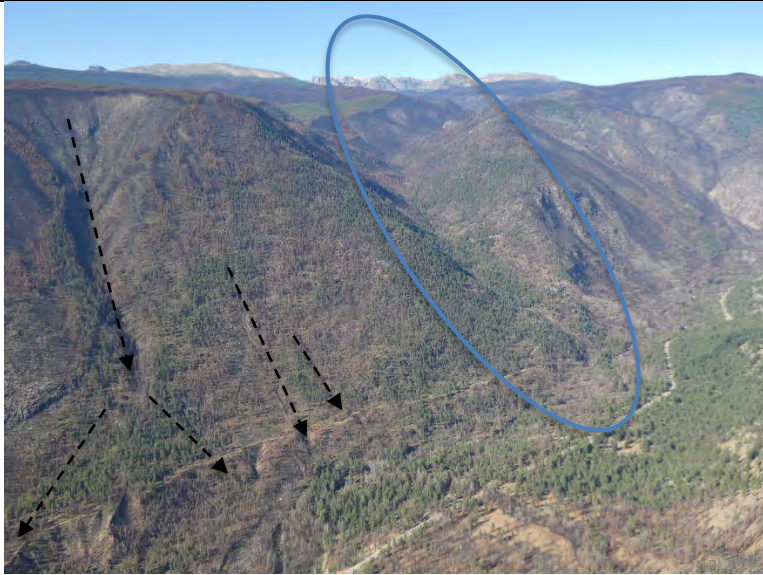
Photo 1: Helicopter overview photo looking south into Lakeview Creek watershed from the Ashnola River (circled). Road on right is Ashnola Road and road on left on terrace is the Lakeview Road accessing Cathedral Park. Note steep, debris-flow prone burned tributaries on Ashnola River Face Unit 4 (arrows).

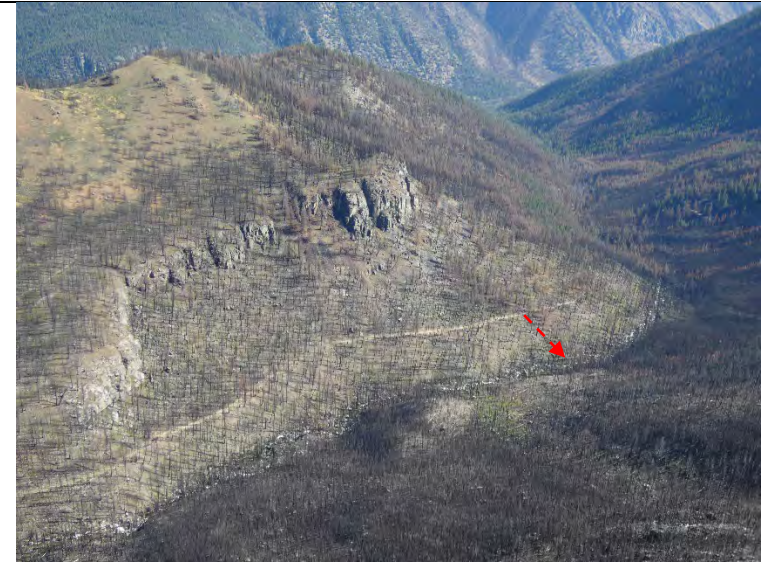
Photo 4: Section of Lakeview Road through steep canyon. Drainage-related landslide is indicated (arrow).

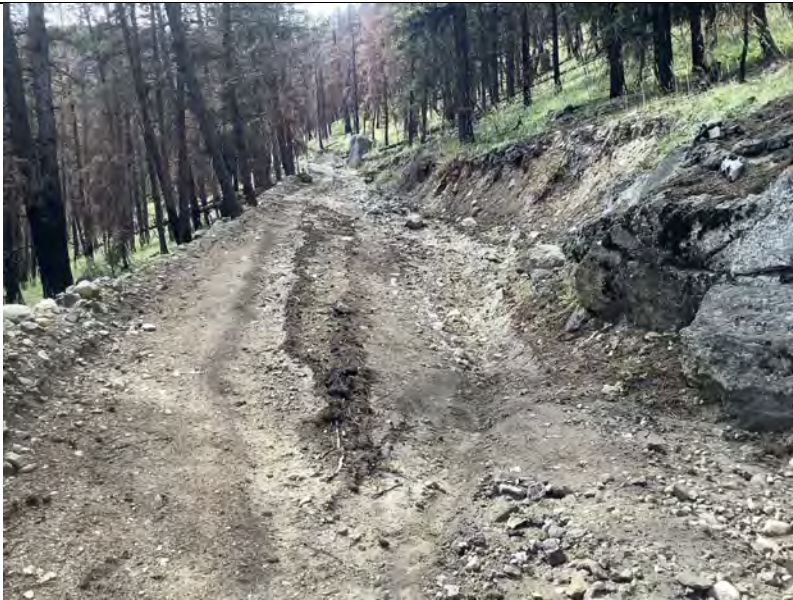
Photo 7: Example surface erosion associated with post-wildfire runoff onto Lakeview Road (~5.2 km).
