June 17, 2025

CGL Project: 24-0103

Reference: Shoudy Creek Watershed Post-Wildfire Natural Hazard Risk Analysis – 2024 Update
Similkameen Valley, BC

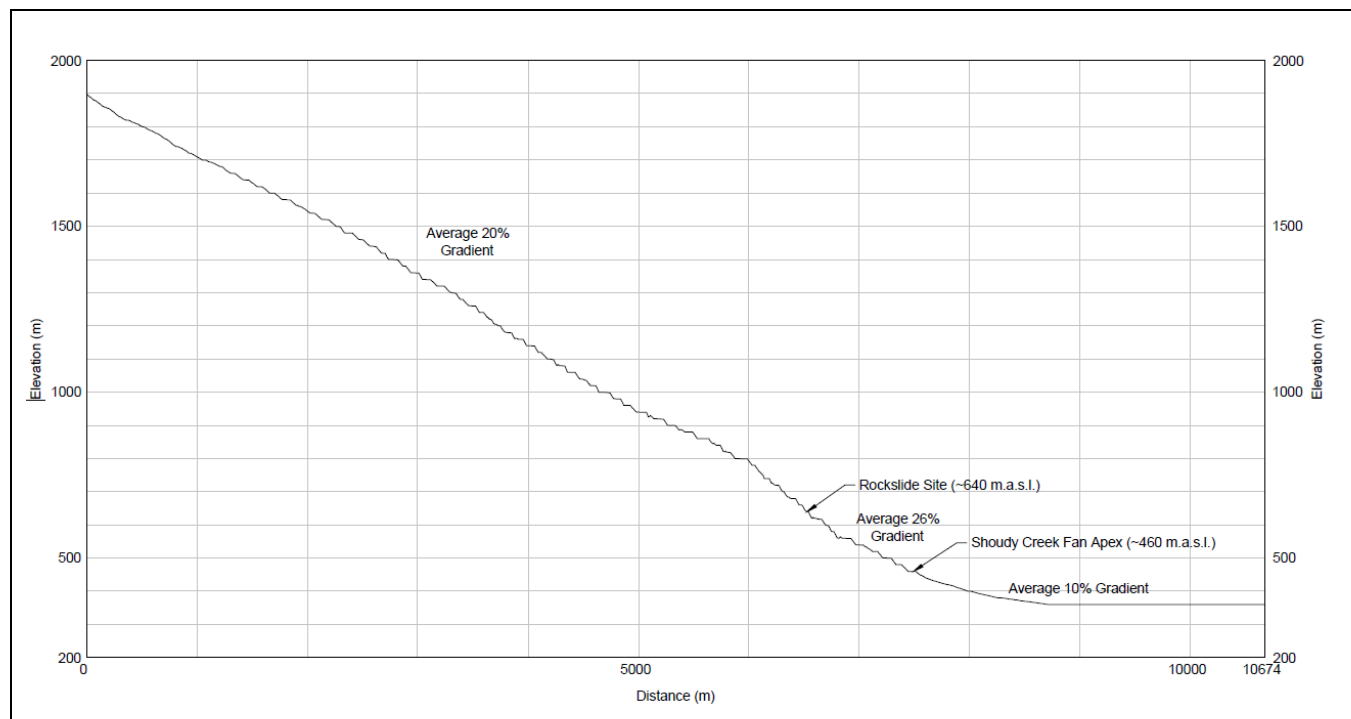
Figure 3-2: Longitudinal Profile of Shoudy Creek

Shoudy Creek has few contributing tributaries. The mainstem channel is relatively confined within a steep sided valley and flows from sub-alpine bowl-shaped headwaters (avg. channel gradient 20%) before reaching a bedrock canyon (avg. channel gradient 26%) just upstream of the fan. Figure 3-2 illustrates the longitudinal stream channel profile of Shoudy Creek. The broad alluvial fan (avg. channel gradient 10%) radiates out from the canyon, extending into the Similkameen River Valley. The distal edge of the fan is bounded by Chopaka Road and an abandoned railway embankment (see Map 002 and Map 003; Appendix B).

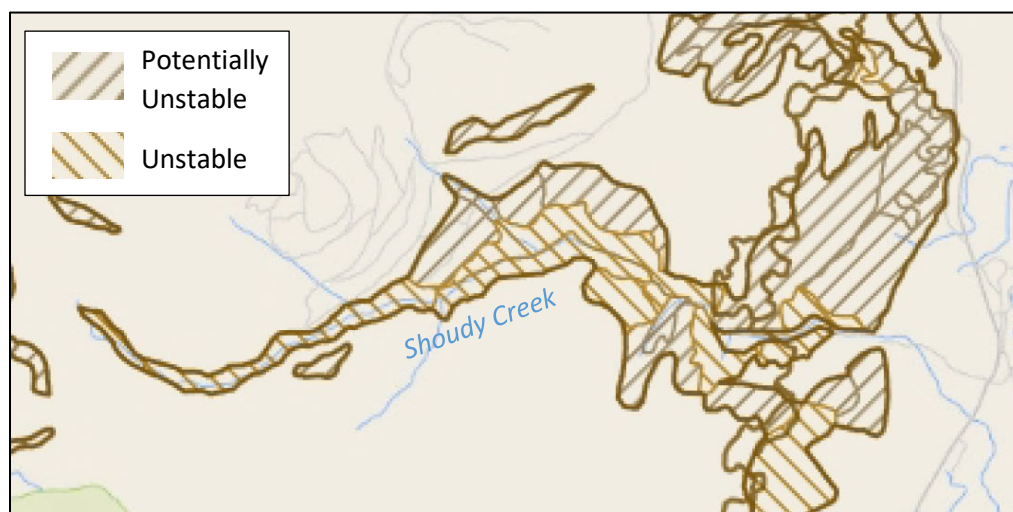
Figure 3-3: Reconnaissance-Level Terrain Stability Mapping for Shoudy Creek Watershed (Source iMAP BC)

Reconnaissance-level terrain stability mapping was obtained from iMAP BC for the Shoudy Creek watershed and is shown in Figure 3-3. The mapping indicates that the steeper valley side slopes along the mainstem channel are potentially-unstable, or unstable. Sediment that is generated by landslide or debris flow activity along the valley side slopes will enter the mainstem channel. The likelihood for sediment to mobilize and become transported downstream to the fan is dependant upon meteorological inputs as well as channel gradient, confinement, and the presence or absence of barriers (such as colluvium, landslide debris, or woody debris).

Based on the hazard criteria (Appendix A), terrain that is most conducive to post-wildfire instability are the potentially-unstable and unstable slopes that are also burned at moderate to high burn severity. In the Shoudy Creek watershed, areas of moderate and high burn severity are primarily located in the upper elevation headwaters; areas that are mapped as “stable”.

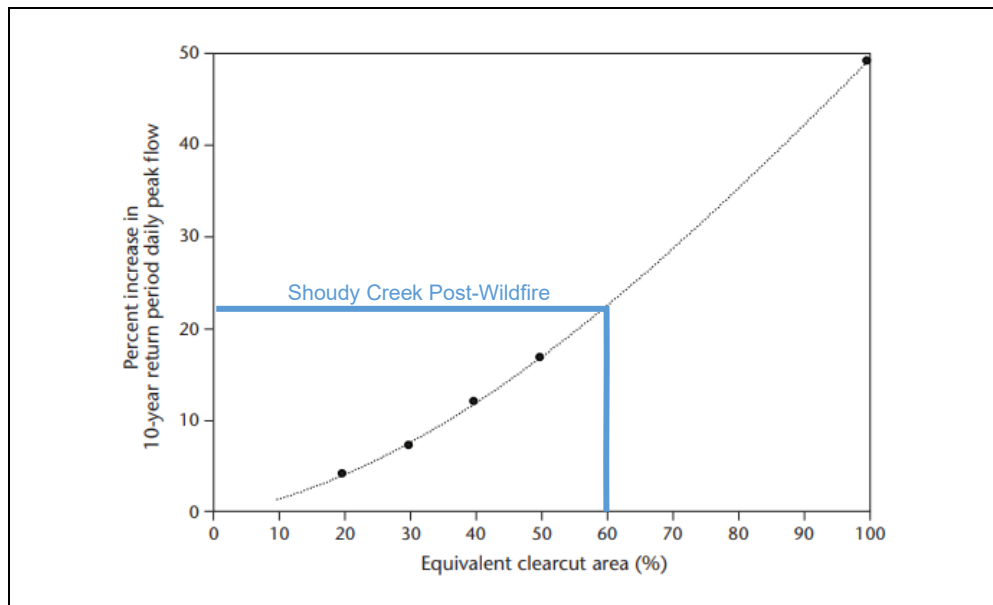
Figure 6-1: Equivalent Clearcut Area (%) Effects on Hydrology (adapted from Winkler and Boon, 2017)

Wildfire effects on watershed hydrology are comparable to the effects of any large-scale disturbance such as insect attack (i.e., mountain pine beetle) and forest harvesting. The measurement of “equivalent clear-cut area (ECA)” is used as an indicator of hydrologic change and is used to estimate effects on water yield and peak flow (Winkler and Boon, 2017). ECA is defined as the cumulative area of disturbance, as a percentage of watershed area, adjusted to account for forest regrowth, or recovery. Research by Winkler and Boon (2017) indicates that watersheds with a snowmelt-dominated peak flow are highly influenced by forest cover changes that influence snow accumulation and rates of snow melt. There is an assumption that as ECA increases, so does the potential for hydrologic change. Figure 6-2, from Winkler and Boon (2017) illustrates the corresponding hydrologic effect of ECA on peak streamflow for two creeks in the Upper Penticton Creek watershed. The figure shows that a 100% ECA represents a 50% increase in the 10-yr return period daily peak flow.

For Shoudy Creek, using this same relationship, a 60% ECA (corresponding to the % area burned at moderate and high severity) corresponds with a ~22% increase in the 10-yr return period daily peak flow in the first year

Based on the high percentage area burned (96%), the high percentage area burned at moderate to high severity (60%), and the higher elevation location of these moderate/high burn areas, post-wildfire effects on hydrology are anticipated to remain high until the forest recovers.

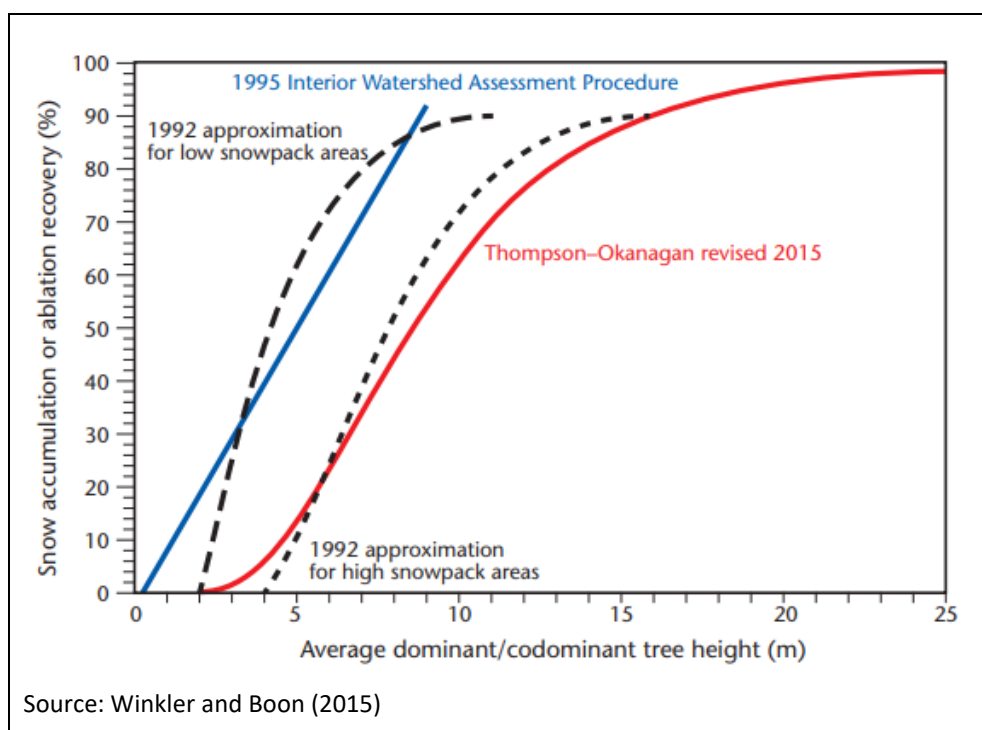
Figure 6-2: Hydrologic Recovery associated with Tree Growth

As the forest recovers from disturbance the effect on peak flow diminishes. Winkler and Boon (2015) provide a “recovery curve” for the Southern Interior (see Figure 6-2), which indicates that for a spruce-fir and lodgepole pine forest, 90% recovery is expected once regrowth is $\geq 65\%$ of the original stand height of 25 m, which corresponds to approx. 16 m.

For Shoudy Creek, based on approximate rates of recovery and rates of tree growth for the Southern Interior, the time to reach a 15 m stand height, representing $\sim 20\%$ ECA, is in the order of 50-60 years.
